**A Comprehensive Asbestos Survey and Assessment
For the
University of Utah's College of Nursing
Building 588
University of Utah Campus
10 South 2000 East
Salt Lake City, Utah**

April 17, 2008

IHI Project No. 08A-1020

Executive Summary

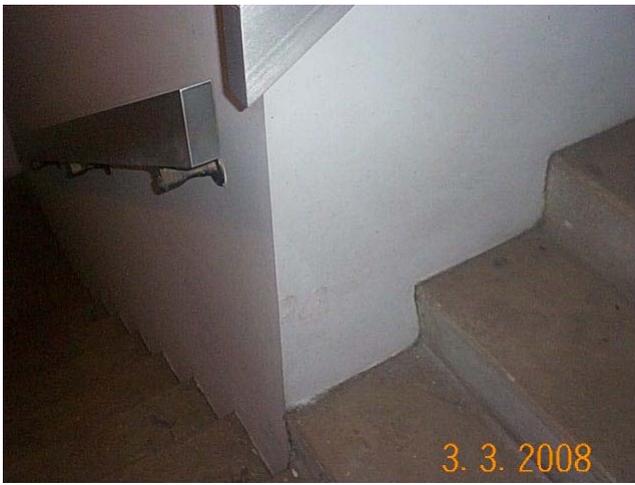
Photograph 1
Asbestos-containing gypsum board wall system, homogeneous area M001.

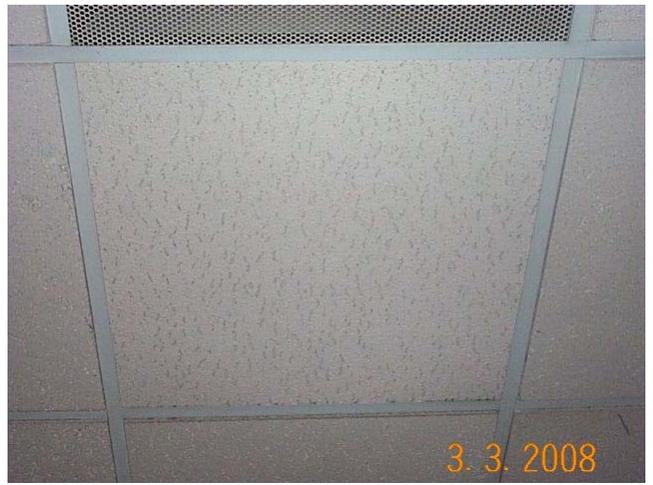
Photograph 2
Asbestos-containing ceiling tile, homogeneous area M007.

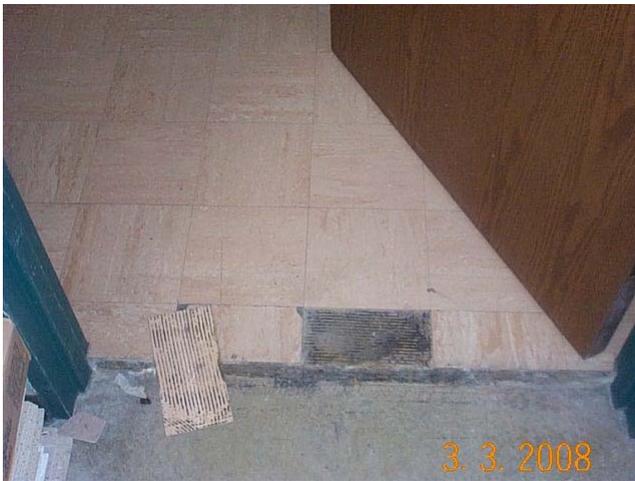
Photograph 3
Asbestos-containing floor tile and black mastic, homogeneous area M008.

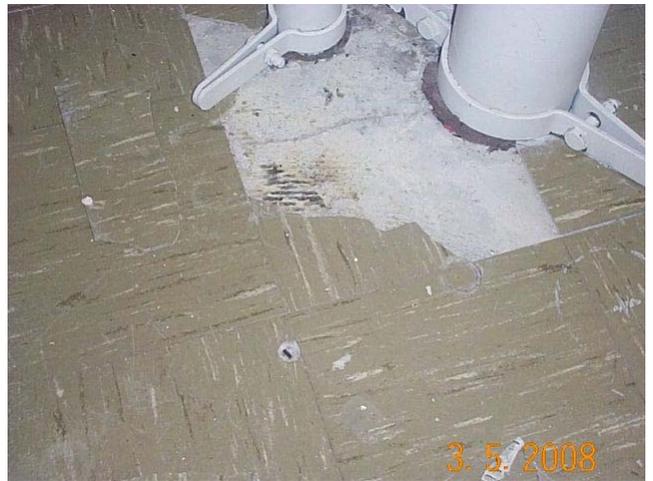
Photograph 4
Asbestos-containing floor tile and black mastic, homogeneous area M019.

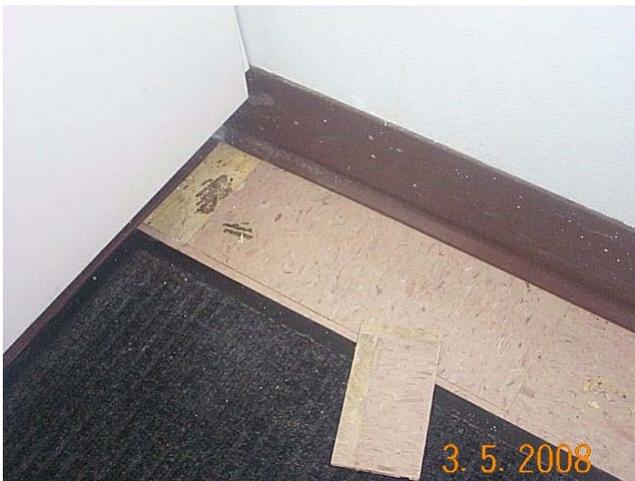
Photograph 5
Non asbestos-containing floor tile with asbestos-containing black mastic, homogeneous area M021.

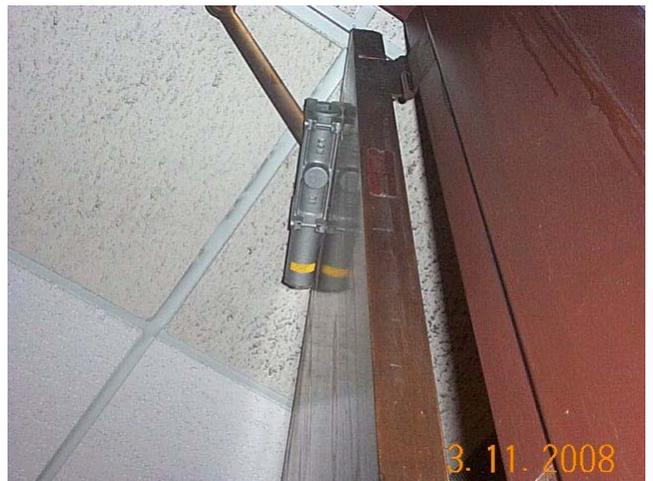
Photograph 6
Asbestos-containing fire door, homogeneous area M028.

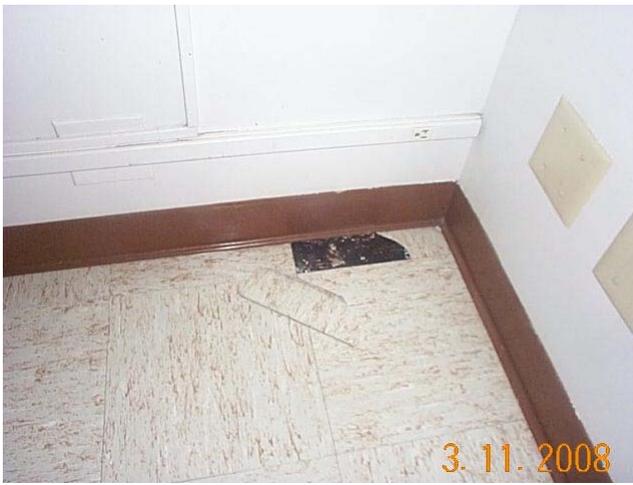
Photograph 7
Asbestos-containing floor tile and black mastic, homogeneous area M030.

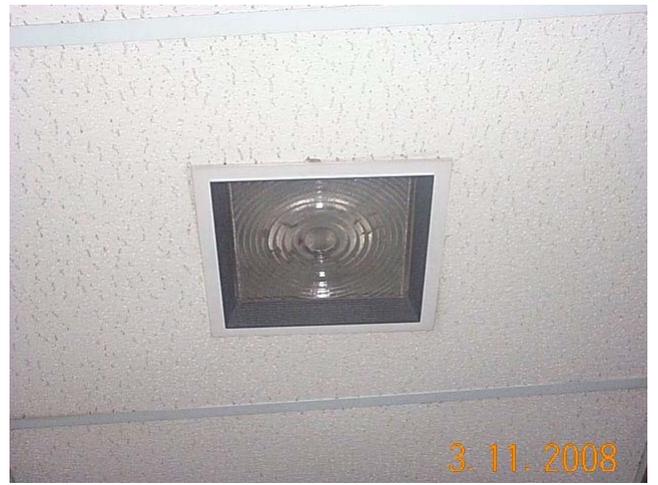
Photograph 8
Recessed light fixture with assumed asbestos-containing wire insulation, homogeneous area M033.

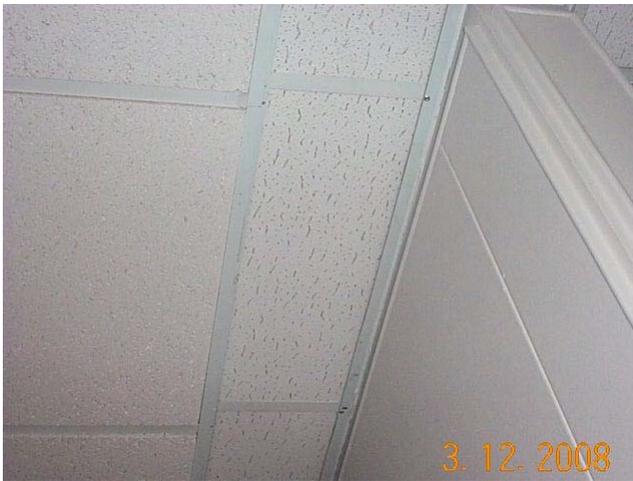
Photograph 9
Asbestos-containing ceiling tile, homogeneous area M037.

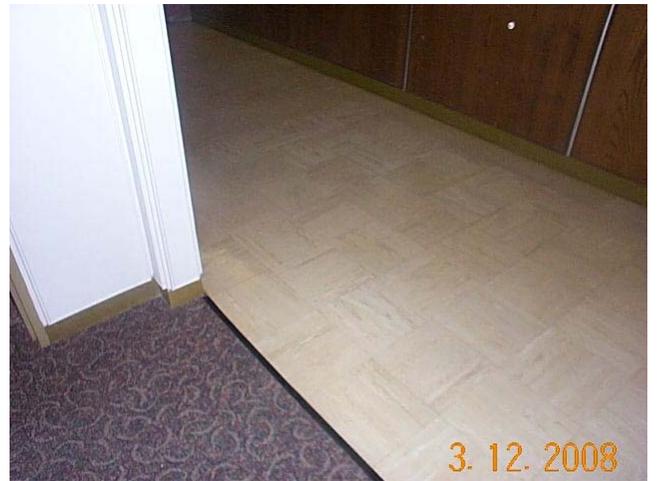
Photograph 10
Asbestos-containing floor tile and black mastic, homogeneous area M038.

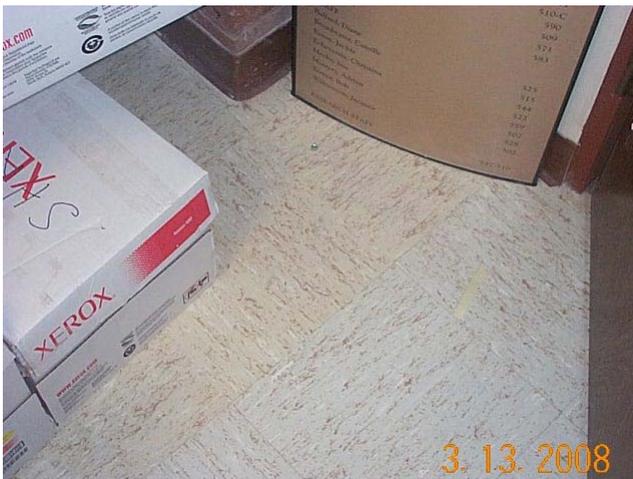
Photograph 11
Asbestos-containing floor tile and black mastic, homogeneous area M043.

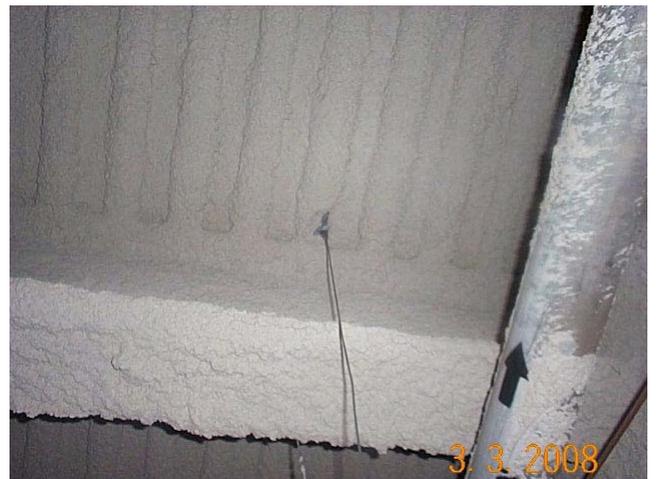
Photograph 12
Asbestos-containing spray structural fireproofing, homogeneous area S001.

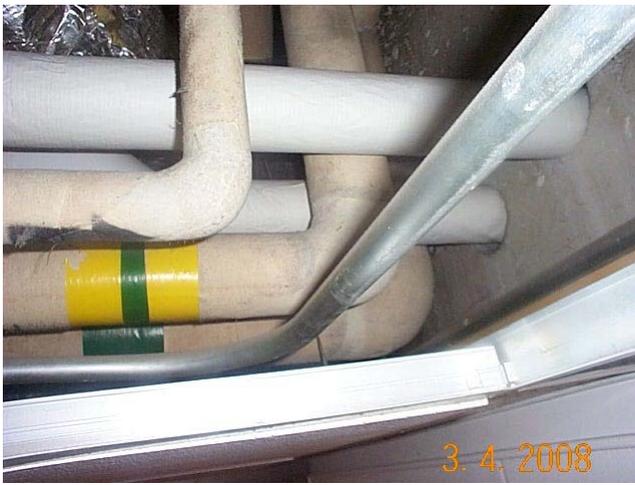
T001	Pipe Fitting Insulation (inaccessible)	Metal	5	No Damage	Periodic Access	Low
T002	Pipe Fitting Insulation	Metal	1	Slight Damage	Periodic Access	Medium

Photograph 13
Asbestos-containing pipe fitting insulation, homogeneous area T001, domestic water system.

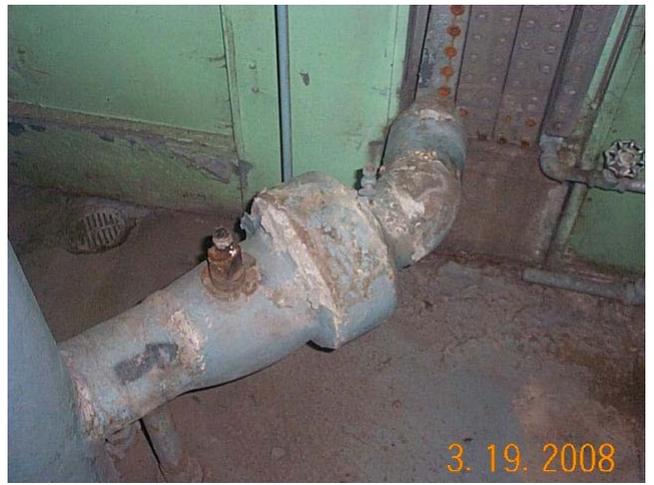
Photograph 14
Damaged asbestos-containing pipe fitting insulation, homogeneous area T002, chilled water system.

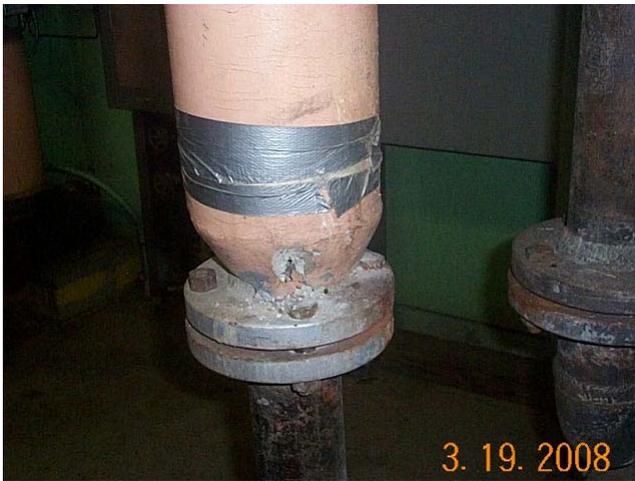
Homogeneous Area Number	Material Type	Substrate	Assessment Category	Damage	Accessibility	Disturbance Potential
T003	Pipe Fitting Insulation	Metal	1	Slight Damage	Periodic Access	Medium
T004	Tank Insulation	Metal	5	No Damage	Periodic Access	Low
T005	Pipe Insulation	Metal	1	Slight Damage	Periodic Access	Medium
T005A	Pipe Fitting Insulation	Metal	5	No Damage	Periodic Access	Low
T006	Pipe Insulation over 12" dia./ln.ft.	Metal	5	No Damage	Periodic Access	Low

Photograph 15
Damaged asbestos-containing pipe fitting insulation, homogeneous area T003, heating supply system.

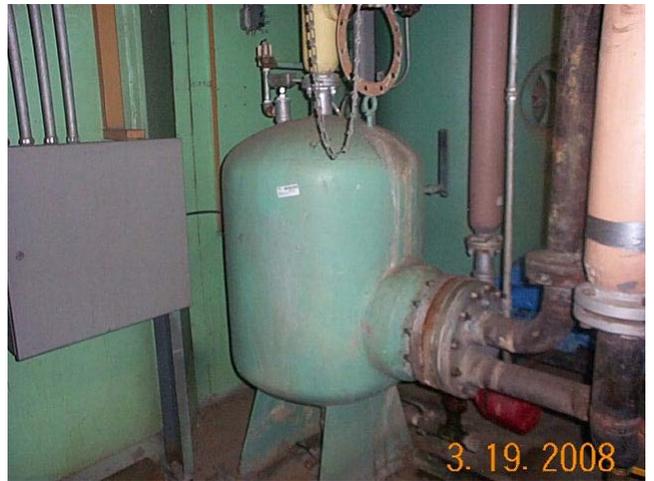
Photograph 16
Asbestos-containing tank insulation, homogeneous area T004, heating supply system.

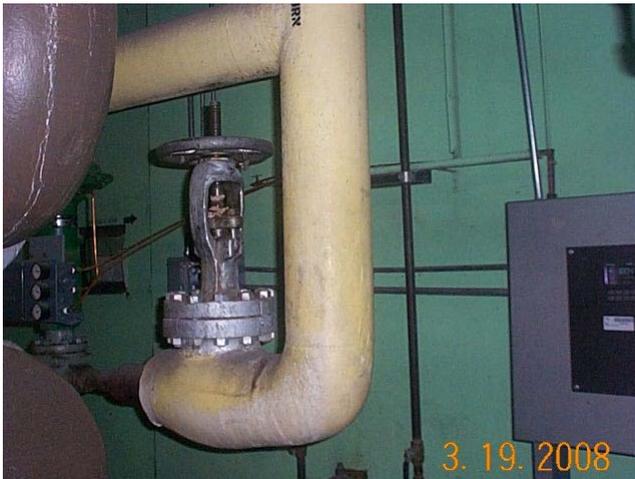
Photograph 17
Asbestos-containing pipe insulation, homogeneous area T005, heating return system.

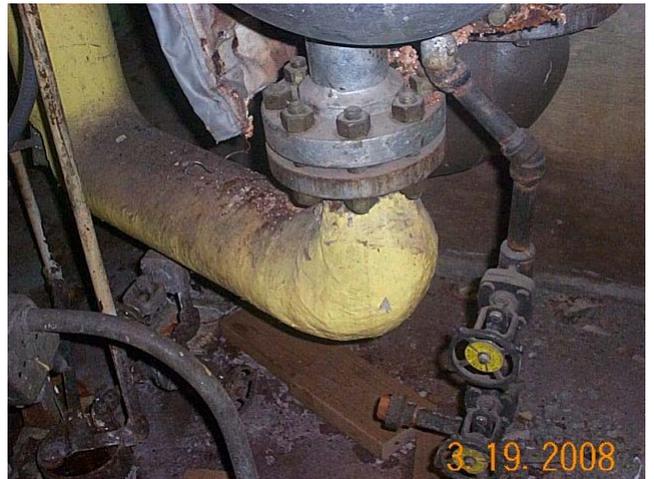
Photograph 18
Asbestos-containing pipe fitting insulation, homogeneous area T005A, heating return system.

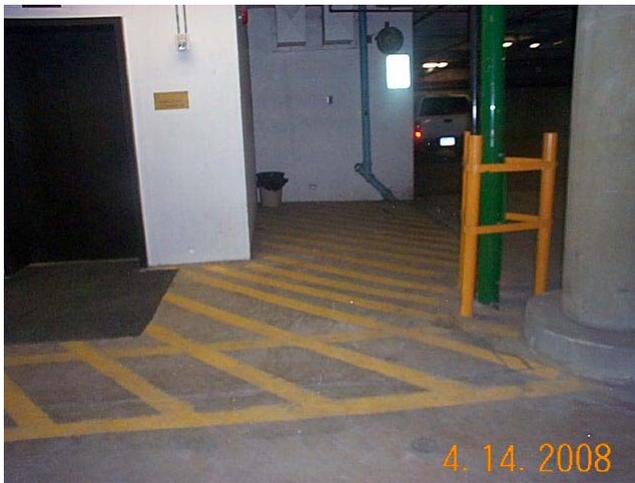
Photograph 1

A view of the yellow paint in the parking with high concentrations of lead (5.1 mg/cm^2).

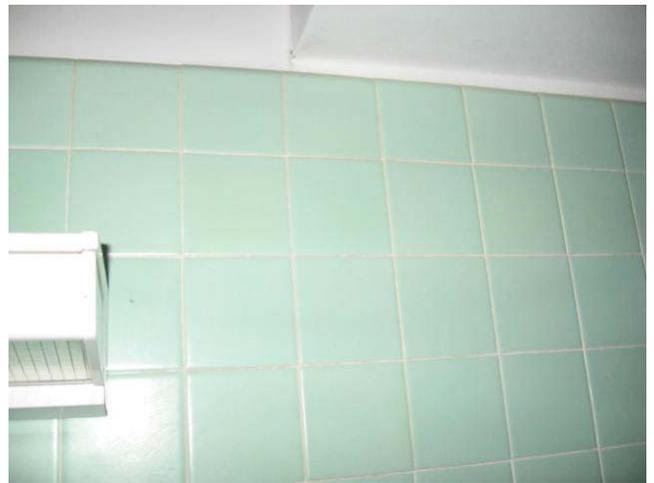
Photograph 2

This is one of the ceramic tile walls in the restrooms with concentrations of lead up to 28 mg/cm^2 .

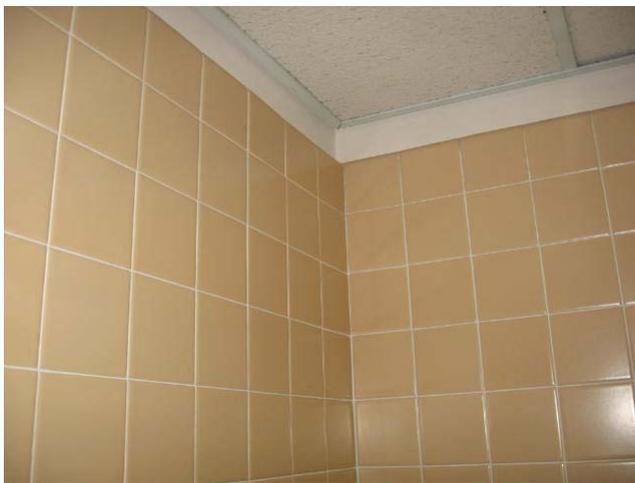
Photograph 3

Another ceramic tile walls in the janitor closet containing up to 22 mg/cm^2 concentrations of lead.

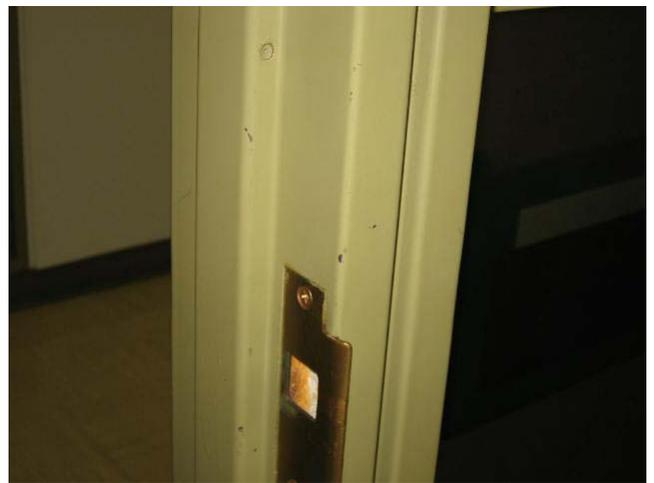
Photograph 4

The above metal doorjamb measured 0.13 mg/cm^2 of lead.

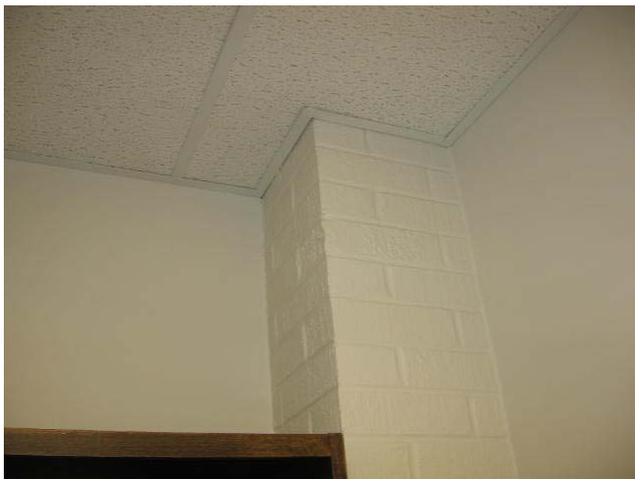
Photograph 5

The brick column shown above measured 1.0 mg/cm^2 of lead. The drywall walls measured 0.19 mg/cm^2 and work must follow OSHA guidelines.

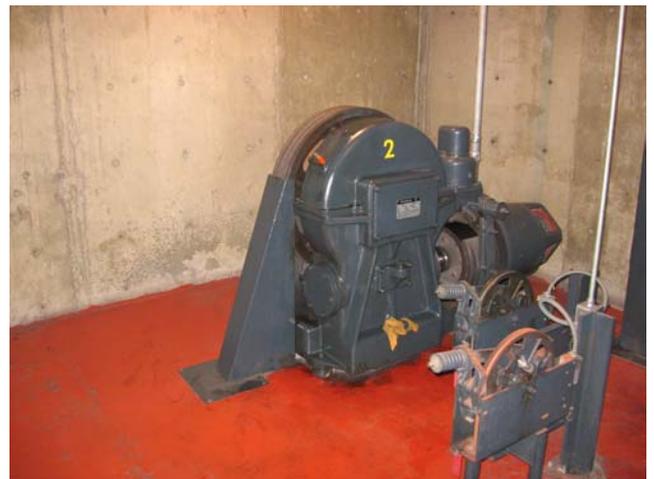
Photograph 6

The concrete floor in the penthouse contained 0.23 mg/cm^2 of lead. .
