## ADDENDUM NO. 1

Reference: Demolition and Electrical – Gibson Science Center  
Southern Utah University – Cedar City, Utah  
DFCM Project No. 07297730

**HAZMAT (ASBESTOS & LEAD BASED PAINT)  
SURVEY AND ASSESSMENT**

*Southern Utah University  
Life Science Building  
Cedar City, Utah*

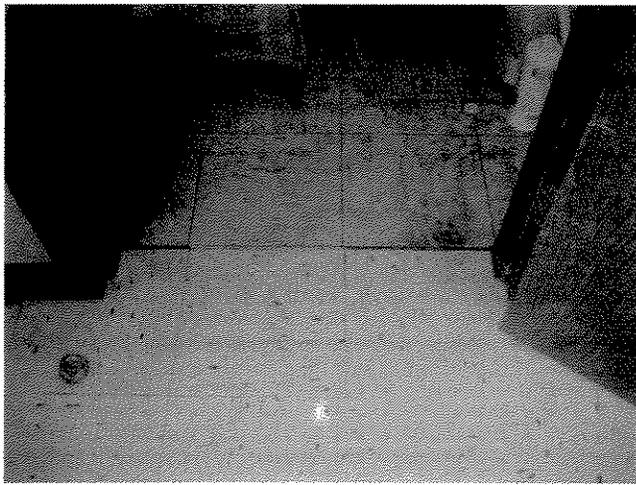
**Photograph 1- M001**  
Asbestos Containing 12" Floor Tile  
Custodial Closet Room 164

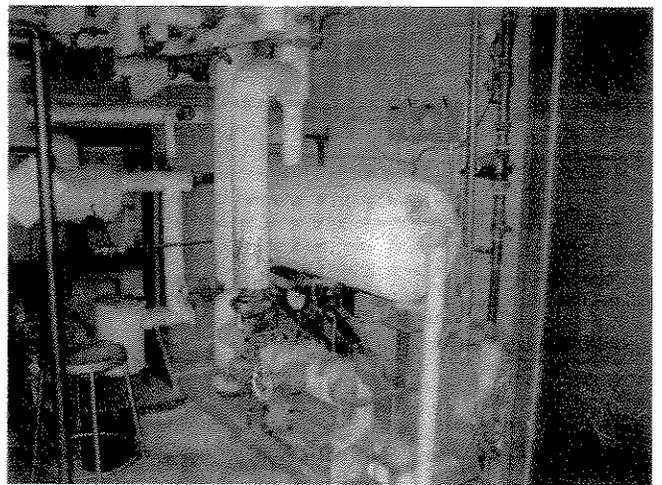
**Photograph 2-T001**  
Hot Water Storage Tank  
4' x 18" w/Mudded Ends  
No Asbestos Detected

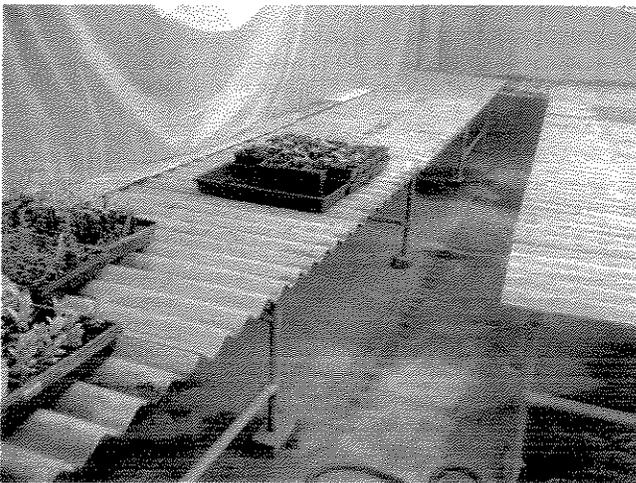
**Photograph 3-M003**  
Asbestos Containing Transite Panels  
(Corrugated), Greenhouse

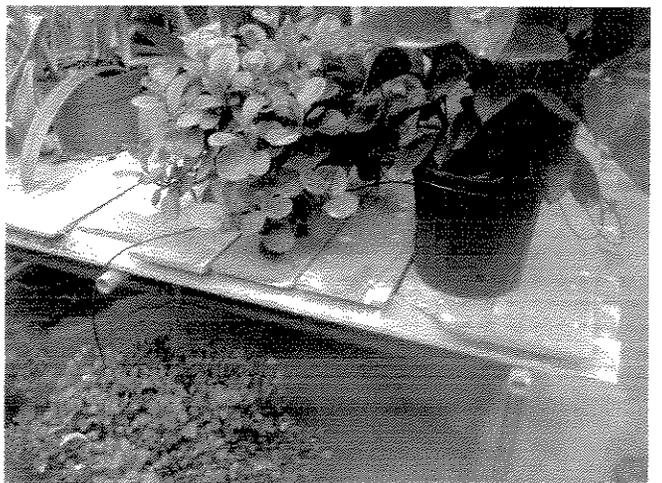
**Photograph 4- M004**  
Asbestos Containing Transite Panels (Flat)  
Greenhouse

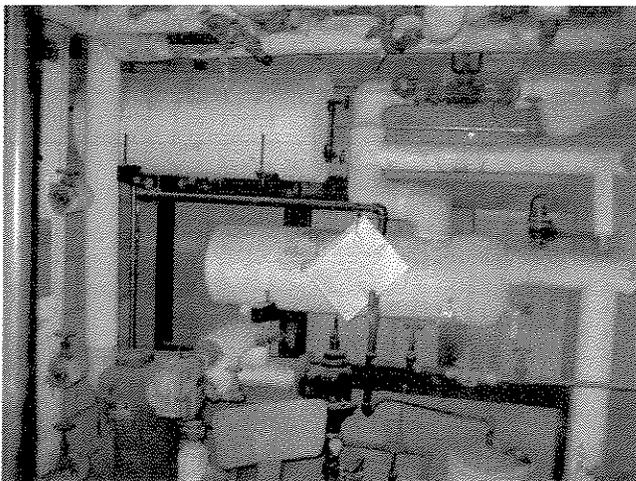
**Photograph 5- T002**  
Heat Exchanger containing less than 1%  
chrysotile asbestos
