LEAD BASED PAINT (LBP) SURVEY AND ASSESSMENT

***UTAH DIVISION OF WILDLIFE RESOURCES
GAME FARM RESIDENCE
3116 South 500 West
Vernal, Utah***

UTAH DIVISION OF WILDLIFE RESOURCES GAME FARM RESIDENCE 3116 South 500 West Vernal, Utah

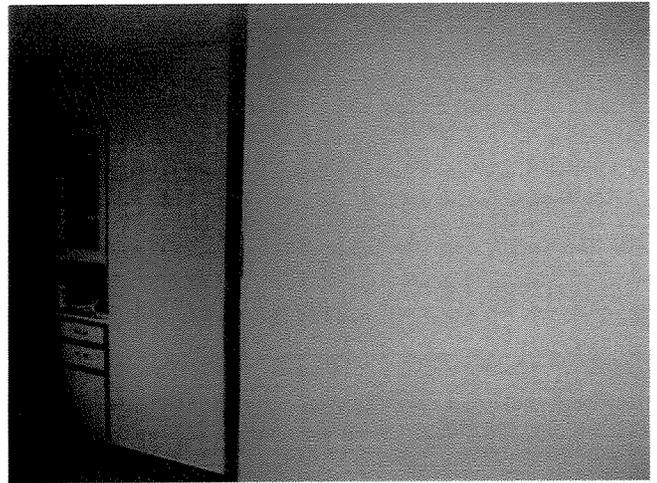
Photograph 2-DWR GAME FARM RESIDENCE
View interior living room, light green paint, no LBP.

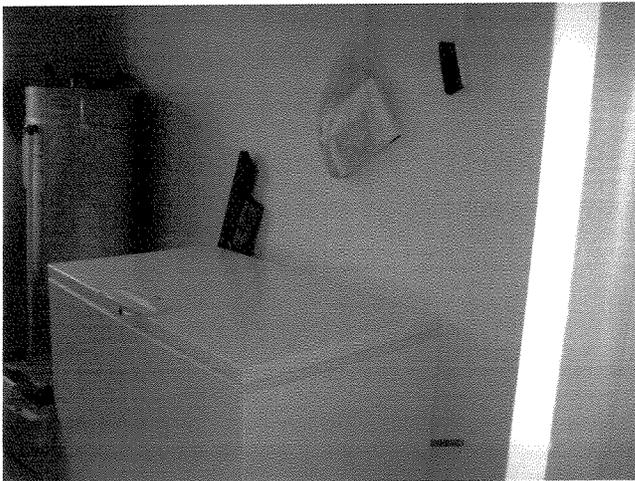
Photograph 3- DWR GAME FARM RESIDENCE
View of garage room, no LBP.

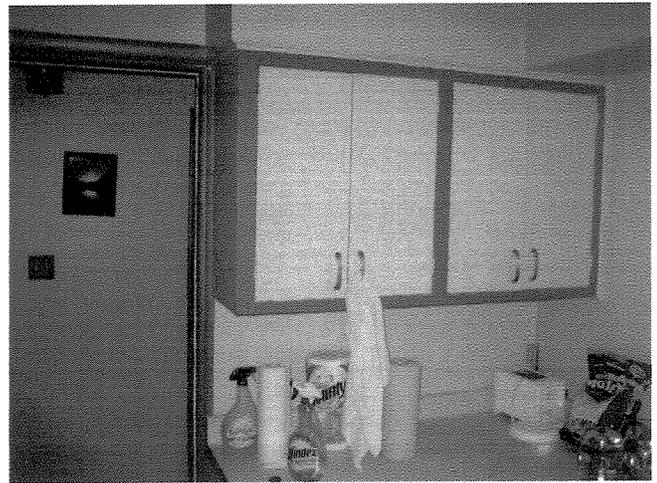
Photograph 4- DWR GAME FARM RESIDENCE
View of Kitchen, dark green trim/light green cabinets,
no LBP.

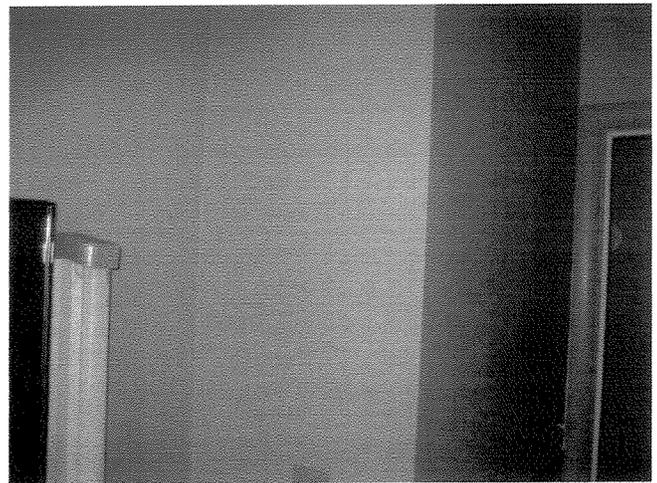
Photograph 6- DWR GAME FARM RESIDENCE
View of Bathroom blue wall, no LBP.

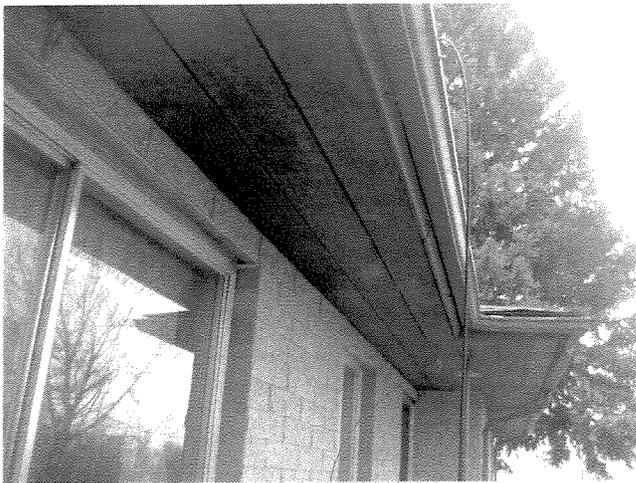
Photograph 7- DWR GAME FARM RESIDENCE
View of exterior wood soffit painted red, no LBP.

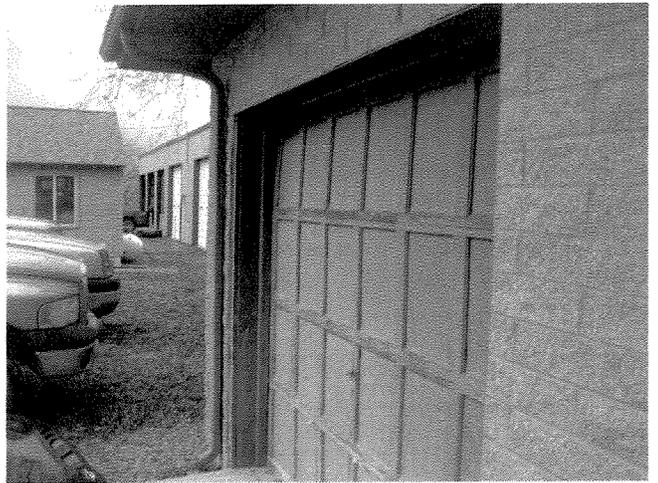
Photograph 8- DWR GAME FARM RESIDENCE
View of exterior garage door, no LBP.

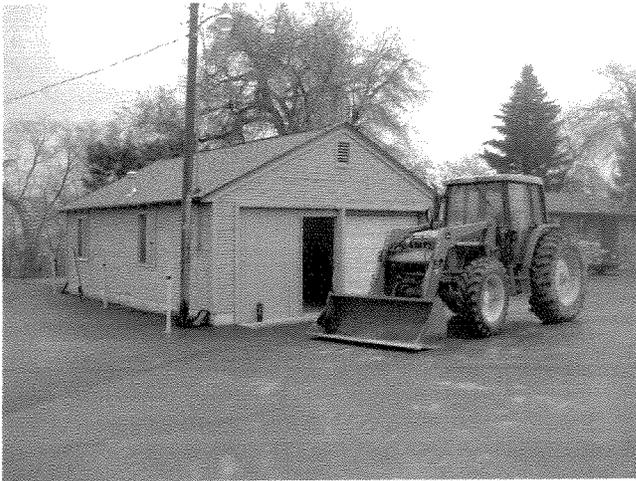
Photograph 9- DWR GAME FARM RESIDENCE
View of Machine Shop. The XRF indicated that ***LBP IS PRESENT ON THE EXTERIOR.*** The XRF will not designate which layer of paint is LBP.

Because Lead has been detected, the OSHA Lead in Construction Standard (29 CFR 1926.62) applies to any construction work-***Lead Related Tasks*** (including renovation and demolition) that may disturb those surfaces. The standard requires, among other things, the following:

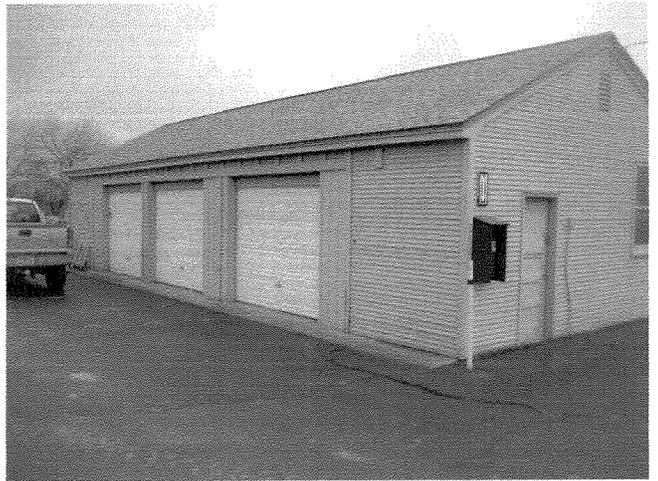
24	Game Farm Residence, Exterior Front porch	Red/fair	Wall/brick	NEGATIVE 0.3
25		Red/fair	Support column/metal	NEGATIVE -0.2
26	Garage exterior	Red/fair	Garage door/wood	NEGATIVE -0.7
27		Red/fair	Garage door frame/wood	NEGATIVE -0.3
28				NEGATIVE -0.3
29	Game Farm Machine Shop, exterior	Light brown/fair	North wall/wood	NEGATIVE -0.4
30		Light brown/fair	West wall/wood	NEGATIVE 0.0
31		<i>Light brown/fair</i>	<i>North wall/wood</i>	<i>POSITIVE 8.7</i>
32		<i>Light brown/fair</i>	<i>East wall/wood</i>	<i>POSITIVE 8.5</i>
33	<i>Game Farm 3 Door Shed, exterior</i>	<i>Light brown/fair</i>	<i>East wall/wood</i>	<i>POSITIVE >9.9</i>
34		Light brown/fair	South wall/wood	NEGATIVE -0.2
35		Light brown/fair	South wall/wood	NEGATIVE -0.1
36		Light brown/fair	West wall/wood	NEGATIVE -0.3
37		<i>Light brown/fair</i>	<i>West wall/wood</i>	<i>POSITIVE >9.9</i>
38		<i>Light brown/fair</i>	<i>North window sill/wood</i>	<i>POSITIVE 6.5</i>

39		<i>Light brown/fair</i>	<i>North window frame/wood</i>	<i>POSITIVE 5.6</i>
40		<i>Light brown/fair</i>	<i>East door/wood</i>	<i>POSITIVE 3.9</i>
41		<i>Light brown/fair</i>	<i>East door frame/wood</i>	<i>POSITIVE 4.8</i>

Photograph 10-DWR GAME FARM RESIDENCE
View of 3 Door Shop. The XRF indicated that ***LBP IS PRESENT ON THE EXTERIOR.*** The XRF will not designate which layer of paint is LBP.
