ADDENDUM NO. 1

Reference: Demolish City Pool & Create Intramural Ball Fields
Southern Utah University – Cedar City, Utah
Project No.07273050

**ADDENDUM NO. 1
TO
CONTRACT DOCUMENTS
FOR
SUU INTRAMURAL SOCCER FIELDS**

**PRE-DEMOLITION INSPECTION
FOR ASBESTOS, LEAD, AND
UNIVERSAL, HAZARDOUS, AND TOXIC WASTES**

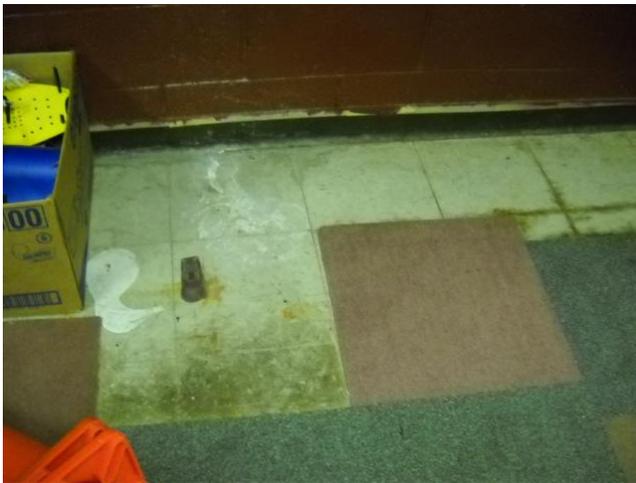
| Homogeneous Area Number | Material Type | Substrate | Assessment Category | Damage | Accessibility | Disturbance Potential |
|---|---|---|---|---|---|---|
| M010 | Floor Tile - Under GDC | Cement | X | No Damage | Rarely Accessed | Low |

Photograph 3
M010: ACM 12 inch floor tile with non-ACM black mastic in Room P110

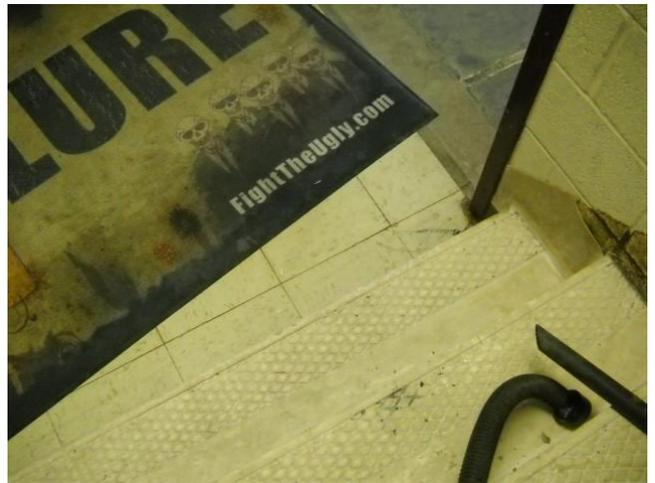
| Homogeneous Area Number | Material Type | Substrate | Assessment Category | Damage | Accessibility | Disturbance Potential |
|---|---|---|---|---|---|---|
| M007 | Floor Tile - Exposed | Wallboard | X | No Damage | Continuous | Medium |

Photograph 4
M007: ACM 12 inch floor tile and non-ACM stair vinyl in Room PS04

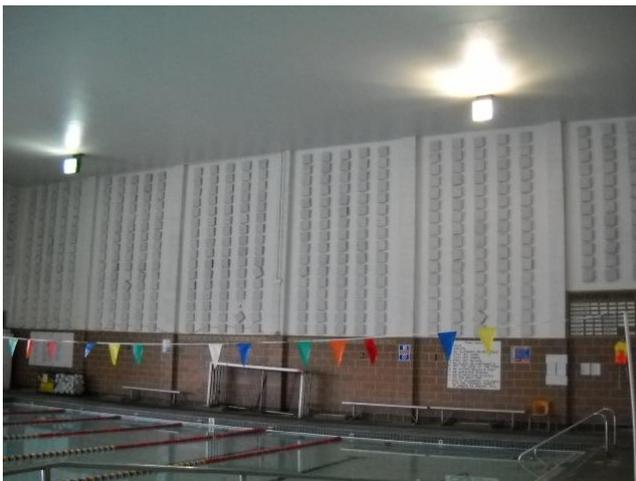
- M012: The gypsum board ceiling system is located approximately 20-25 feet above ground level (pool)
- M013: The wall system was found to contain 0.8% chrysotile asbestos (joint compound) and less than 1% asbestos (overall) by PLM analysis during a September 2000 inspection. The State of Utah DAQ does not regulate the removal of materials that contain 1.0% (or less) asbestos. However, point count analysis for the overall wall system indicated that it contains a trace of chrysotile asbestos (<0.1%), which falls under the OSHA regulatory requirements for Class II Asbestos Work. IHI therefore recommends that this material be removed by a Utah-certified Asbestos Abatement contractor following the provisions of the OSHA Asbestos in Construction Standard.

| Homogeneous Area Number | Material Type | Substrate | Assessment Category | Damage | Accessibility | Disturbance Potential |
|---|---|---|---|---|---|---|
| M012 | Wallboard and Joint Compound | Wood | X | No Damage | Rarely Accessed | Low |
| M013 | Wallboard and Joint Compound | Wood | X | No Damage | Rarely Accessed | Low |

Photograph 5
M012 and M013: Gypsum board ceiling and wall system in Room P121 with ACM joint compound and non-ACM ceiling tiles (M008) on walls

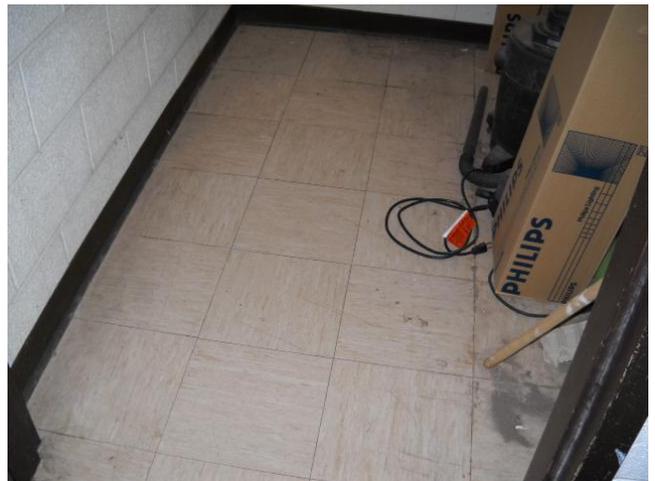
| Homogeneous Area Number | Material Type | Substrate | Assessment Category | Damage | Accessibility | Disturbance Potential |
|---|---|---|---|---|---|---|
| M023 | Floor Tile and Mastic on Cement | Cement | X | No Damage | Continuous | Low |

Photograph 6
M023: ACM black mastic under non-ACM 12 inch floor tile in Room P105 and non-ACM cove base (M024)

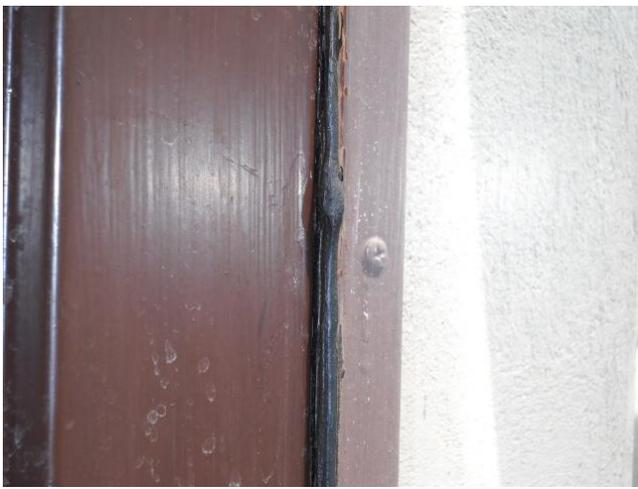
- M031: This material was found on the interior of the fixed windows in the pool area and was not readily visible or noted on all windows during the inspection.

| Homogeneous Area Number | Material Type | Substrate | Assessment Category | Damage | Accessibility | Disturbance Potential |
|---|---|---|---|---|---|---|
| M031 | Window Caulking/ln.ft. | Metal | X | No Damage | Rarely Accessed | Low |

Photograph 7
M031: ACM black window caulk in fixed windows of Room P121

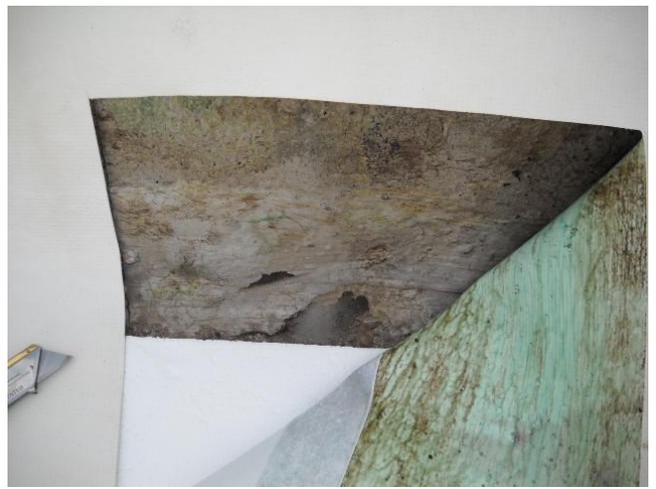
| Homogeneous Area Number | Material Type | Substrate | Assessment Category | Damage | Accessibility | Disturbance Potential |
|---|---|---|---|---|---|---|
| M016 | Roofing Tar & Felt | Wood | X | No Damage | Rarely Accessed | Low |
| M017 | Roof Sealant | Various | X | No Damage | Rarely Accessed | Low |

Photograph 8
M016: ACM roof flashing felt on west end of west roof under rubberized membrane showing ACM (M017) silver sealant on felt

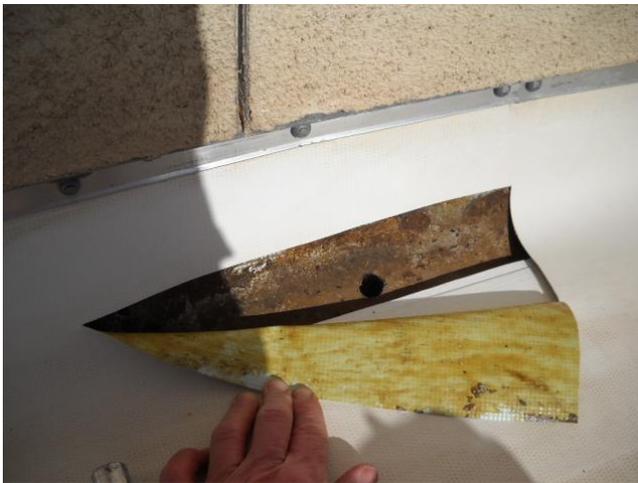
Photograph 9
ACM flashing roofing felt (M016) on east side of west roof under non-ACM membrane

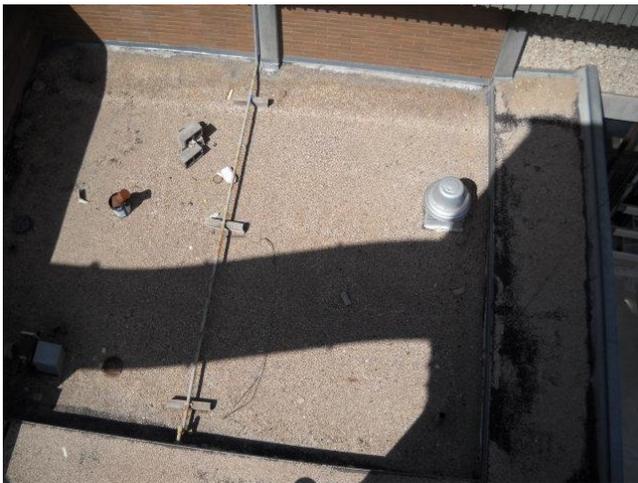
Photograph 11
View from top of water slide tower of connecting roof with assumed ACM flashing felt (M016) and tar sealants (M017) on roof penetrations

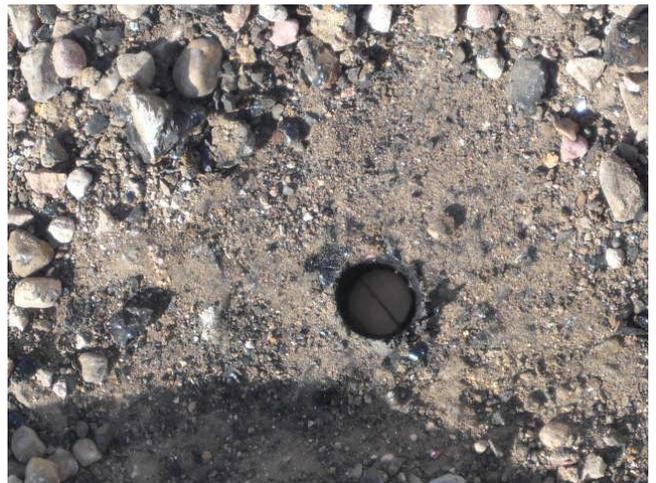
Photograph 12
M015: Non-ACM built-up tar and felt under membrane and foam insulation on west roof

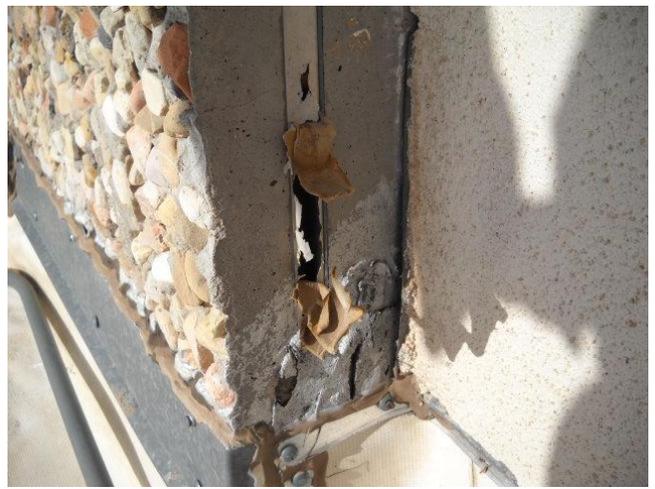
Photograph 14
M017: ACM black and silver tar sealant and non-ACM expansion joint (M019)

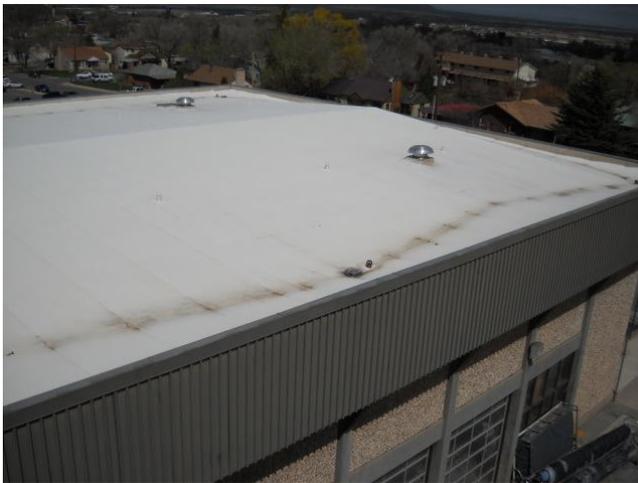
Photograph 15
View of main roof with assumed ACM flashing felt (M016) and tar sealants (M017) from top of water slide tower

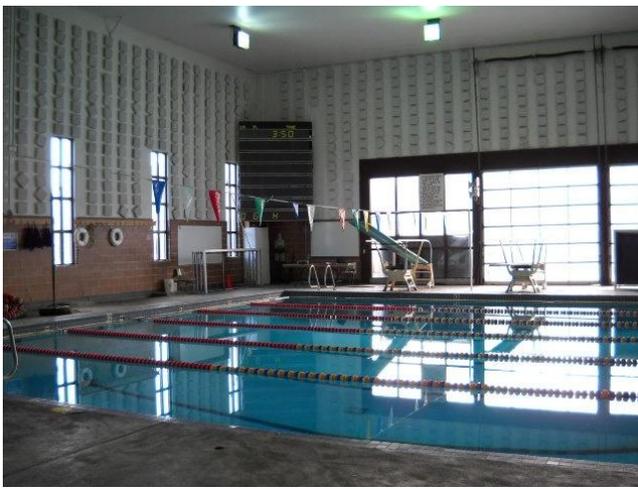
Photograph 19
View of non-ACM ceiling tiles (M008) on walls of Room P121 and fixed windows with ACM window caulk (M031)

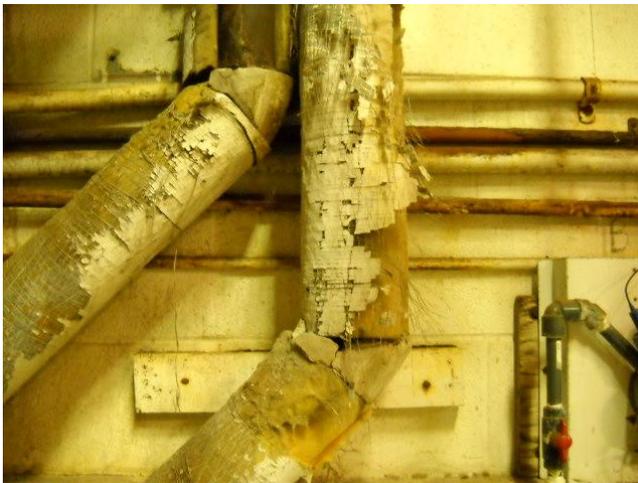
Photograph 33
Damaged non-ACM pipe fitting insulation (T002) in Room P122

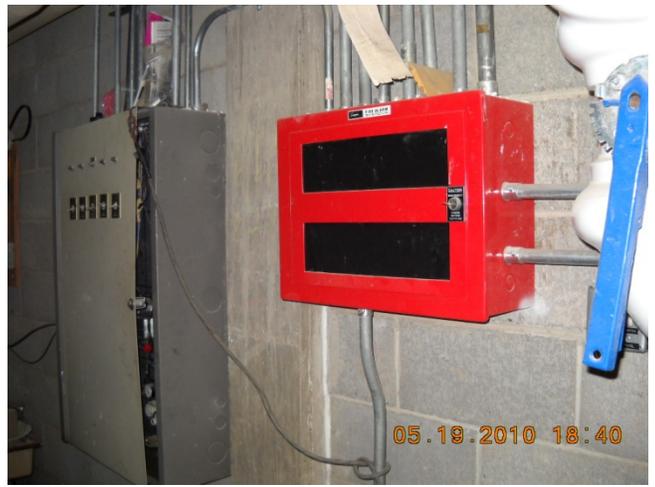
Photograph 2
This alarm box contained 0.8 mg/cm^2 of lead as measured by the Niton 300 XLP.

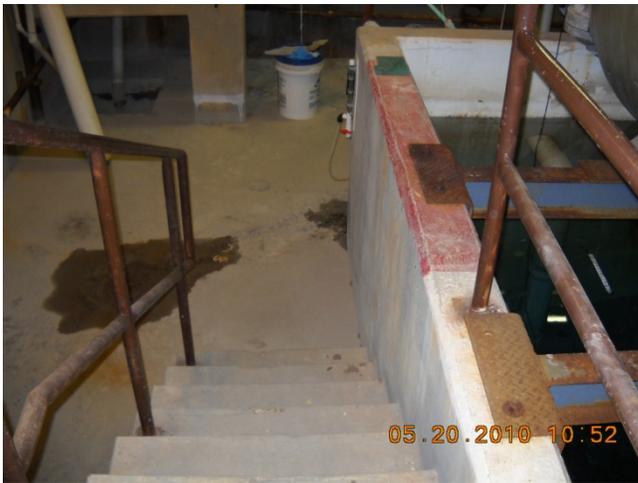
Photograph 3
The red paint above measured 0.8 mg/cm^2 of lead by the Niton 300 XLP.

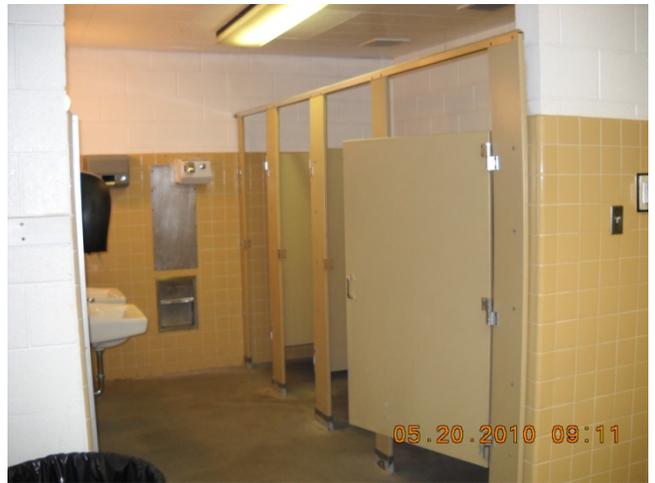
Photograph 4
The stalls in the boys' and girls' locker rooms contained up to 0.47 mg/cm^2 of lead.

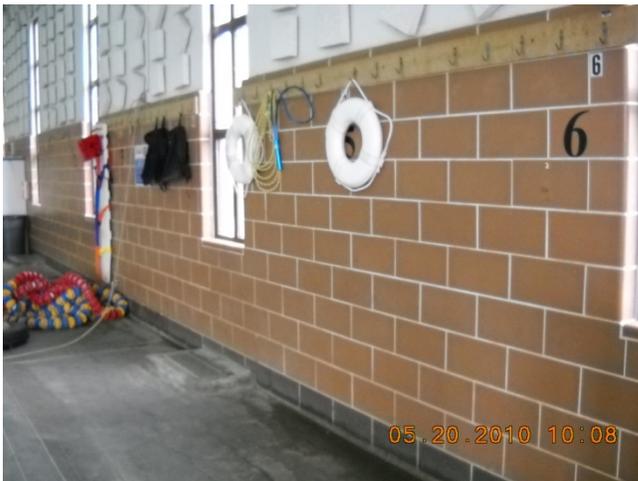
Photograph 5
There is a thin layer of glazing on the brick walls that contained low levels of lead up to 0.22 mg/cm^2 .

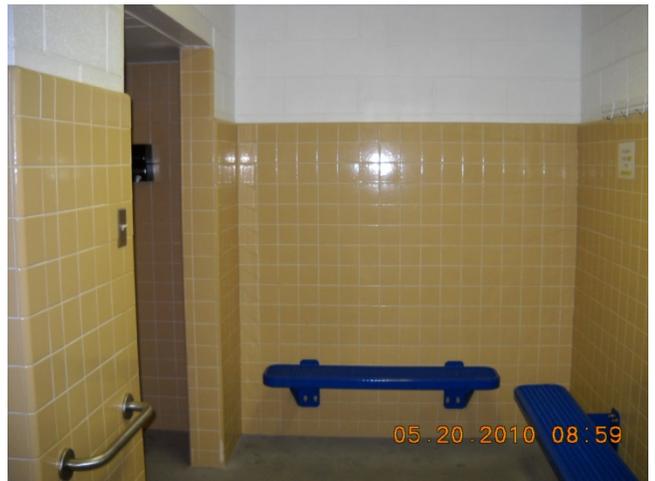
Photograph 6
A paint chip sample of the ceramic tiles showed 0.0012% of lead.

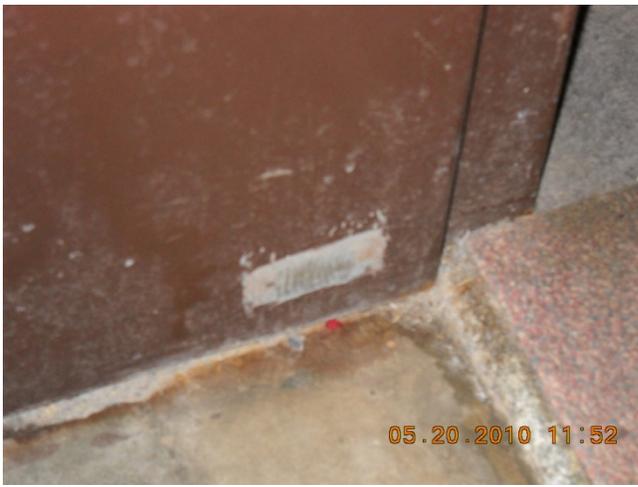
Photograph 7

The Niton XRF measured 0.22 mg/cm² of lead. The paint chip result was reported at 0.001 mg/cm² below the reporting limit of 0.007.

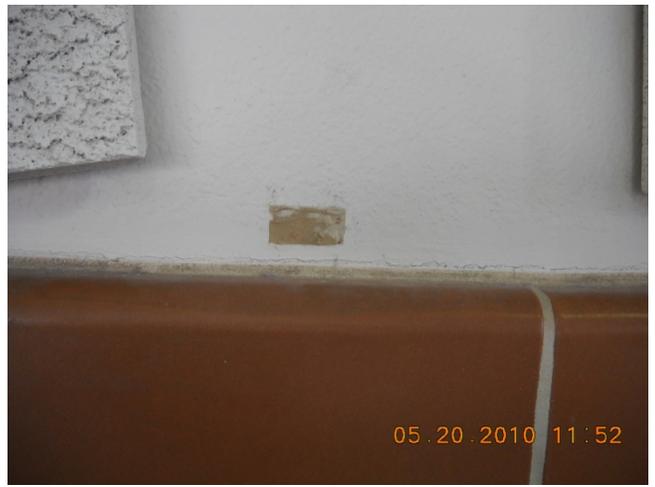
Photograph 8

The paint chip sample of the white paint on drywall was reported at 0.001 mg/cm² of lead concentration.

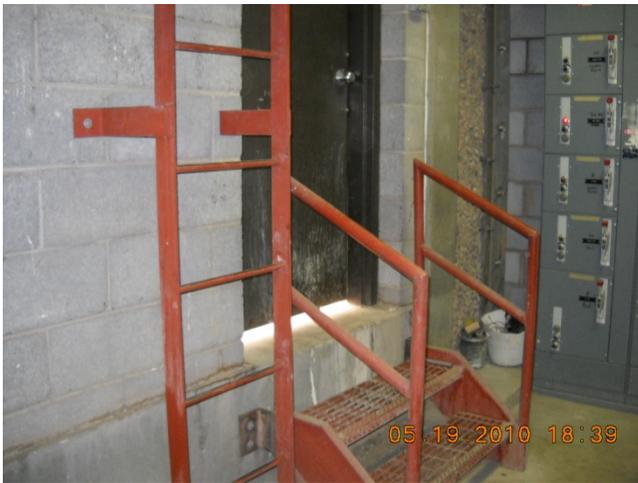
Photograph 9

These painted surfaces measured 0.00 to 0.07 mg/cm² of lead concentration by the Niton XLP.

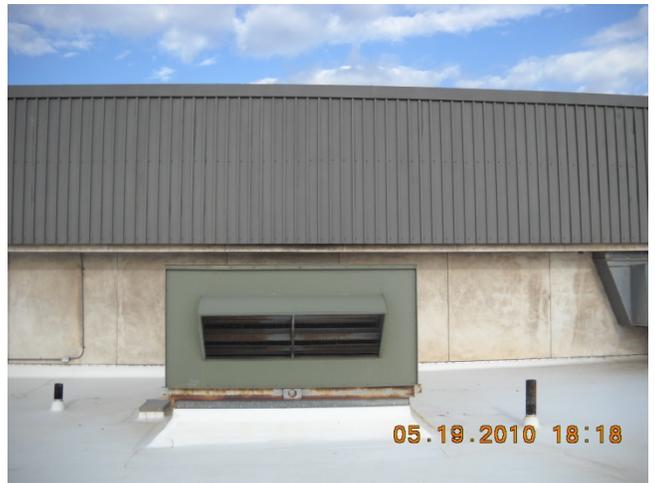
Photograph 10

The metal fascia and mechanical equipment measured 0.00 to 0.03 mg/cm² of lead concentration.

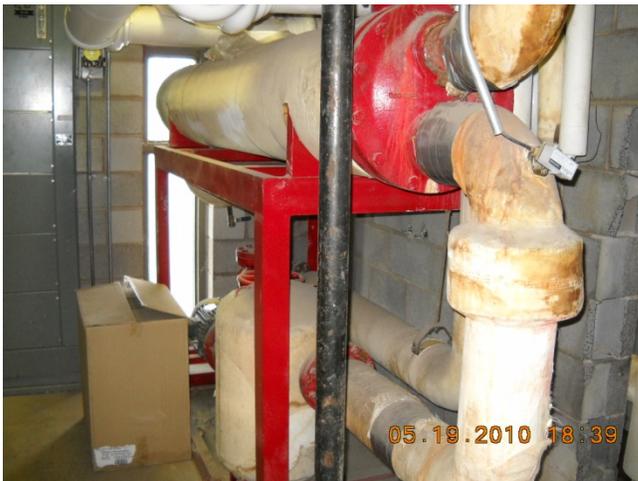
Photograph 11

These red surfaces have very low concentration of lead. OSHA Lead in Construction Standards must be followed during demolition.
