## Addendum No. 1

Reference: Addition/Renovation Fine Arts Complex  
Utah State University - Logan, Utah  
DFCM Project No. 14385770

Subject: **Addendum No. 1**

RENOVATION & ADDITION | LOGAN, UTAH  
**FINE ARTS COMPLEX**

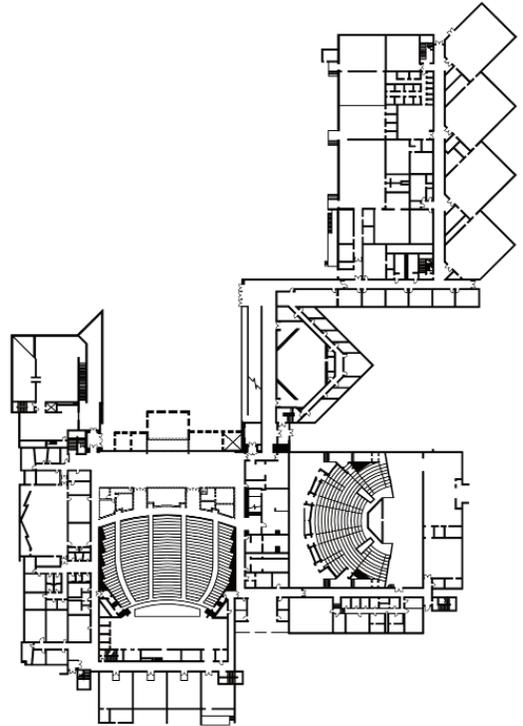
Emergency lighting for the complex is inadequate. This project will connect additional, existing light fixtures to the existing generator(s) of the facility. Prior to doing this project, a generator replacement is necessary (see G9).

The current emergency lighting in the FAC is greatly below current electrical code standards. The proposed additional emergency lighting fixtures and related generator replacement (G9) would bring the entire facility up to current electrical codes providing the appropriate emergency footcandles in all areas of the complex.

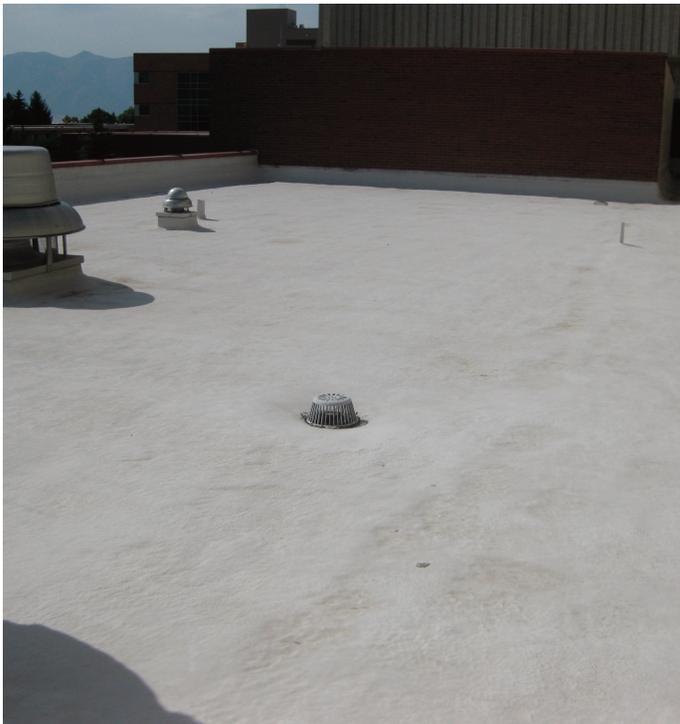
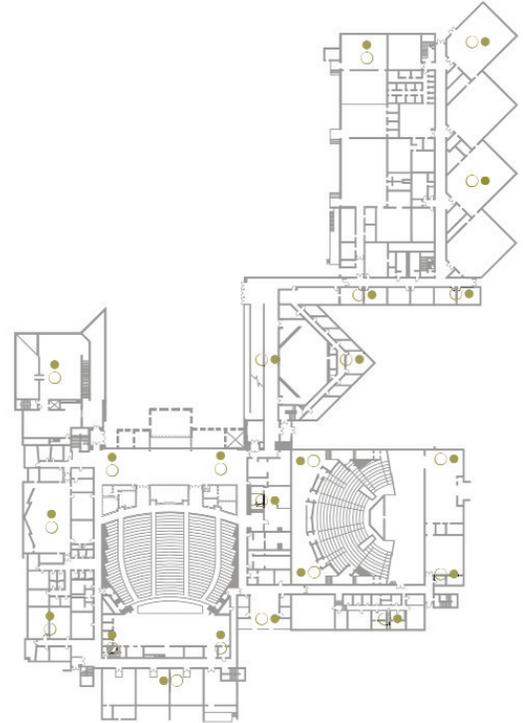
There are currently no secondary drains on any of the buildings in the FAC complex. This is a concerning issue because there is no way to tell if any of the primary drains are clogged without the secondaries in place. If a primary were to clog, the weight of the pool of water that would form would overburden the structure of the building, possibly causing structural failure. The cost covers the adding of one secondary drain to every primary drain location.

This is a lump sum given by VBFA for adding secondary overflow drains to the existing roofs. This project can be broken up into smaller projects as feasible.

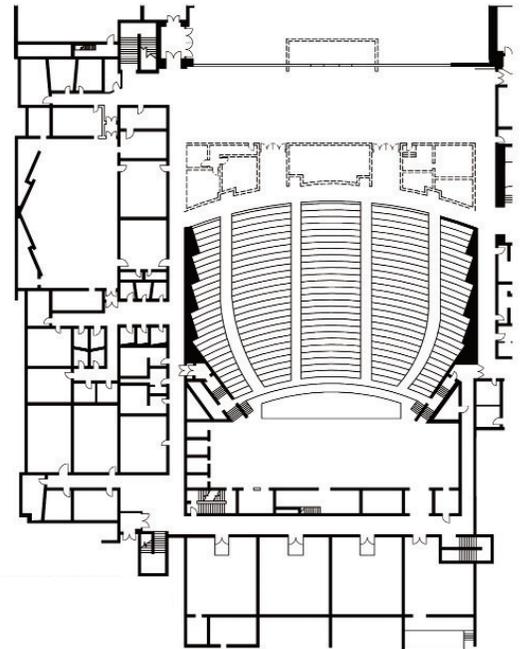
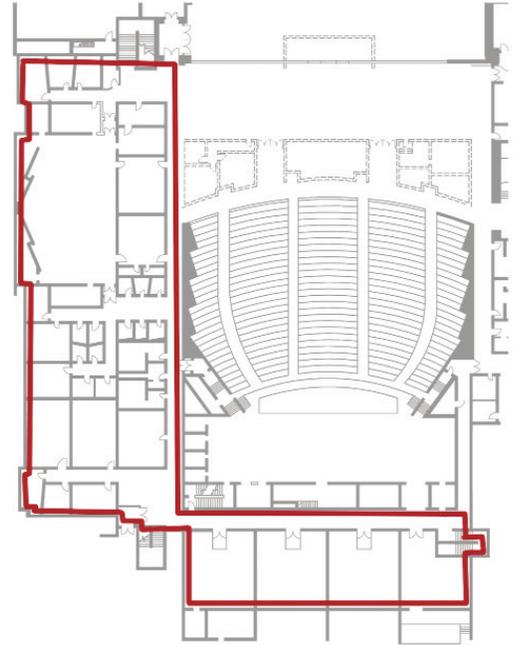
**K1 Ceilings, classrooms**

The current ceilings are not seismically braced and are recommended for replacement. During the replacement, the project will be designed to current seismic codes negating the life safety issue.

Replace lay-in ceiling tile throughout with new seismically braced ceiling system.

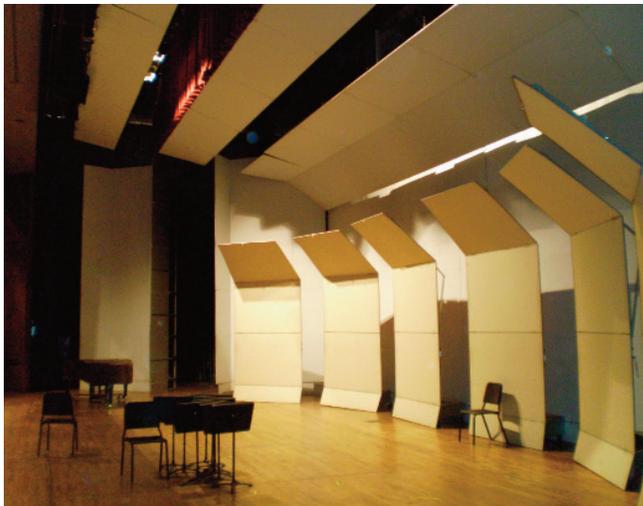
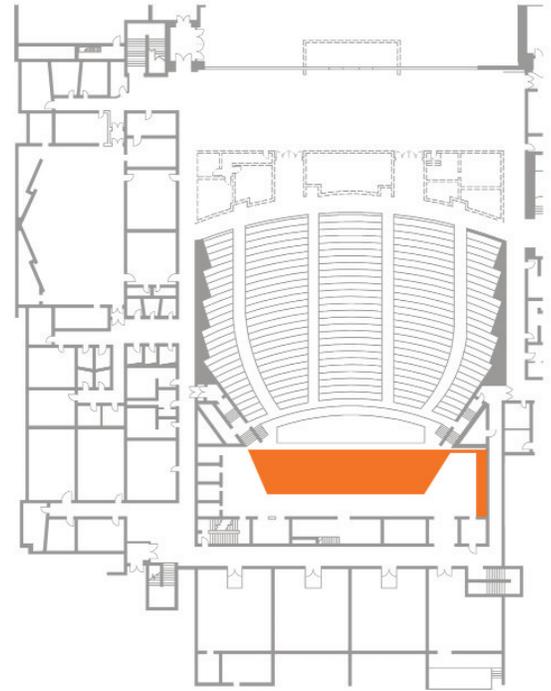
The existing shell should be replaced with a lighter, more effective shell. It should be timed to fit the new rigging. This presents an opportunity for separate fundraising. Cost range is due mainly on finish, design and materials selected.

This item is also related to the redesign and replacement of the house ceiling in that the design of the stage shell and the house ceiling will need to complement each other acoustically as a whole.

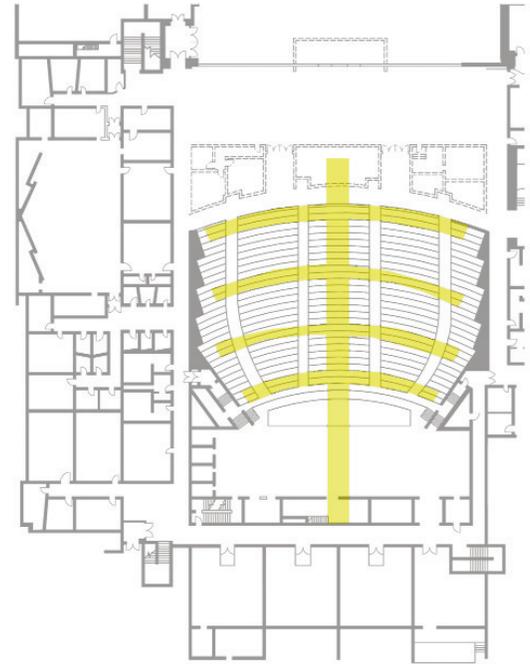
The Kent Concert hall lobby is very noisy. The abundance of sound appears to be the result of excessive airflow through the ductwork and diffusers. Additionally, the existing pneumatic dual duct boxes (DD-boxes) are typically inaccessibly located above gyp ceilings. The remote DD-box locations appear to have exacerbated HVAC noise over time due to limitations in the ability of maintenance personnel to perform routine balancing, lubricate and maintain the existing boxes serving that area. There also appears to be sufficient transient air noise above the ceilings to warrant repair of the existing ductwork infrastructure. Based on experience from the Tippets Art Gallery renovation completed in 2009, excessive supply diffuser velocities, failed dual-duct boxes, and fan noise are the predominant factors contributing to HVAC noise.

The ductwork in both the Kent Concert Hall proper will need to be seismically braced as this is both a life safety issue as well as an acoustic issue with the ducts, in some areas, resting directly on the ceiling transmitting vibration noise throughout the building.

1. Replace all constant volume air terminals and rebalance the systems. Most of the noise problems are from air flow imbalance and poor control of the systems.
2. Replace existing supply and return grilles with modern low NC outlets.
3. Add sound boots to the return air opening to the mechanical room. This will help reduce fan noise into the concert hall.

This is a lump sum given by VBFA which includes the separating of the ducts over the Kent Concert Hall house from the ceiling, replacement of diffusers, and seismic bracing. It is intended that this will mitigate vibrational sound transmission.

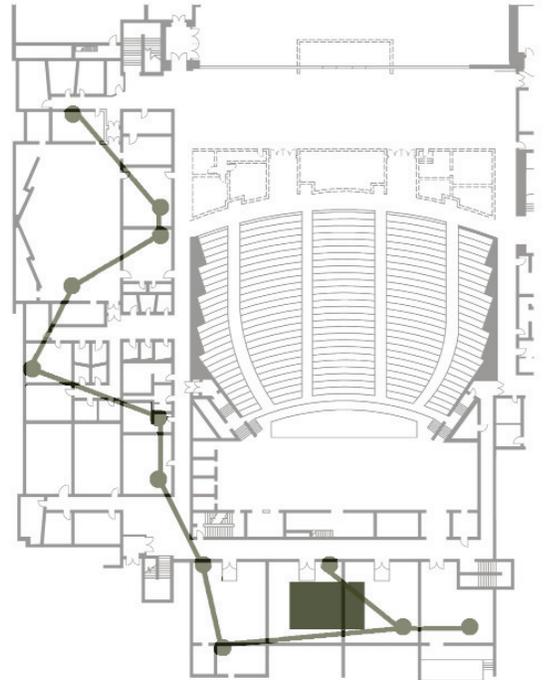
The automatic temperature control system has pneumatic controllers and pneumatic valve and damper actuators. It can be assumed that many of the controllers and actuators have been replaced over the years. The average useful life for pneumatic control systems is 20 years. In general, the controls are well beyond their average useful life.

The air handler ventilation rates are based on 5-cfm/person. Current code requires 20-cfm/person. The pre-heat coils must be replaced in order to provide adequate ventilation. The basement air-handlers serving the Kent Concert area are built-in-place-type air-handlers commonly found in 1960's buildings. These air-handlers may not be replaced outright with new air-handlers due to their location and due to the size limitations of the existing rooms. The air-handler walls & construction however may be left in place, while the internal components should be replaced with new. Furthermore the Kent Concert air-handlers should be lined with perforated interior liners for sound deadening, the coils should be removed and replaced with new, the control dampers and actuators should be replaced, and the dual duct air-handler single supply fan should be removed and replaced with independent variable volume fan wall systems in both the hot and cold deck.

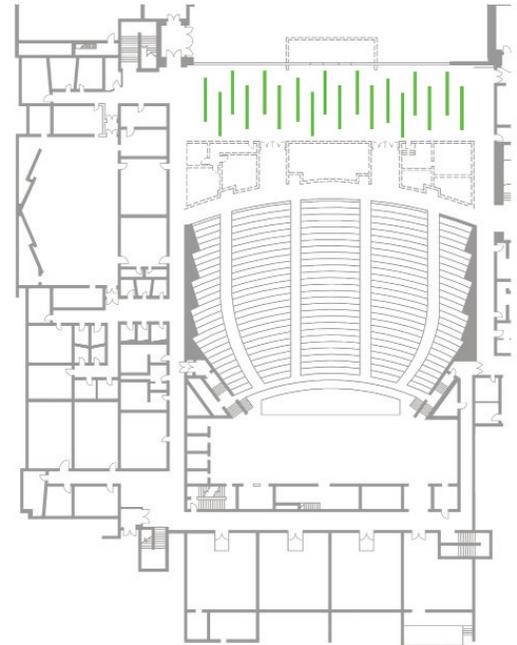
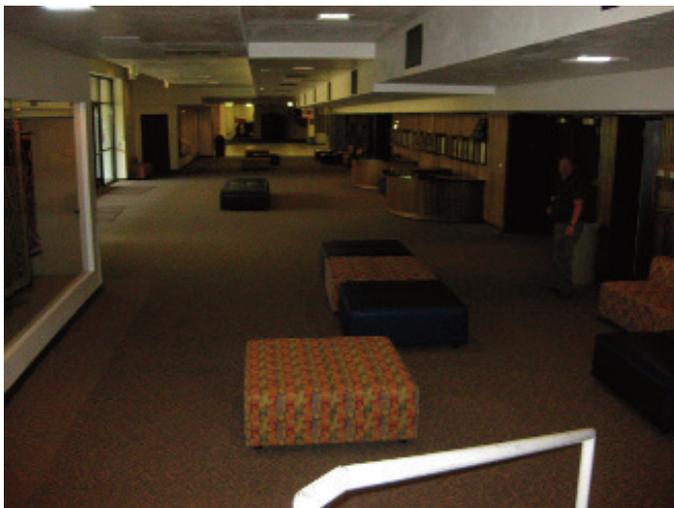
A lighting upgrade is recommended as part of an overall lobby and ceiling remodel for upgraded appearance and energy efficiency. The fixtures are dim and old and now that the Morgan lobby fixtures have been upgraded, there is a noticeable difference.

This is a lump sum given by Spectrum Engineers which includes the replacement (one for one) of the lobby fixtures for aesthetics and efficiency.

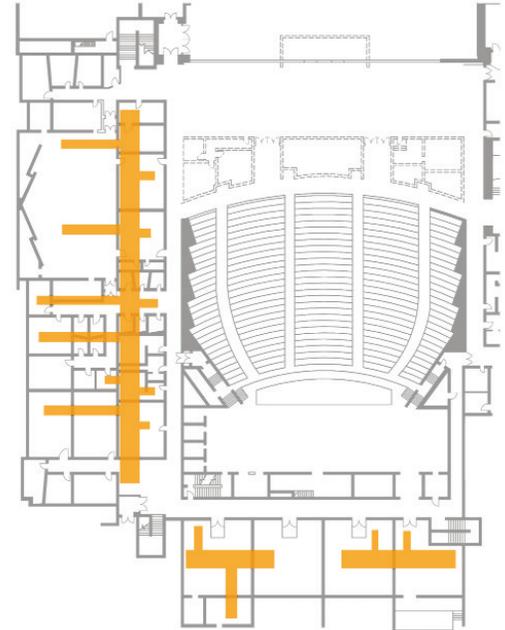
The ductwork in both the Kent Concert Hall and the Kent Classroom/Music Wing will need to be seismically braced as this is both a life safety issue as well as an acoustic issue with the ducts in some areas resting directly on the ceiling itself transmitting vibration noise throughout the building.

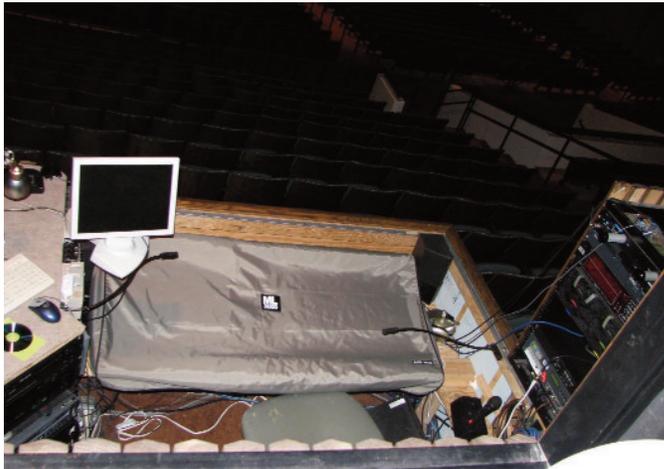
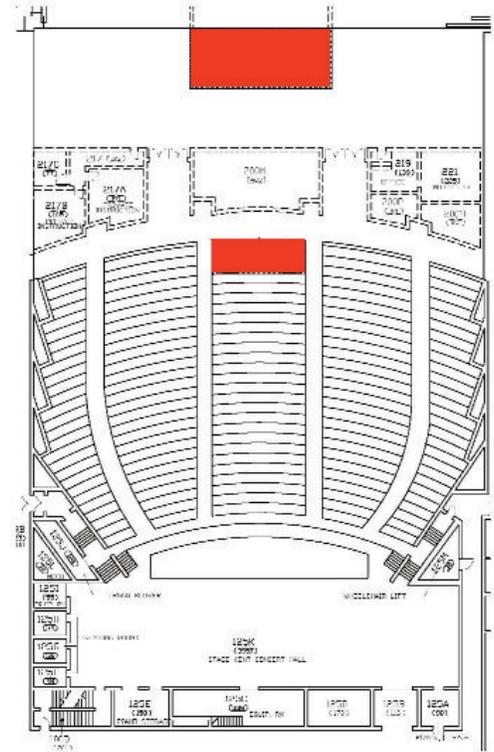
The existing location of the sound control booth is not optimum and is recommended to be relocated per the University’s request. The new location would be directly adjacent to, or on the stage side of, the main cross aisle, aligned with the center of the stage. This could be done as a part of a sound equipment renovation and would mostly be the extension and/or pulling of the existing wires under the cross aisle to this new location.

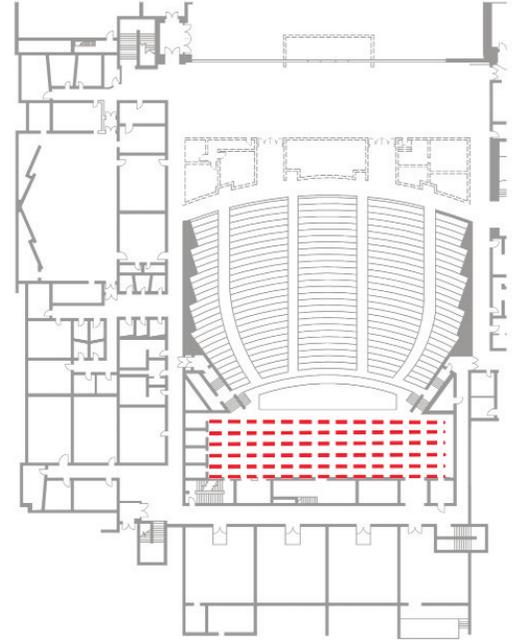
The existing rigging is not safe and is very labor intensive to operate. Replacement with a manual system could be \$190,000. Fully motorized system starts at \$350,000. Either option requires the addition of a loading bridge with a budget of \$25,000 (or more) plus steel to anchor it. Mixed lines (some manual, others motorized) are possible to save money and facilitate operations.

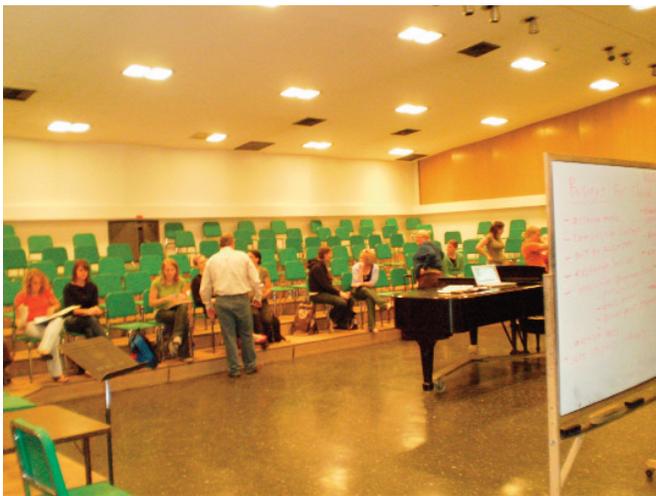
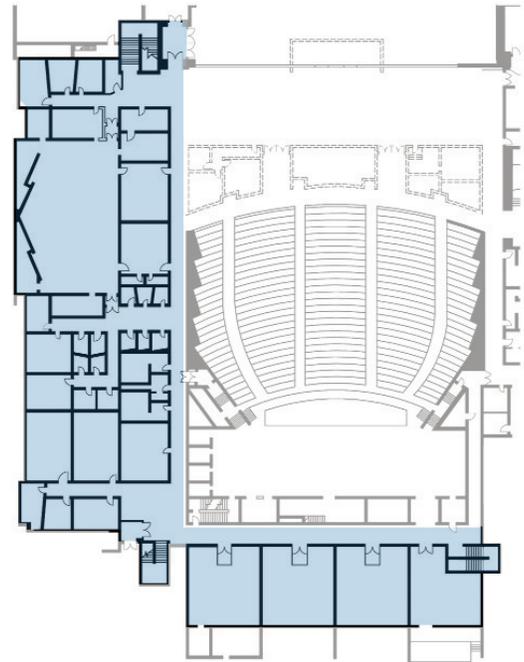
There are no sprinklers currently in the Kent Music Classroom areas. The current IBC Code would classify these classroom spaces as part of the Kent Hall's A-1 occupancy and require sprinklers. Also, the current DFCM design guidelines say "it is desirable that all buildings constructed by the State of Utah be equipped with an automatic sprinkler system to provide added life safety for the occupants and to protect the building from fire loss." Therefore, it is recommended that sprinklers be provided in all spaces within the entire FAC.

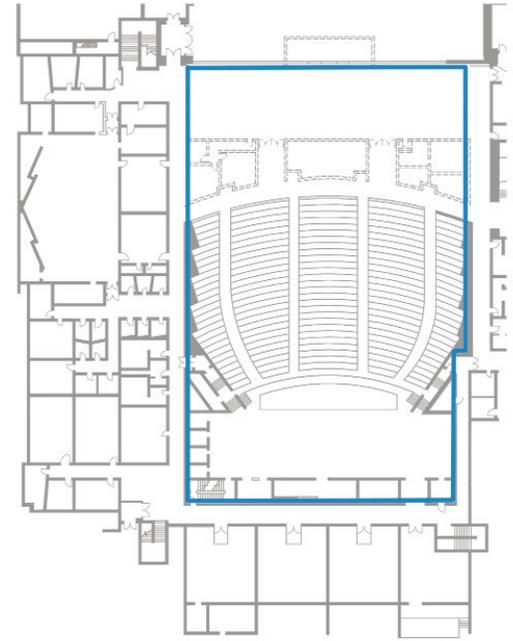
There are no automatic sprinklers currently in the Kent Concert Hall proper. The current IBC code would classify this venue as an A-1 occupancy and would, therefore, require automatic sprinklers. The current IBC code also requires all stages to be sprinkled. In addition, the current DFCM design guidelines say "it is desirable that all buildings constructed by the State of Utah be equipped with an automatic sprinkler system to provide added life safety for the occupants and to protect the building from fire loss." Therefore, it is recommended that sprinklers be added to the hall and existing sprinkler heads on stage be upgraded.

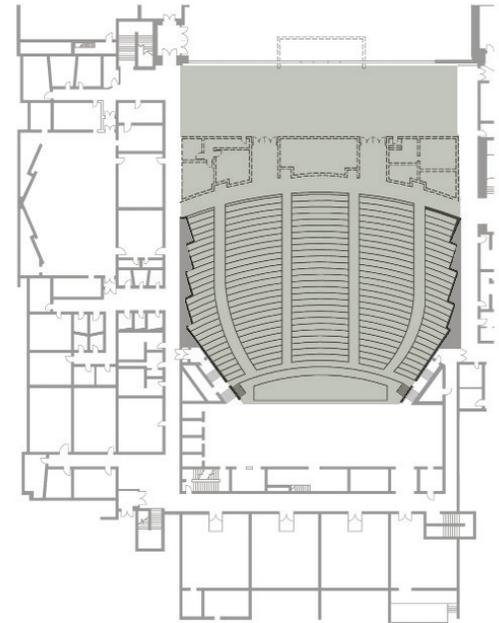
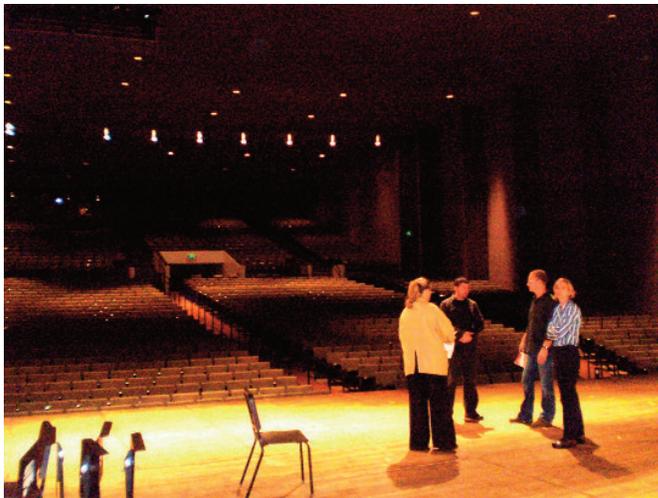
The suspended ceiling system in the Kent Concert Hall lacks any kind of bracing for seismic loads. Based on experience from past earthquakes, this ceiling would most likely fail during a major earthquake and could receive significant damage in a moderate earthquake. As a result, this ceiling poses a major life safety hazard to the building's occupants. It may be possible to seismically brace this ceiling in place but it makes more sense to replace this ceiling since it does not meet the acoustic properties desired for the space. In the redesign and replacement of this ceiling, it will be important to design it jointly with the recommended redesign of the stage acoustic shell (item K2) so that they act together as one continuous acoustic system.

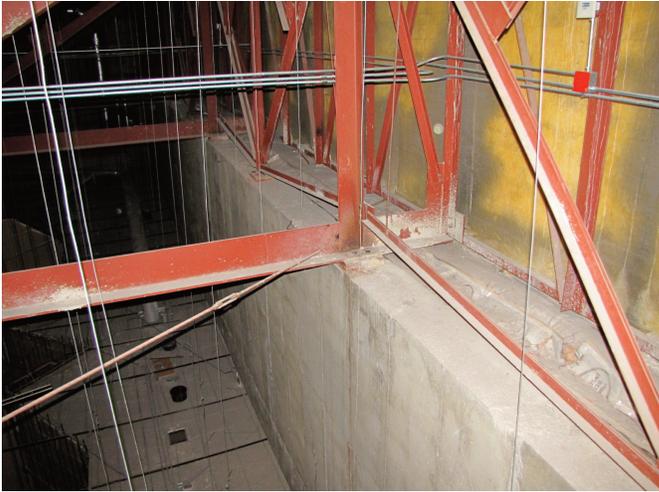
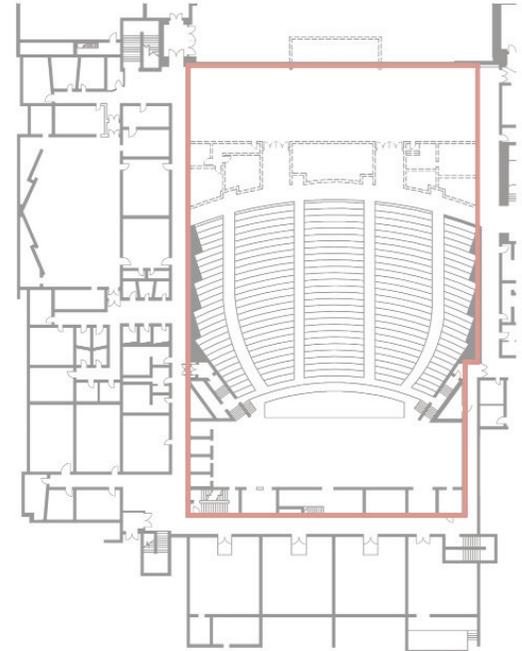
In the Kent Concert Hall the longitudinal walls are braced by the connection of the main girder to the tops of the concrete walls. This connection appears to be inadequate for out of plane seismic forces per current code requirements and needs to be strengthened.

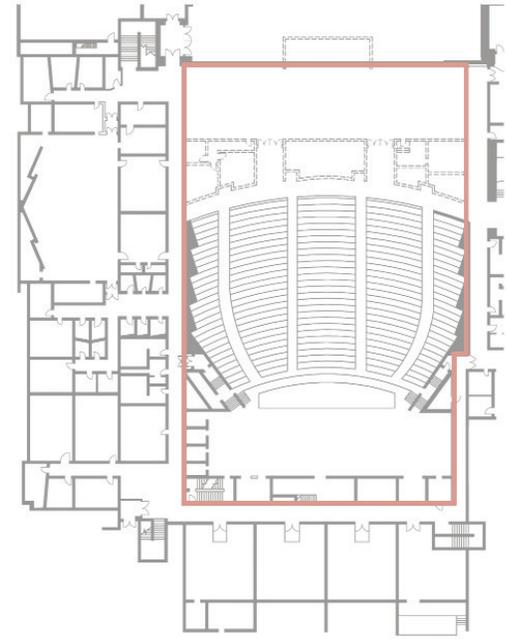
The system now consists of blocking trusses between the cantilevered ends of the main girder trusses and rod x-bracing along the wall parallel to the girder trusses at the stage wall of the Kent Concert Hall. It appears that the connection of the blocking trusses to the concrete walls needs to be strengthened and the rod x-bracing needs to be replaced with angle or tube x-bracing.

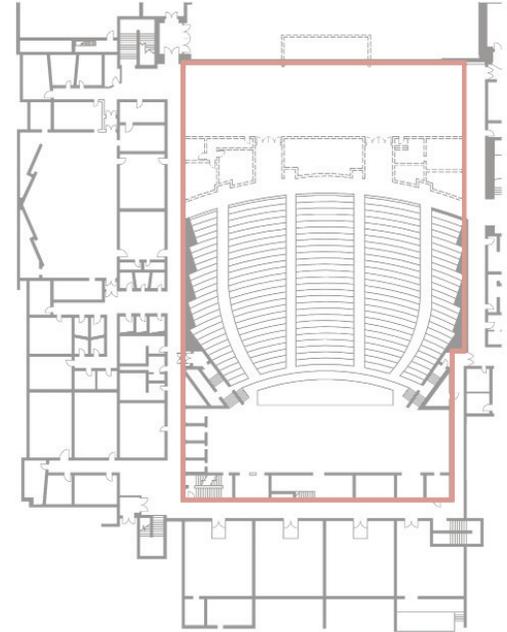
Note that before construction begins, this information must be verified with a detailed investigation to determine if our as-built assumptions are correct and to determine if the assumed deck capacities are valid for the in-place welds.

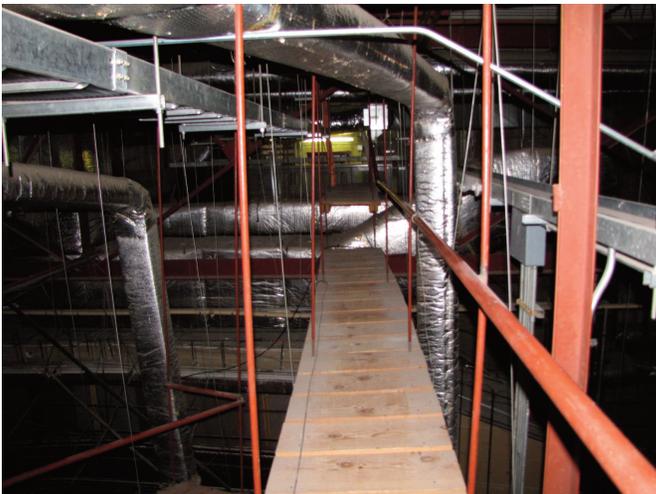
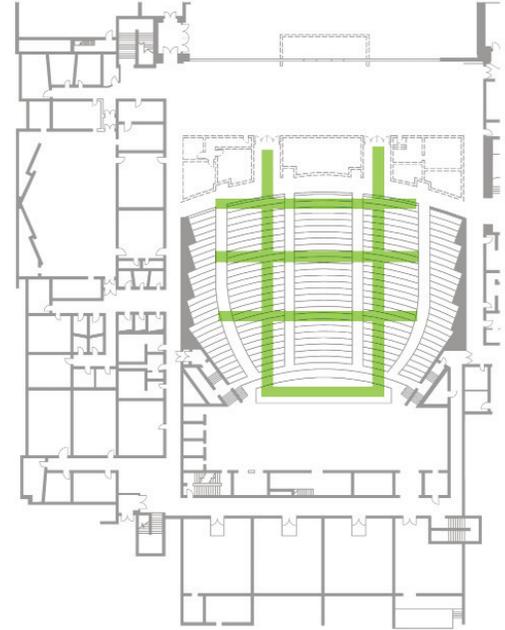
The current IBC code does not require catwalks to be fire-rated. They only need to be built in accordance with the materials allowed by the code, depending on the type of construction for the building. However, due to the minimal nature of the construction of the current catwalks and that there are currently no railings in place anywhere, it is highly recommended that the catwalks be replaced with steel catwalks and handrails constructed as per the current IBC code and to comply with OSHA.
