**LIMITED ASBESTOS SURVEY AND
LEAD-BASED PAINT INSPECTION**

**MATHESON COURTHOUSE
450 SOUTH STATE STREET
SALT LAKE CITY, UTAH 84111**

PROJECT # 15037150

September 22, 2015

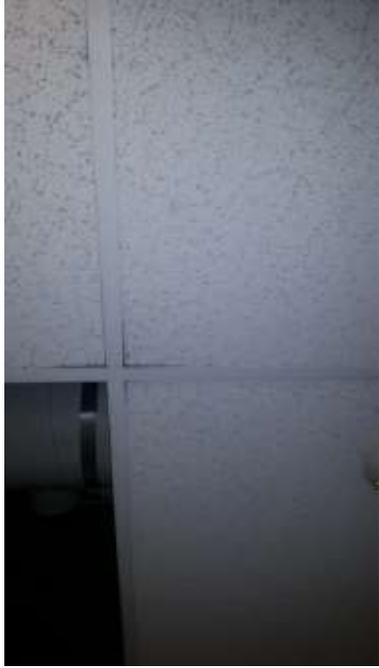
MC-01 – 2' x 4' Ceiling Tile

Lab HW1011, Field MC-01 2 x 4 Ceiling Tile - Elevators 1-3 motor room

This is a light gray sample with perlite, 25% plant fiber, and 30% mineral wool in resin binder with a white coating on one side. **Asbestos is none detected.**

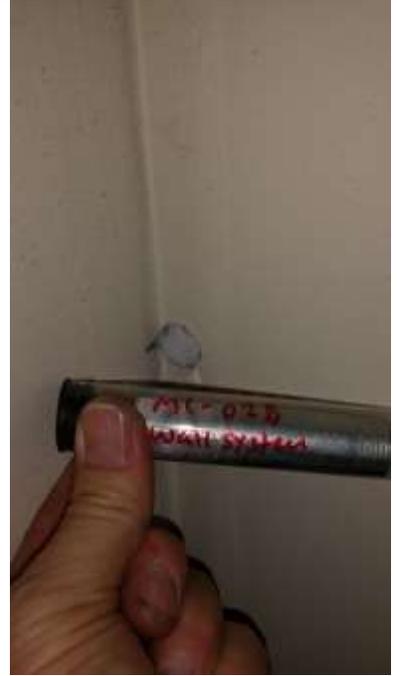
MC-02B Sheetrock Wall System

Lab HW1013, Field MC-02B Sheetrock wall system Elevators 6-7 motor room

This sample contains four types of material: The first type is off-white paint, the second type is white limestone plaster with perlite and mica, the third type is tan and off-white plant fiber paper, and the fourth type is white gypsum plaster with 1% fiberglass. This sample is non-homogeneous. **Asbestos is none detected.**

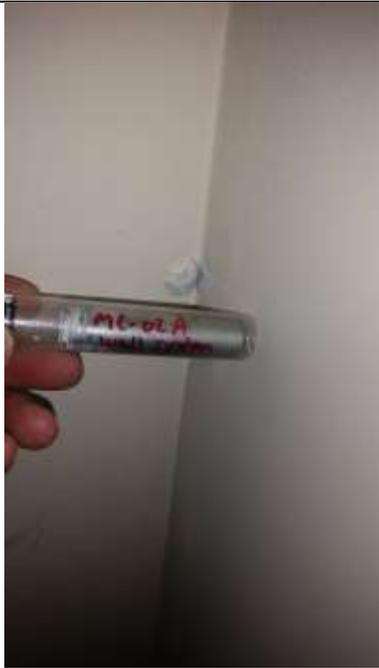
MC-02A Sheetrock Wall System

Lab HW1012, Field MC-02A Sheetrock wall system Elevators 1-3 motor room

This sample contains four types of material: The first type is off-white paint, the second type is white limestone plaster with perlite and mica, the third type is tan and off-white plant fiber paper, and the fourth type is white gypsum plaster with 1% fiberglass. This sample is non-homogeneous. **Asbestos is none detected.**

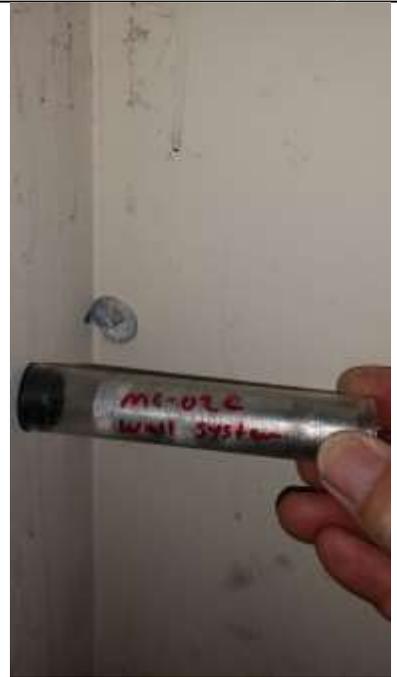
MC-02C Sheetrock Wall System

Lab HW1014, Field MC-02C Sheetrock wall system Elevators 5-6 motor room

This sample contains four types of material: The first type is off-white paint, the second type is white limestone plaster with mica, the third type is tan plant fiber paper, and the fourth type is white gypsum plaster with 1% plant fiber. This sample is non-homogeneous. **Asbestos is none detected.**

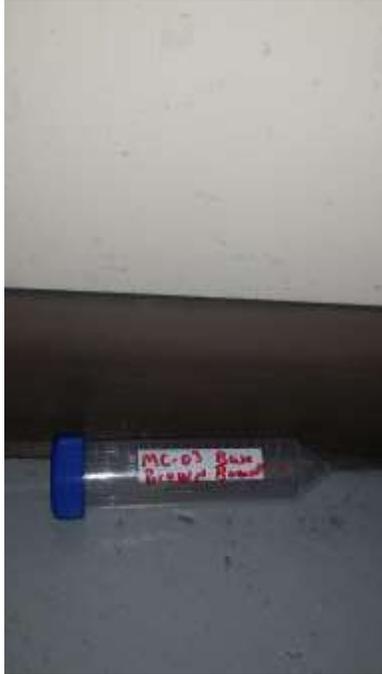
MC-03 Brown vinyl baseboard

Lab HW1015, Field MC-03 Brown baseboard

This is brown rubber and limestone cove base with surface debris. **Asbestos is none detected.**

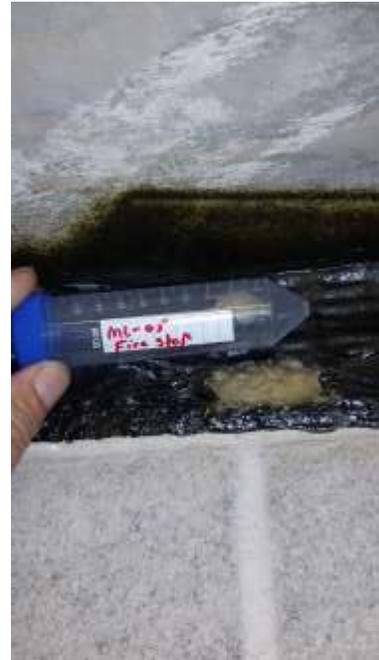
MC-05 Fire Stop

Lab HW1017, Field MC-05 Fire Stop

This sample contains three types of material: The first type is black coating; the second type is green resin; the third type is 90% mineral wool in yellow resin. This sample is non-homogeneous. **Asbestos is none detected.**

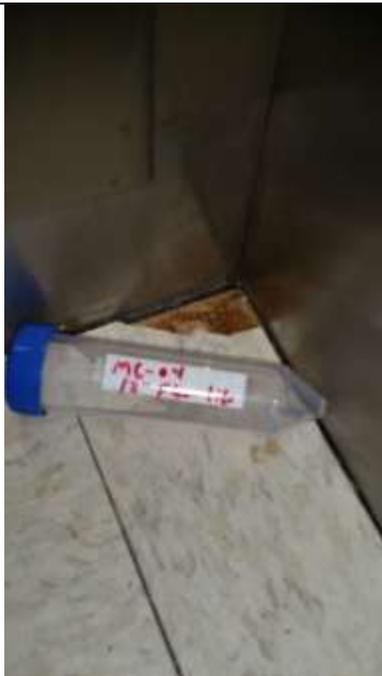
MC-04 12" Beige Floor tile

Lab HW1016, Field MC-04 Elevator 12" Beige Floor Tile

This is a off-white plastic and limestone tile with yellow resin mastic. **Asbestos is none detected.**

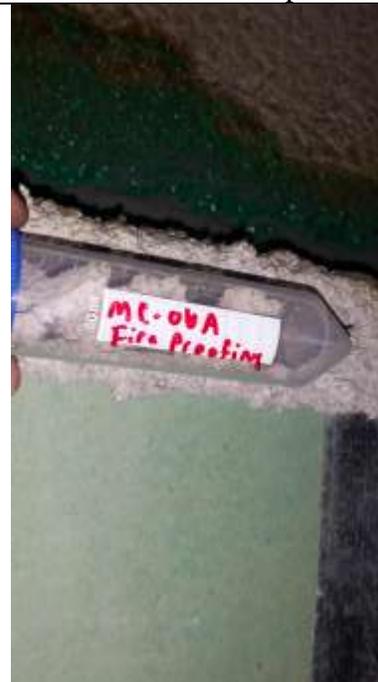
MC-06A Fireproofing

Lab HW1018, Field MC-06A Fireproofing - Floor 5

This is 3% plant fiber in gray plaster with debris. **Asbestos is none detected.**

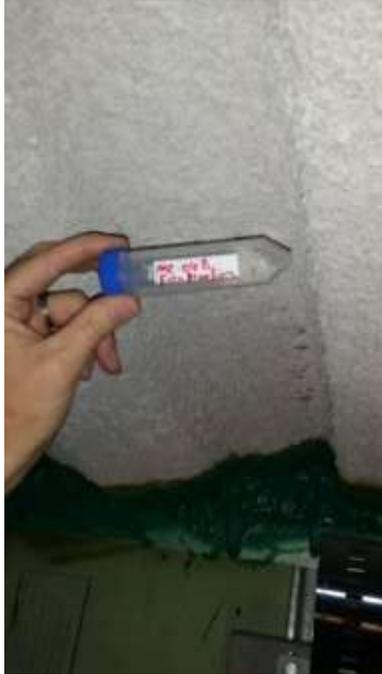
MC-06B Fire Proofing

Lab HW1019, Field MC-06B Fireproofing - Floor 5

This is 3% plant fiber in gray plaster. **Asbestos is none detected.**

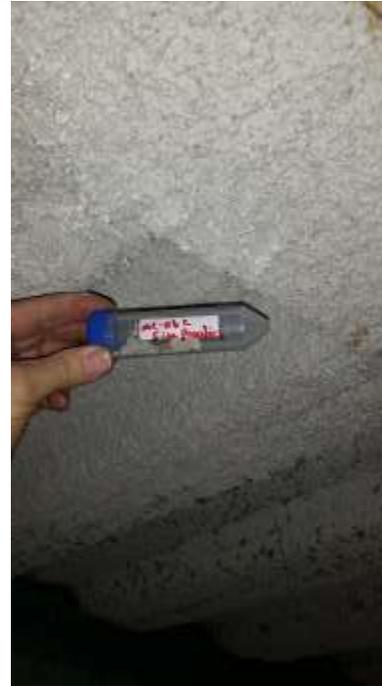
MC-06C Fire Proofing

Lab HW1020, Field MC-06C Fireproofing - Floor 5

This is 3% plant fiber in gray plaster with a trace of debris. **Asbestos is none detected.**

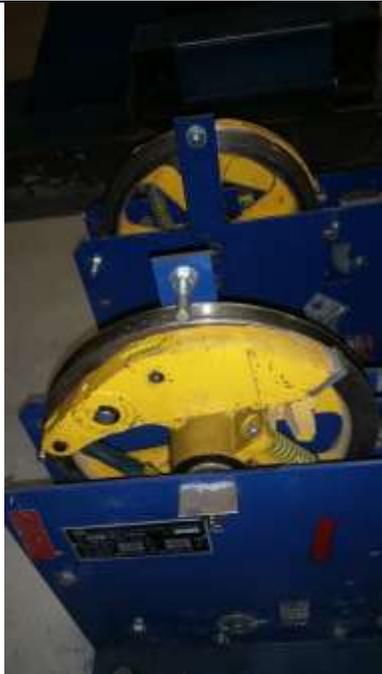
Lead – Lead paint is present on the yellow Emergency Drop Break Wheels and black floor paint under the elevator motors.

Lead painted coating
Emergency Drop Break Wheel

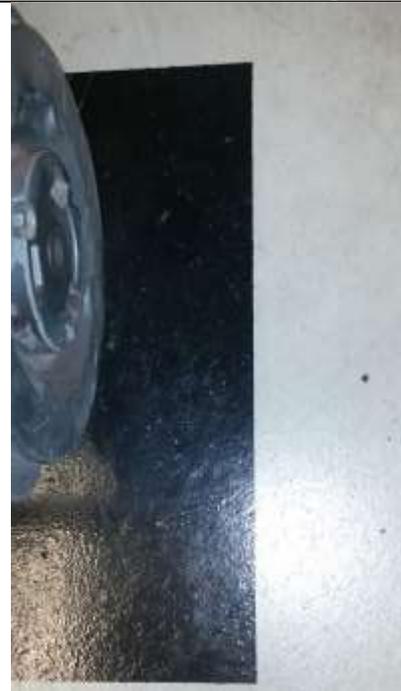
Lead paint coating
Painted concrete flooring under motors
