Feasibility Study

Clinical Services Building

**PRE-DEMOLITION/RENOVATION INSPECTION
FOR ASBESTOS, LEAD, AND
UNIVERSAL, HAZARDOUS AND TOXIC WASTES**

**Utah State University
Center for Persons with Disabilities
6800 Old Main Hill
Logan, Utah 84322**

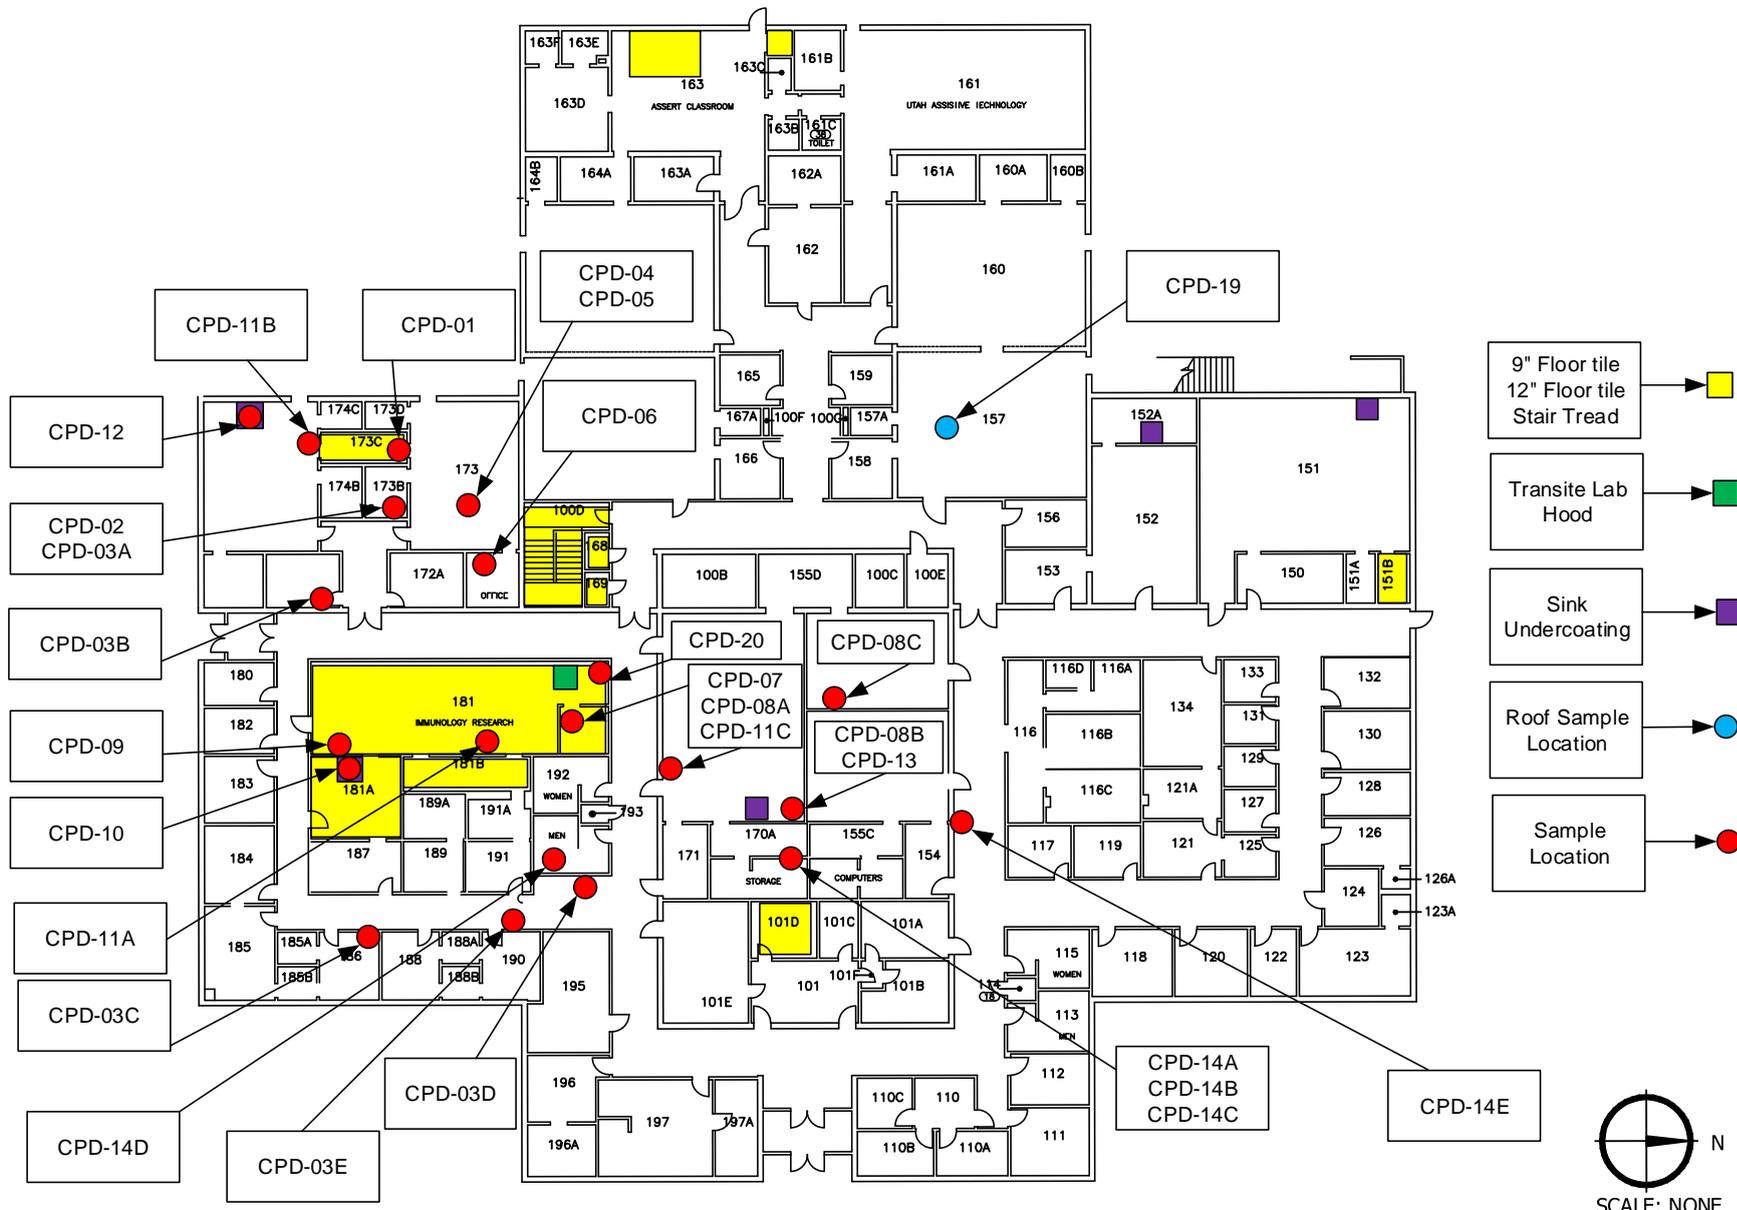
Drawing No.
Figure 1

Center for Persons with Disabilities
First Floor

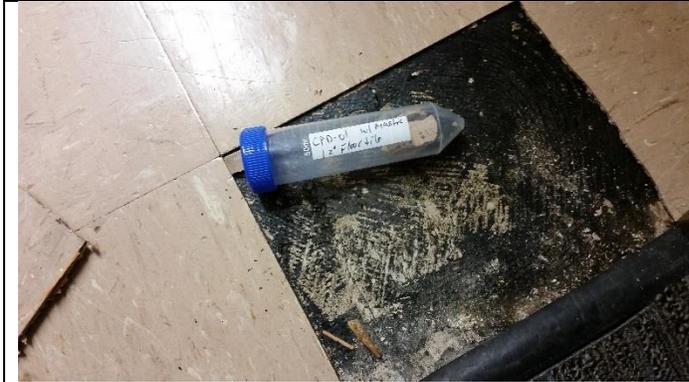
CPD-01 Tan 12" Floor tile
with black mastic

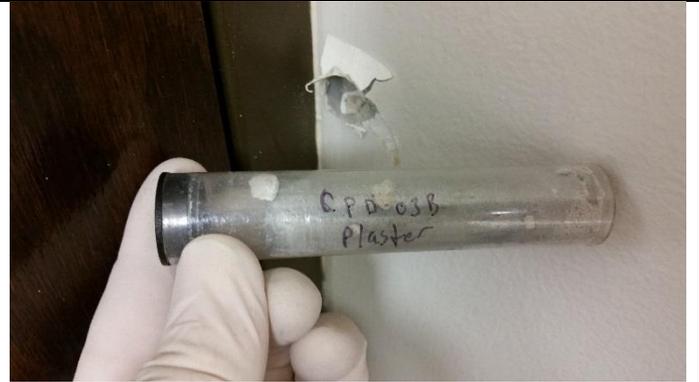
CPD-03B Plaster

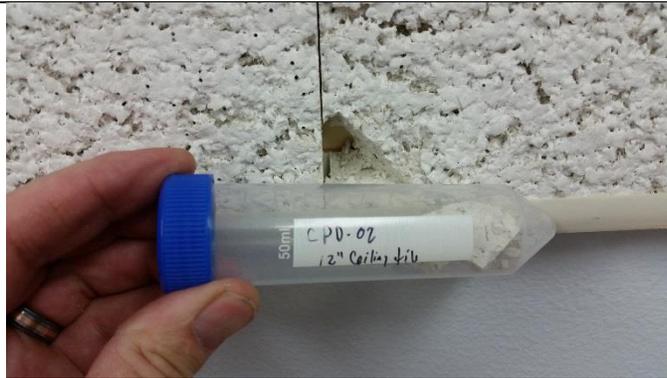
CPD-02 12" Acoustical wall and ceiling tile

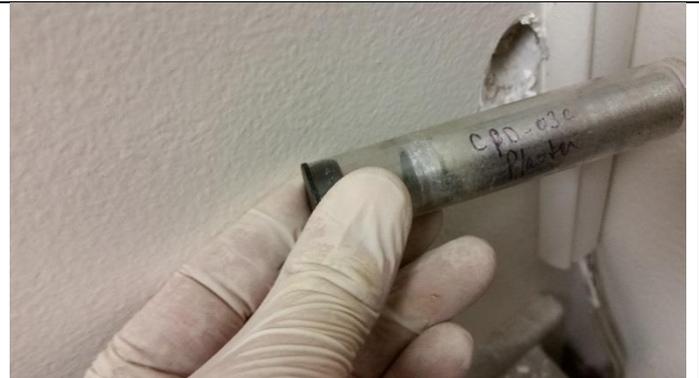
CPD-03C Plaster

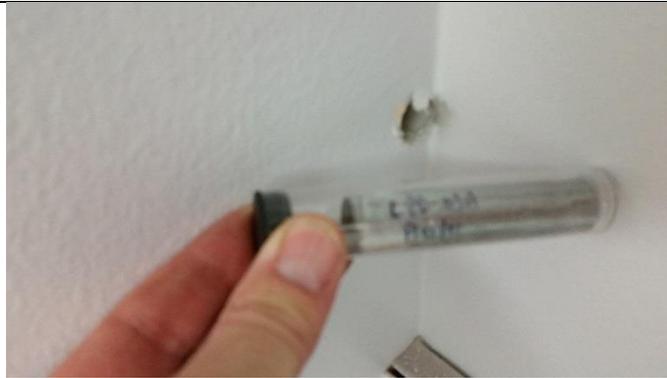
CPD-03A Plaster

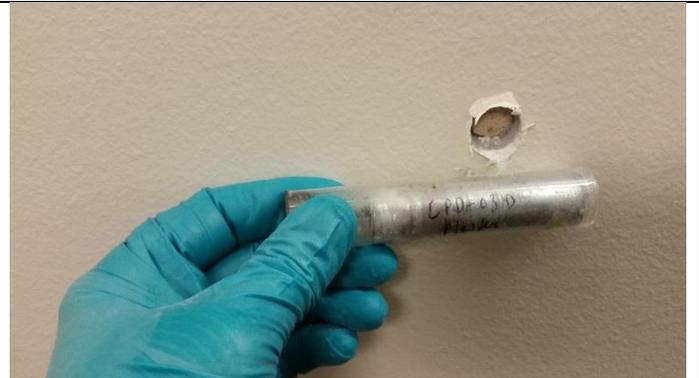
CPD-03D Plaster

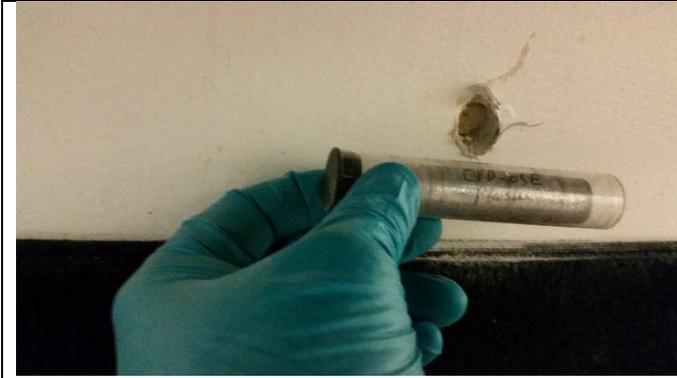
CPD-03E Plaster

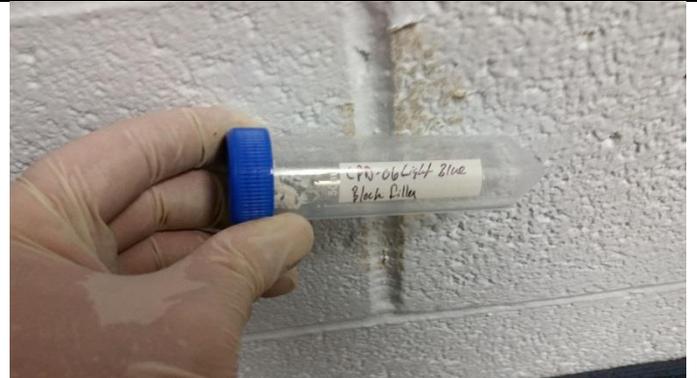
CPD-06 Block filler

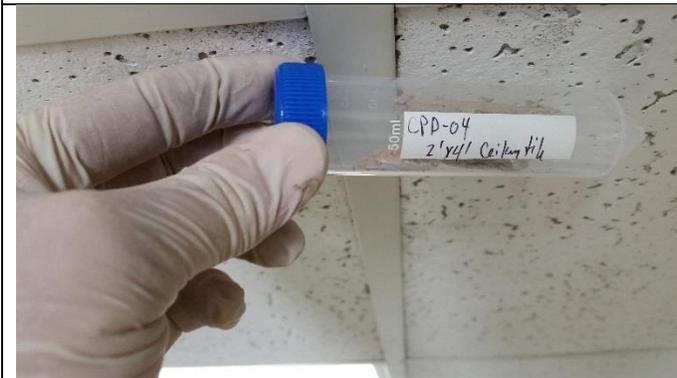
CPD-04 2' x 4' Ceiling tile worm pattern

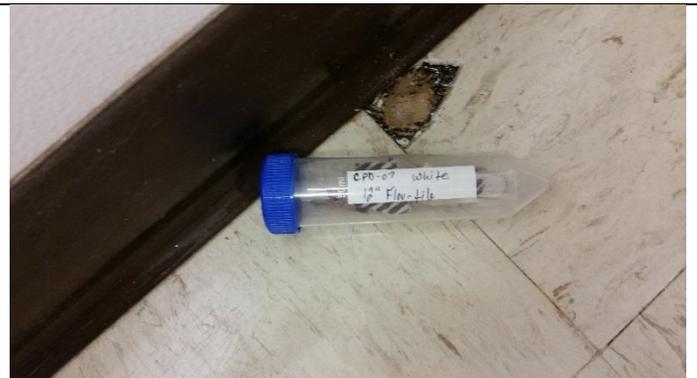
CPD-07 Beige 12" Floor tile with black mastic

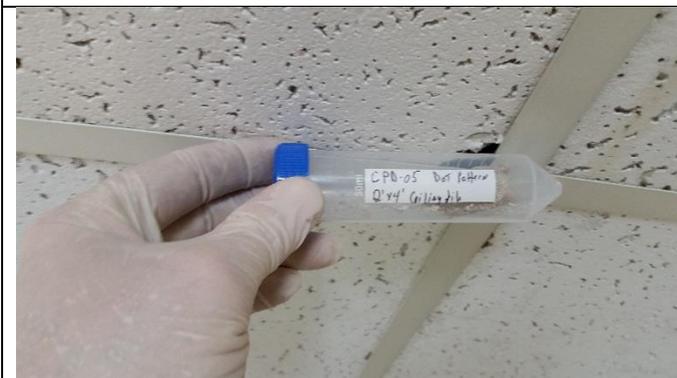
CPD-05 2' x 4' Ceiling tile dot pattern

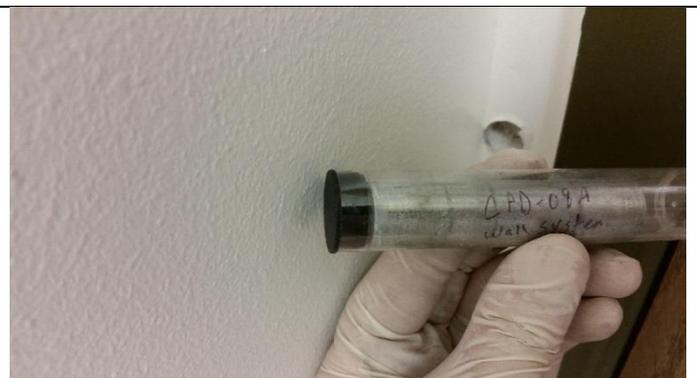
CPD-08A Sheetrock wall system

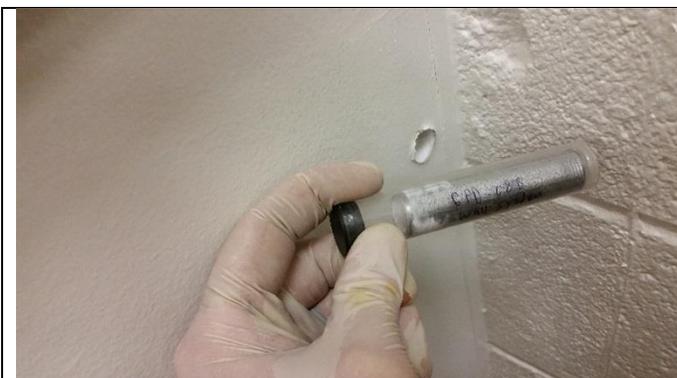
CPD-08B Sheetrock wall system

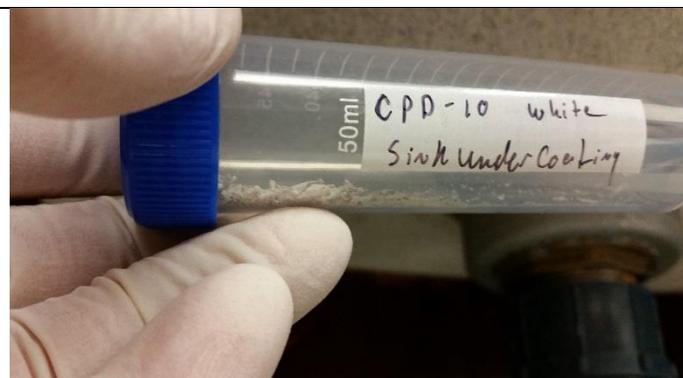
CPD-10 Sink undercoating White

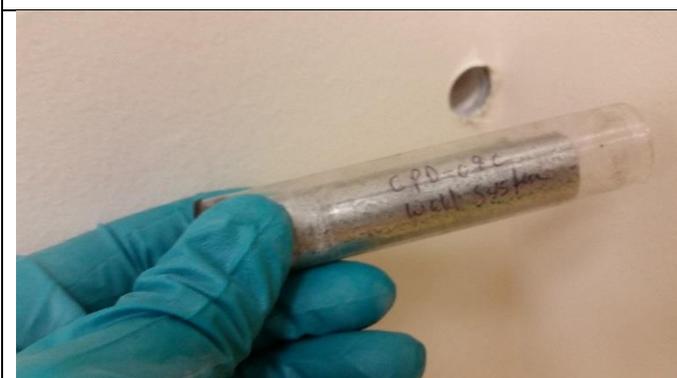
CPD-08C Sheetrock wall system

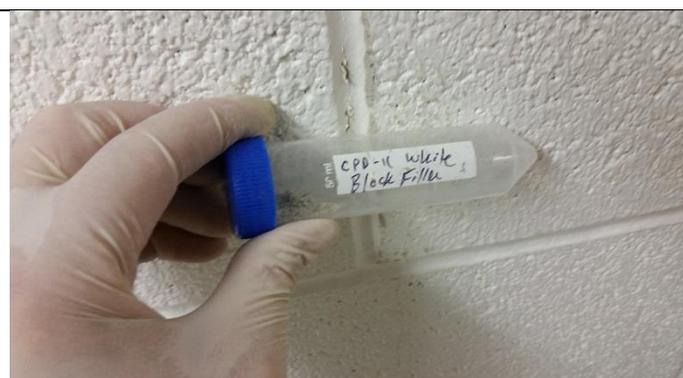
CPD-11A Block filler

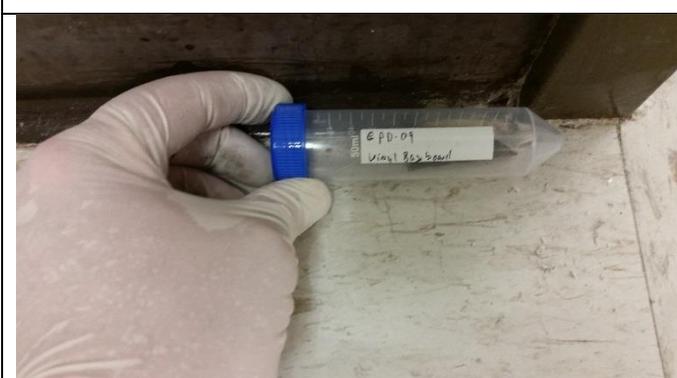
CPD-09 Vinyl Baseboard

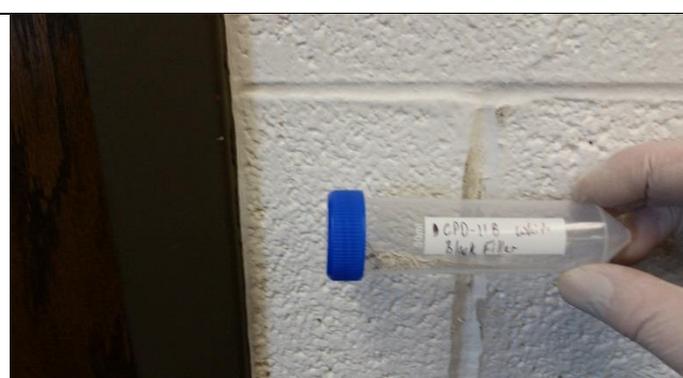
CPD-11B Block filler

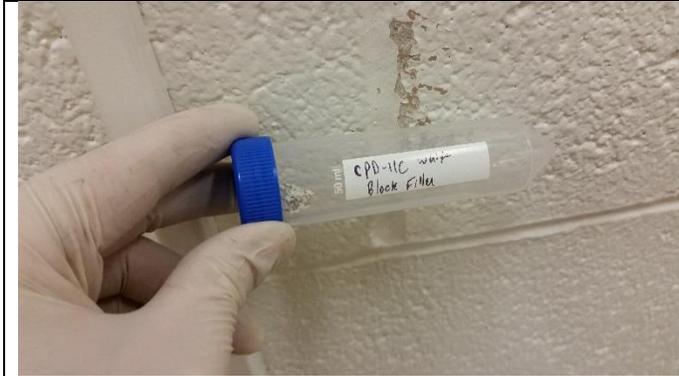
CPD-11C Block filler

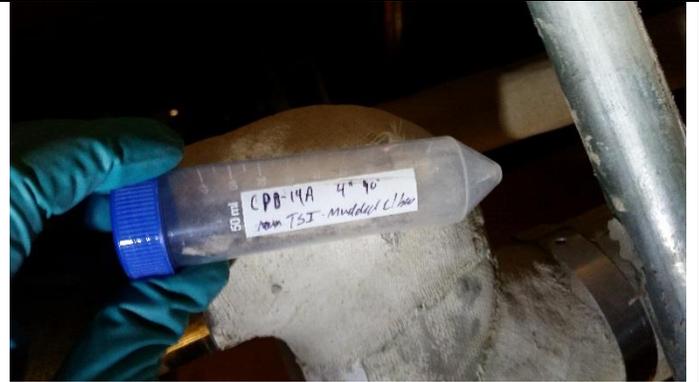
CPD-14A TSI - 4" 90° Elbow

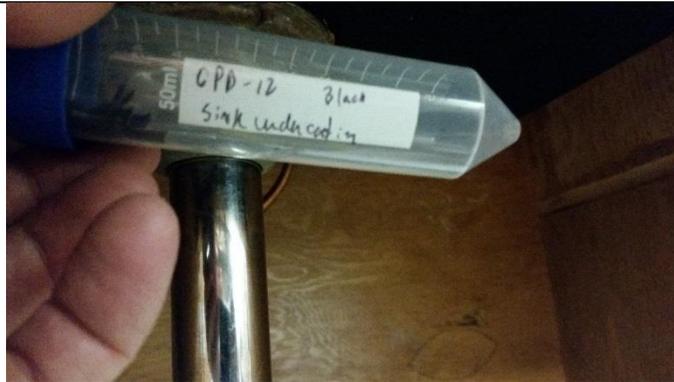
CPD-12 Sink undercoating - Black

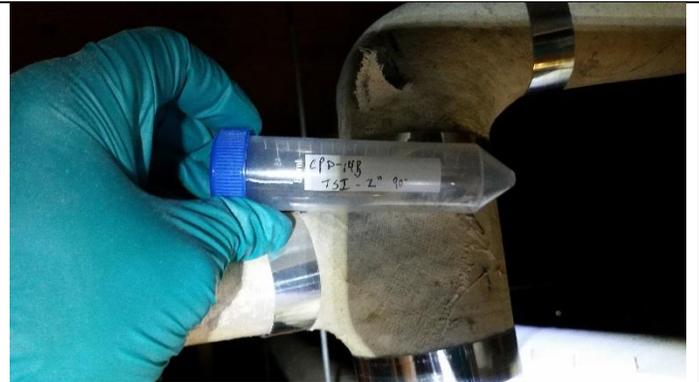
CPD-14B TSI - 2" 90° Elbow

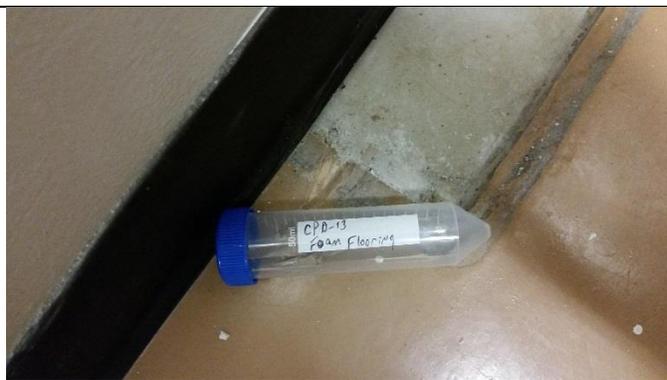
CPD-13 Foam flooring

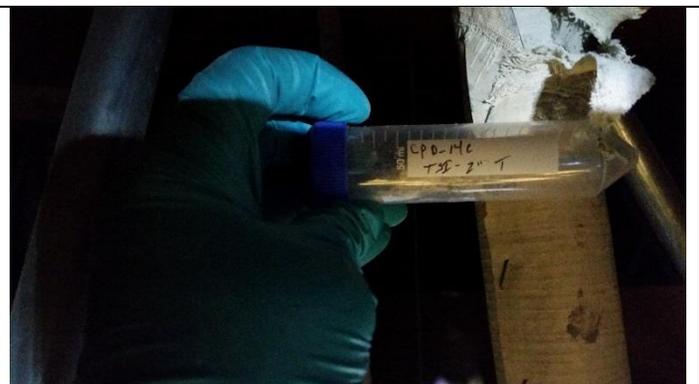
CPD-14C TSI - 2" T Joint

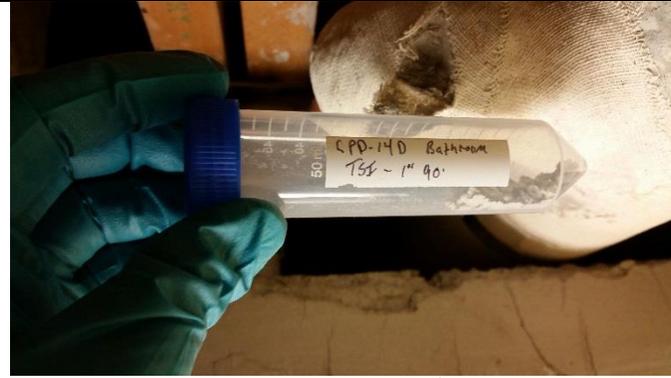
CPD-14D TSI - 1" 90° Elbow

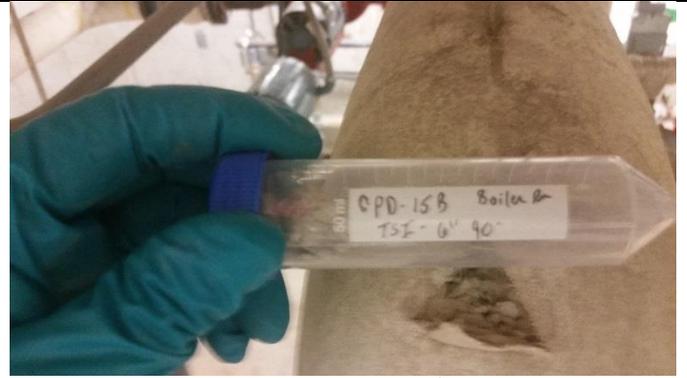
CPD-15B TSI - 6" 90° Elbow

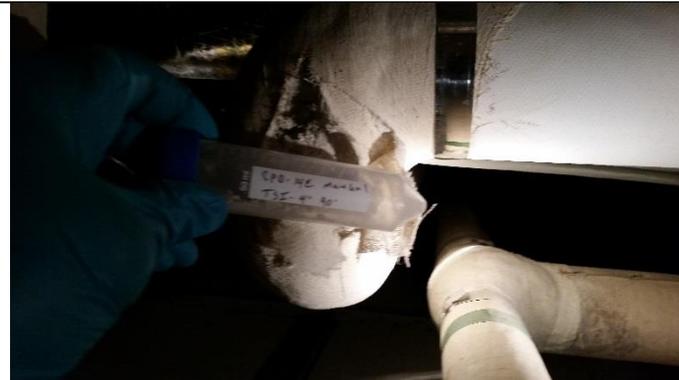
CPD-14E TSI - 4" 90° Elbow

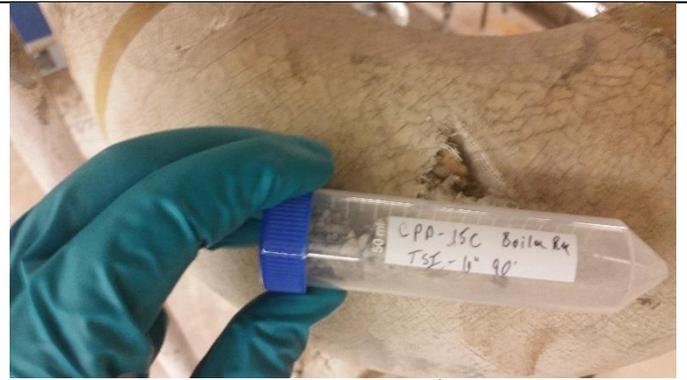
CPD-15C TSI - 6" 90° Elbow

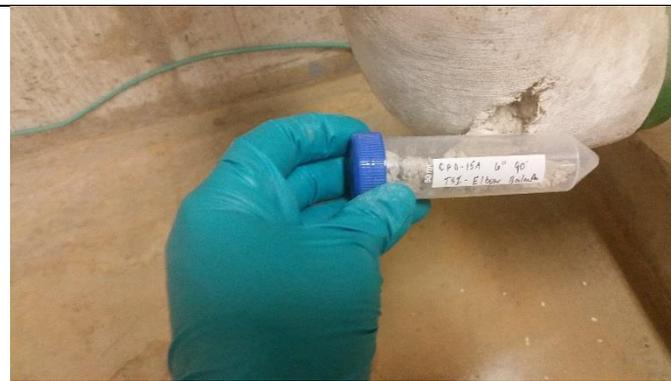
CPD-15A TSI - 6" 90° Elbow

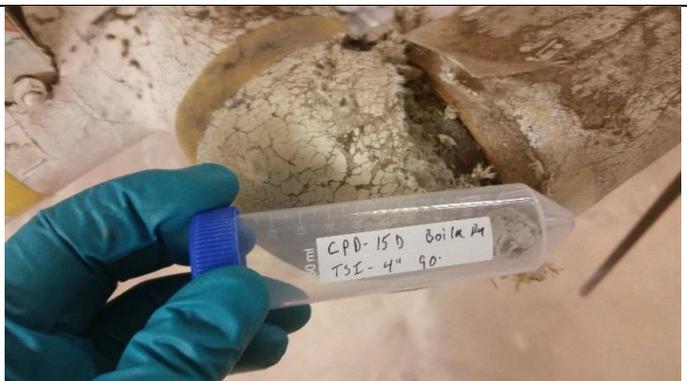
CPD-15D TSI - 4" 90° Elbow

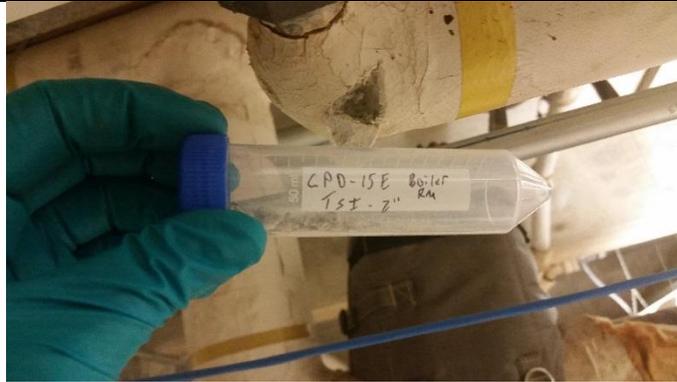
CPD-15E TSI - 2" 90° Elbow

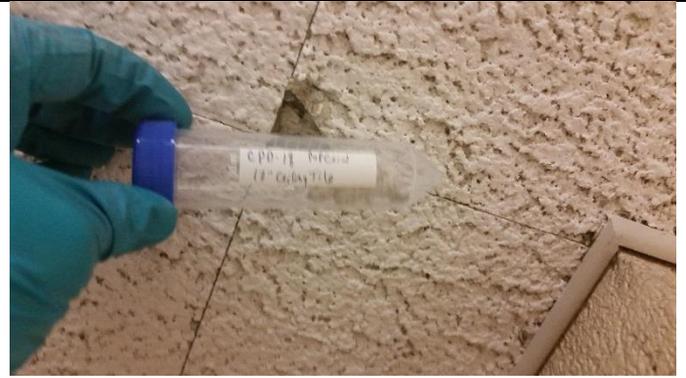
CPD-18 12" Acoustical ceiling tile

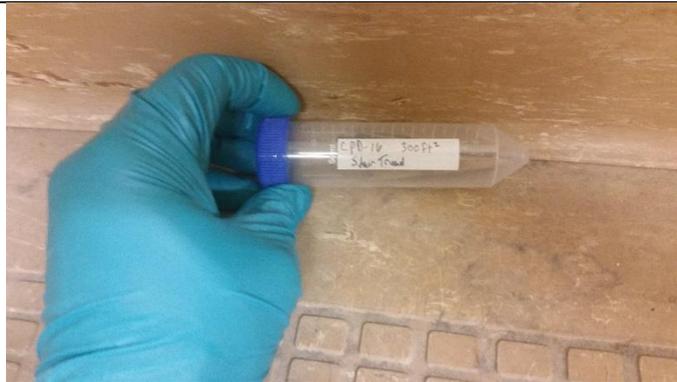
CPD-16 Stair Tread

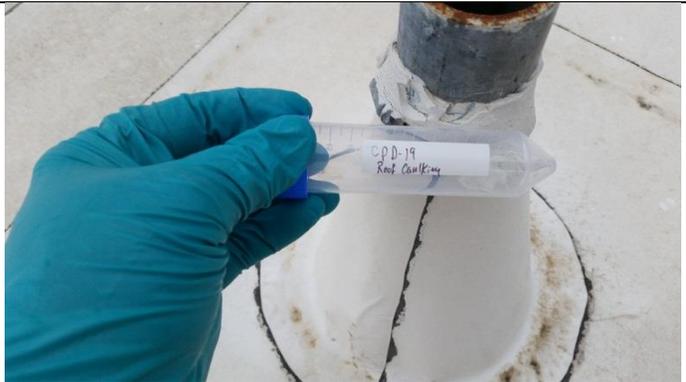
CPD-19 Roof caulking

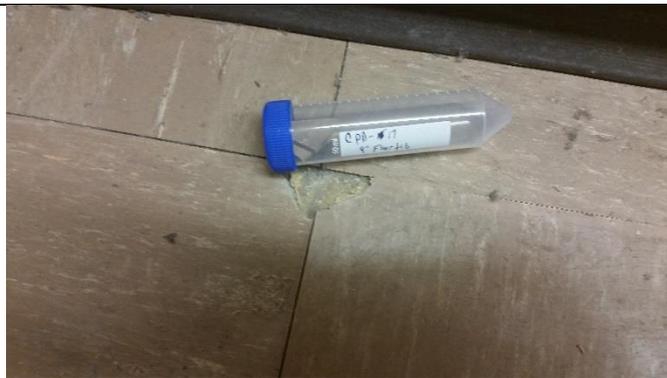
CPD-17 Tan 9" Floor tile

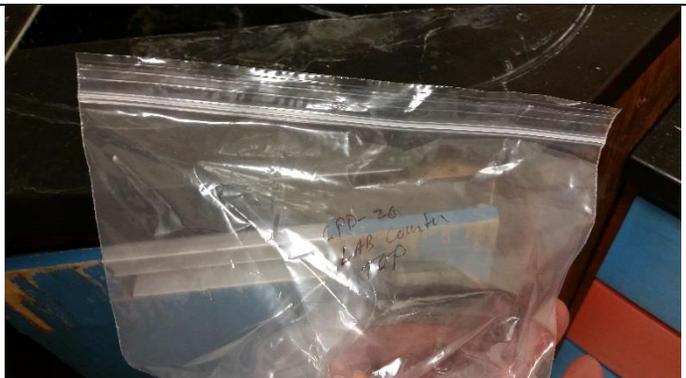
CPD-20 Laboratory counter top

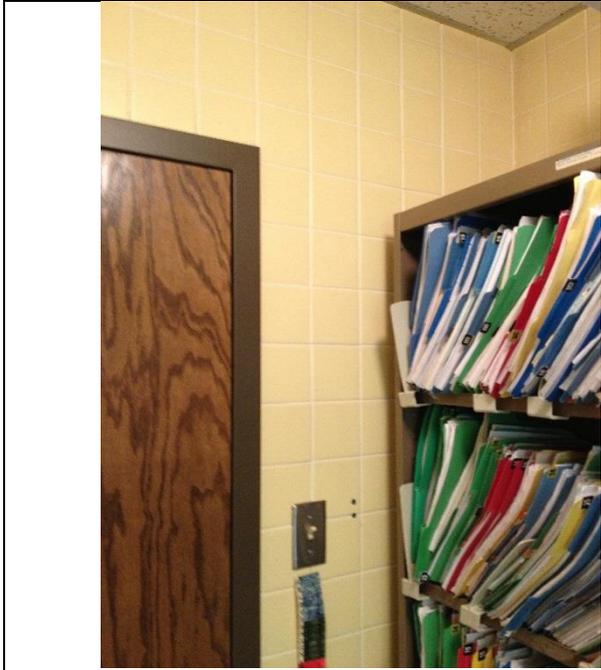
Yellow wall tile – All bathrooms

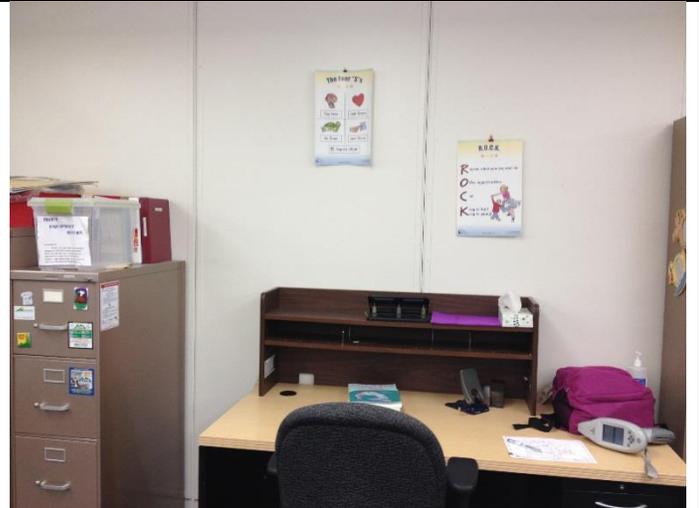
Room dividers

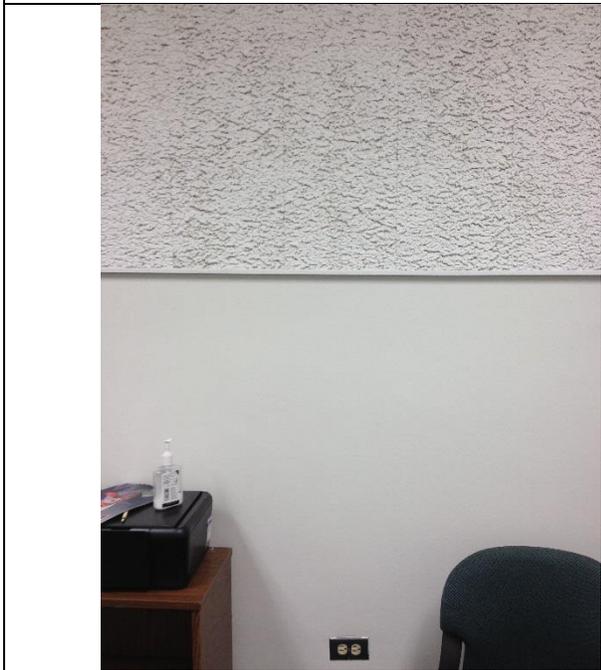
Plaster walls

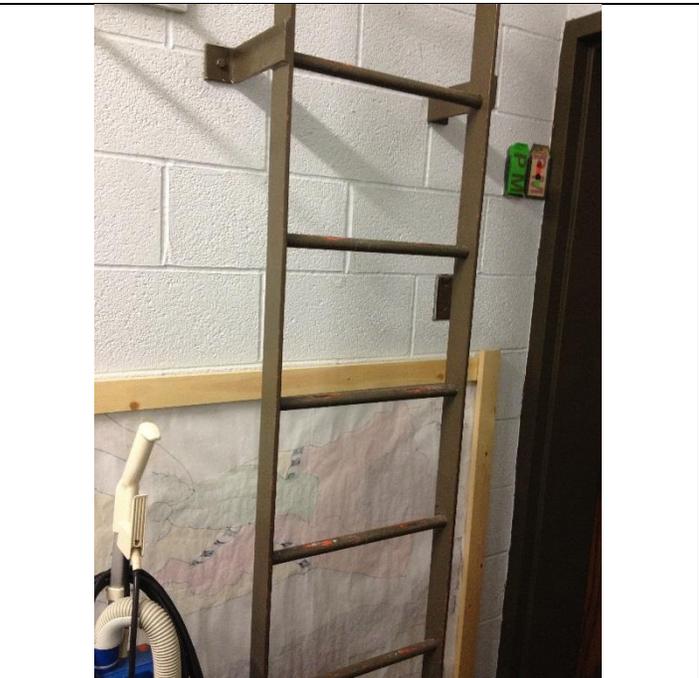
Metal ladder

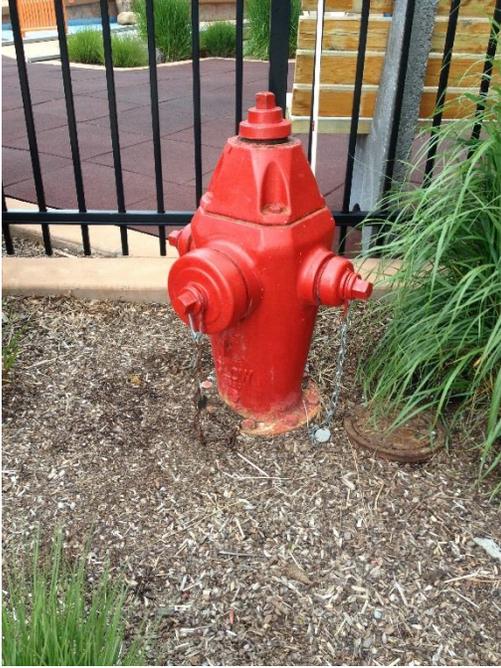
Exterior fire hydrant
