## ADDENDUM NO. 3

Reference: Libbie Edwards School Remodel  
The Utah School for the Deaf and Blind  
DFCM Project No. 08260200

## ADDENDUM - 1

Project: Libbie Edwards School Remodel, Utah School For The Deaf and Blind

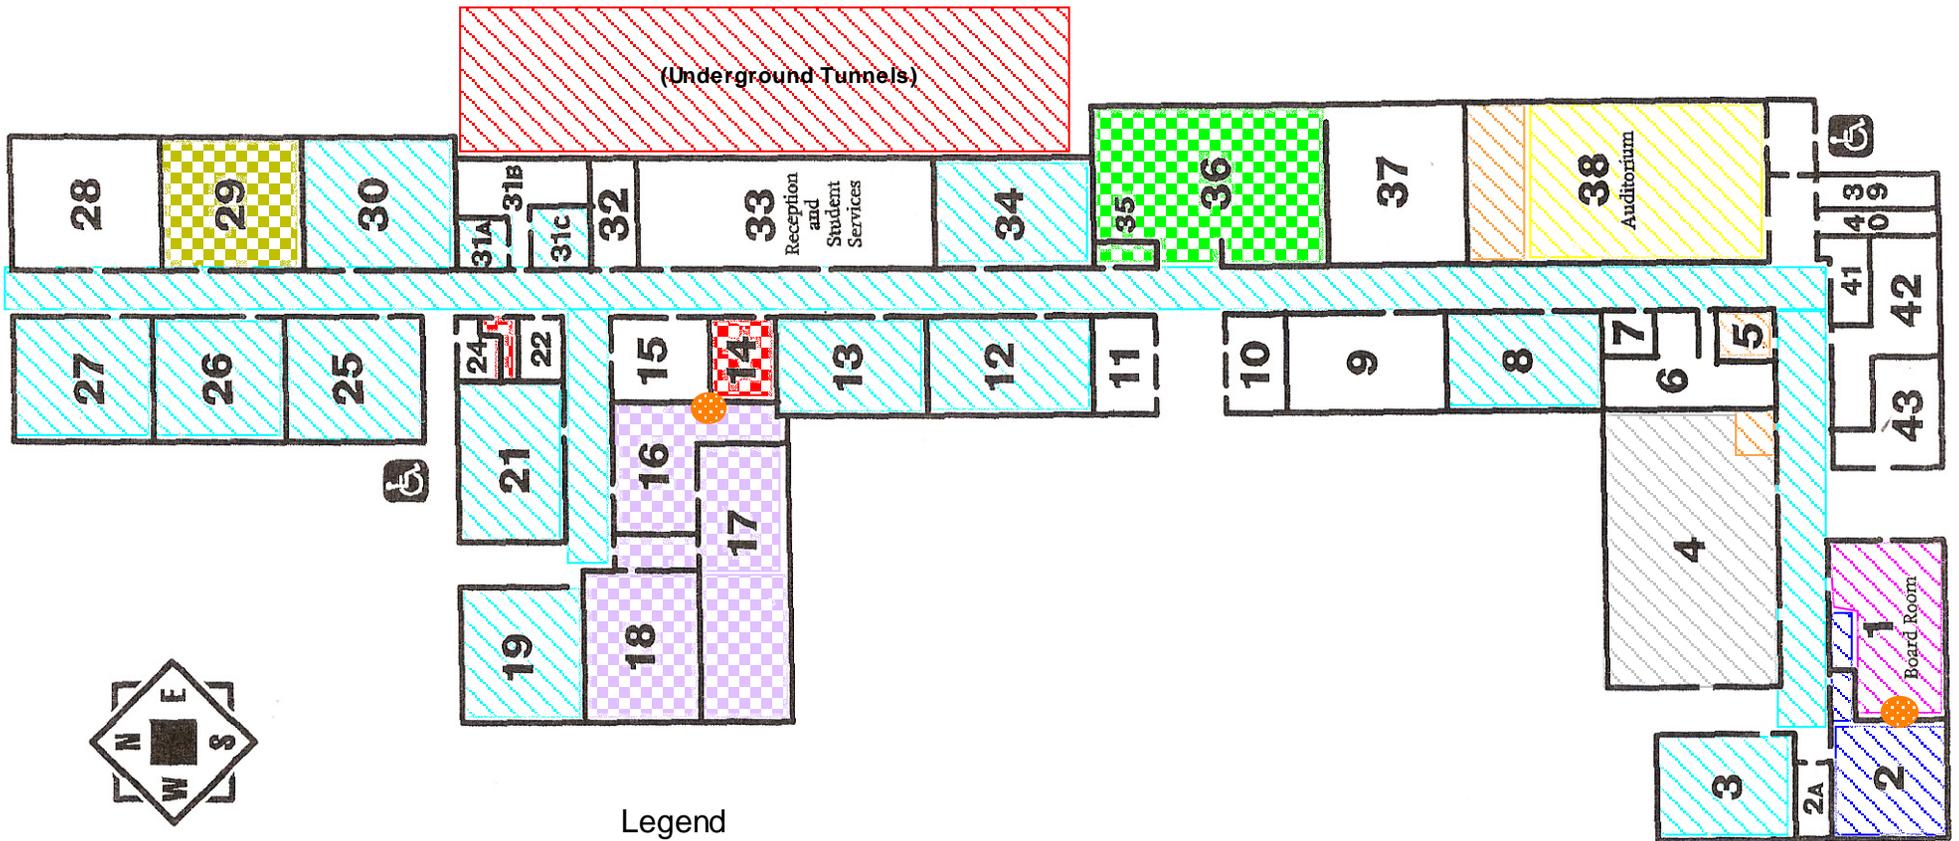
# Utah School for the Deaf and Blind (Former Libbie Edward Elementary School) Asbestos Location Map

= M008, 9" Floor Tile, Brown w/Tan Streaks		= T001 & T002, Mudded Fittings and Pipe Insulation
	= M009, 9" Floor Tile, Light Brown w/Tan Stripe & M010, 12" Floor Tile, Tan w/Black Speck		= M003, 9" Floor Tile, Brown
	= M011, 9" Floor Tile, Red & M012, 9" Floor Tile, Grey		= M004, 9" Floor Tile Red w/Tan Stripe
	= M013, 12" Floor Tile, Off-White w/Tan Stripe		= M005, 9" Floor Tile, Maroon
	= M020, 9" Floor Tile, Tan w/Red Speck		= M006, 9" Floor Tile, Tan w/Brown Stripe
	= M018 & M019, Undersink Coating		= M007, 9" Floor Tile, Brown w/Red Stripe

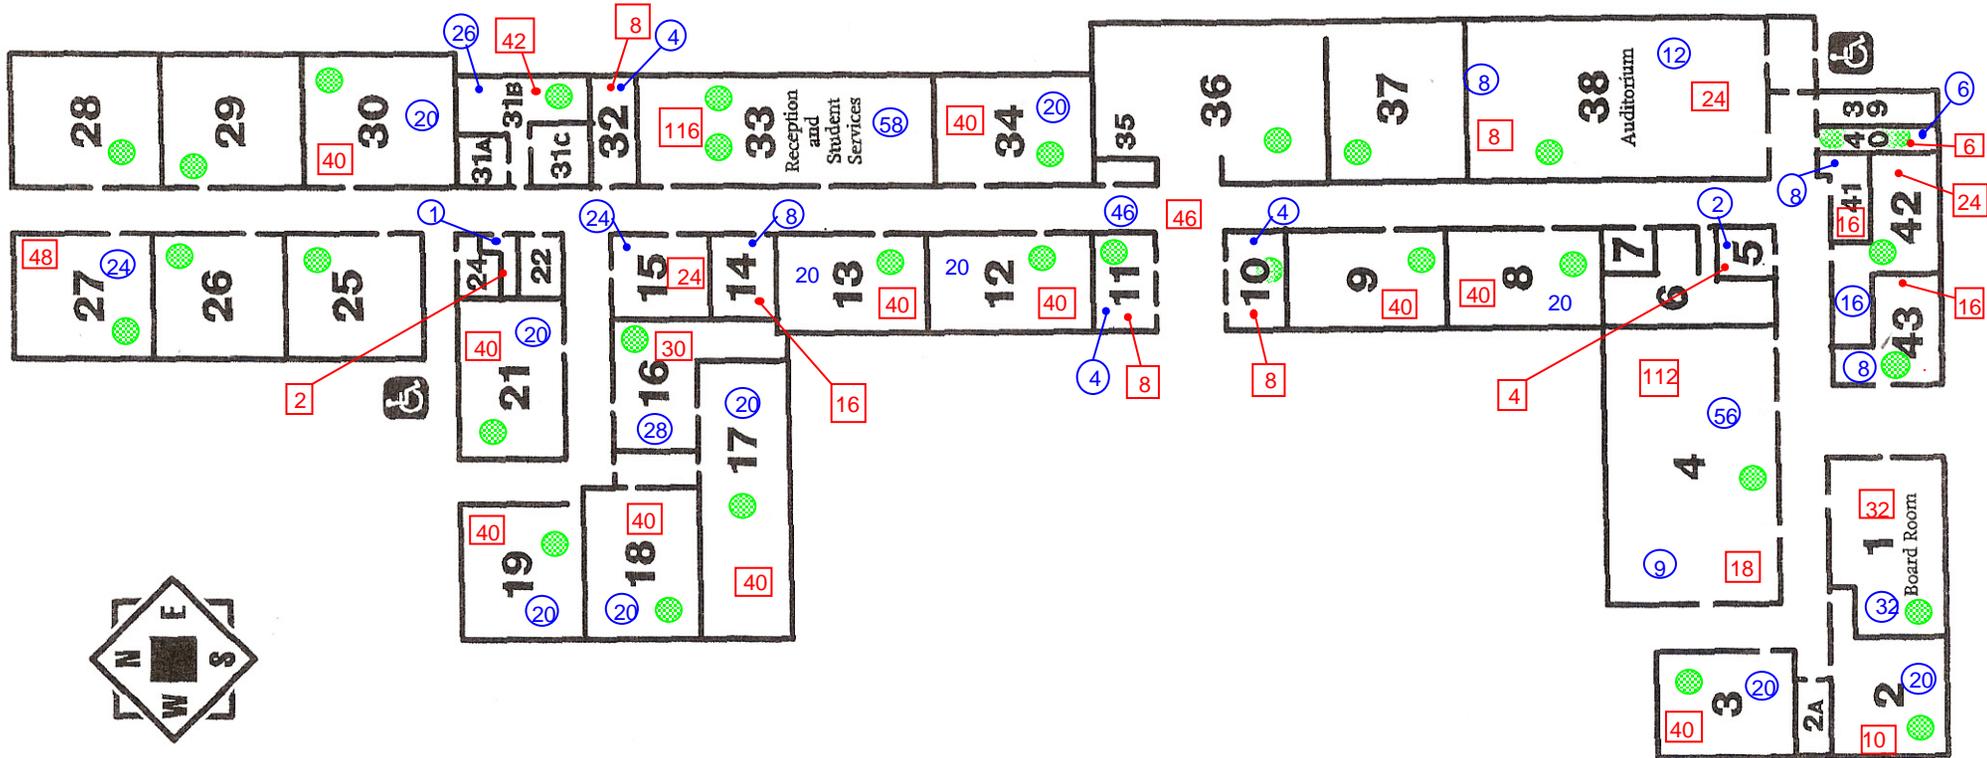
# Utah School for the Deaf and Blind (Former Libbie Edward Elementary School) Mercury Switches, Fluorescent Light Tubes & Ballasts

- # = Number of Fluorescent Light Tubes
- # =PCB Ballasts
- =Mercury Switches

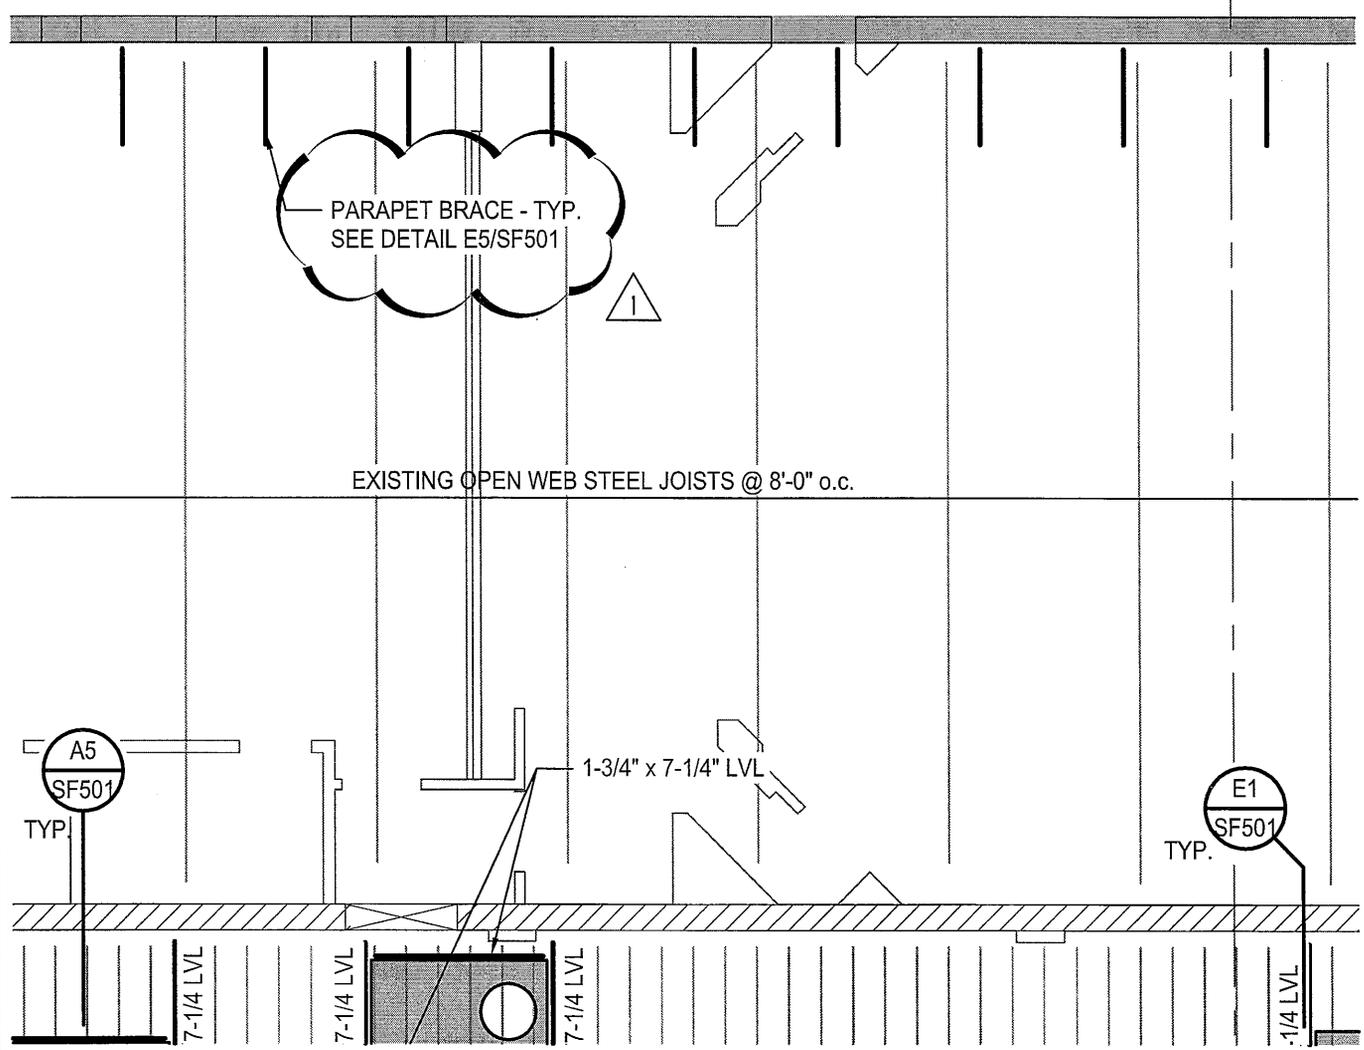
**EXIST. ROOF FRAMING - AREA 'A'**

SEE UPGRADE NOTE #3

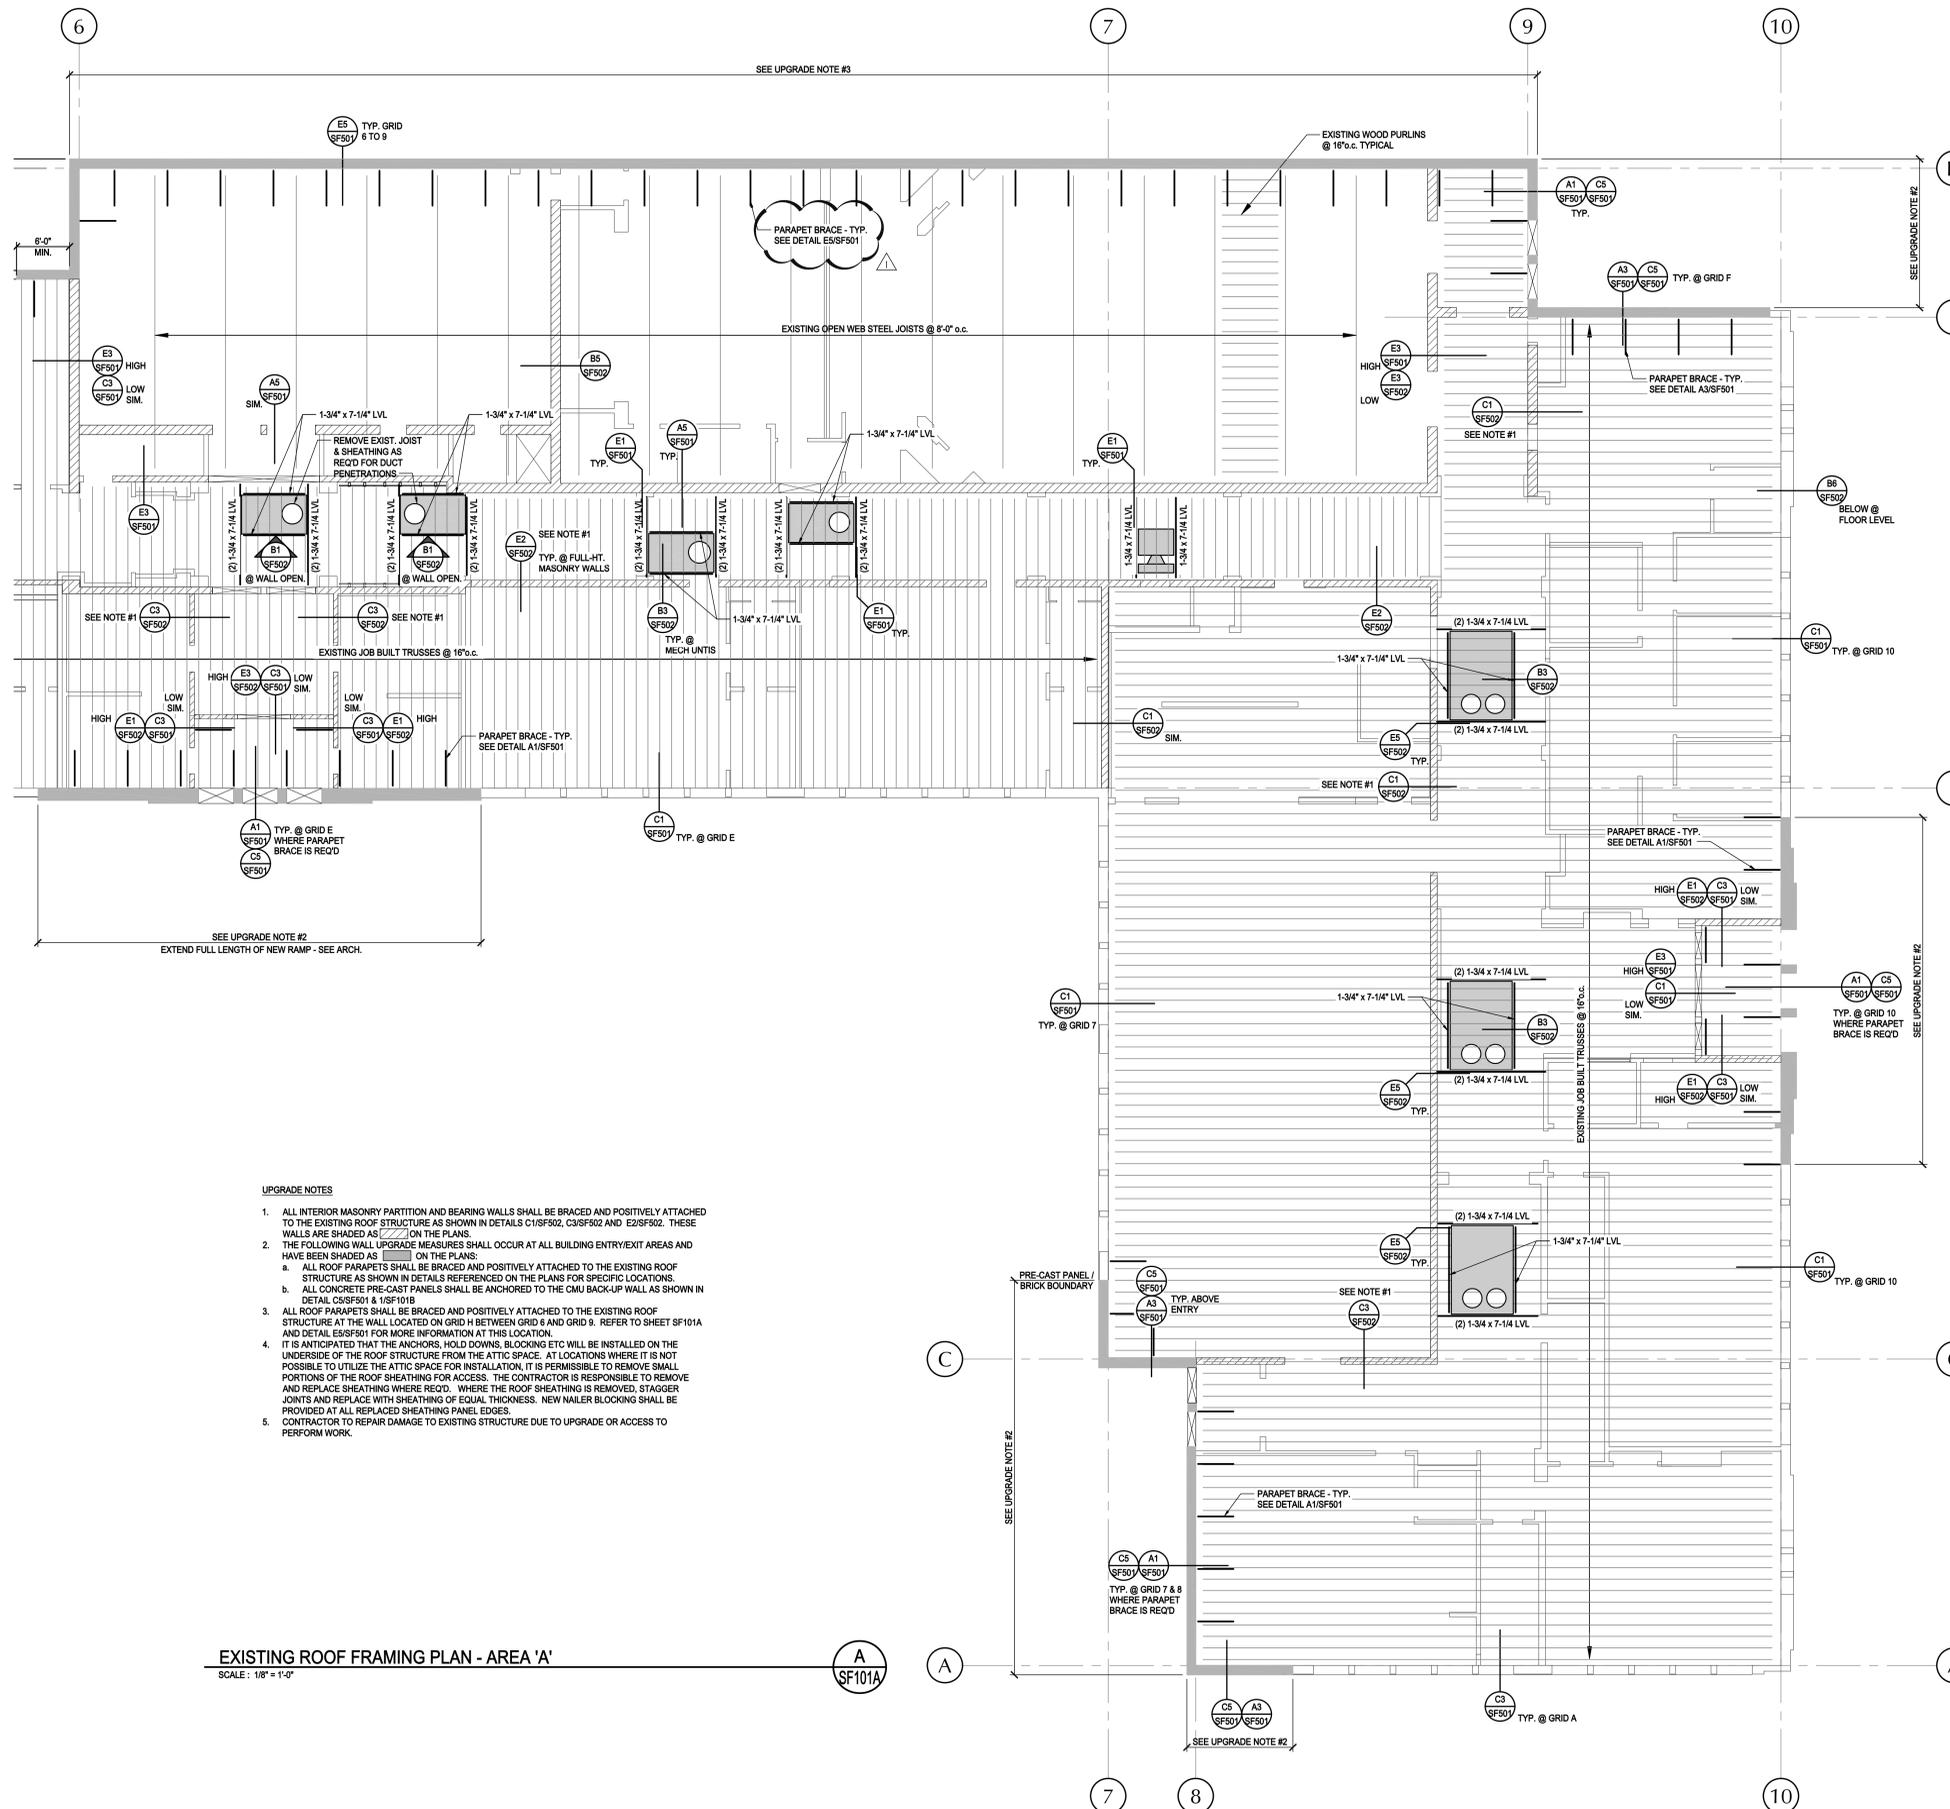
SG001

- UPGRADE NOTES**
- ALL INTERIOR MASONRY PARTITION AND BEARING WALLS SHALL BE BRACED AND POSITIVELY ATTACHED TO THE EXISTING ROOF STRUCTURE AS SHOWN IN DETAILS C1/SF502, C3/SF502 AND E2/SF502. THESE WALLS ARE SHADED AS [diagonal lines] ON THE PLANS.

- THE FOLLOWING WALL UPGRADE MEASURES SHALL OCCUR AT ALL BUILDING ENTRY/EXIT AREAS AND HAVE BEEN SHADED AS [diagonal lines] ON THE PLANS.
    - ALL ROOF PARAPETS SHALL BE BRACED AND POSITIVELY ATTACHED TO THE EXISTING ROOF STRUCTURE AS SHOWN IN DETAILS REFERENCED ON THE PLANS FOR SPECIFIC LOCATIONS.
