Solicitation for Architect / Engineer Services

WASATCH HALL RENOVATION

**WEBER STATE UNIVERSITY
OGDEN, UTAH**

DFCM Project No. 09191810

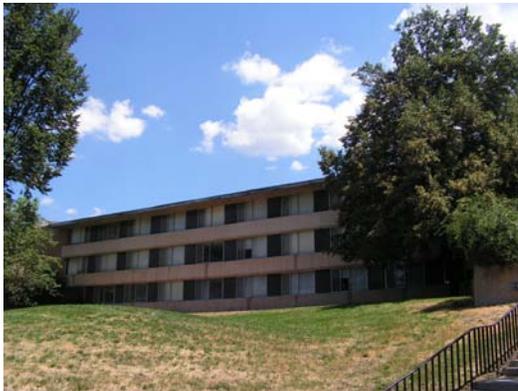
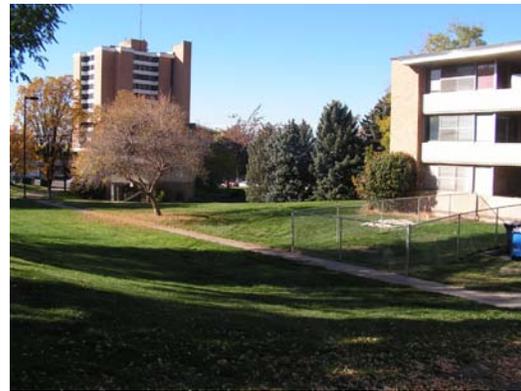
There are no handicapped stalls in the East Terrace Parking and there is no ADA compliant path from the parking to the building. There is moderate cracking in the East Terrace Parking asphalt and the lot's drainage is poor, allowing water collection in low areas. The lot has an estimated lifespan of 7-12 years before requiring "a significant rebuild". Light poles and bases in the lot have significant deterioration. The existing size and shape of the parking lot makes access by current fire apparatus difficult.

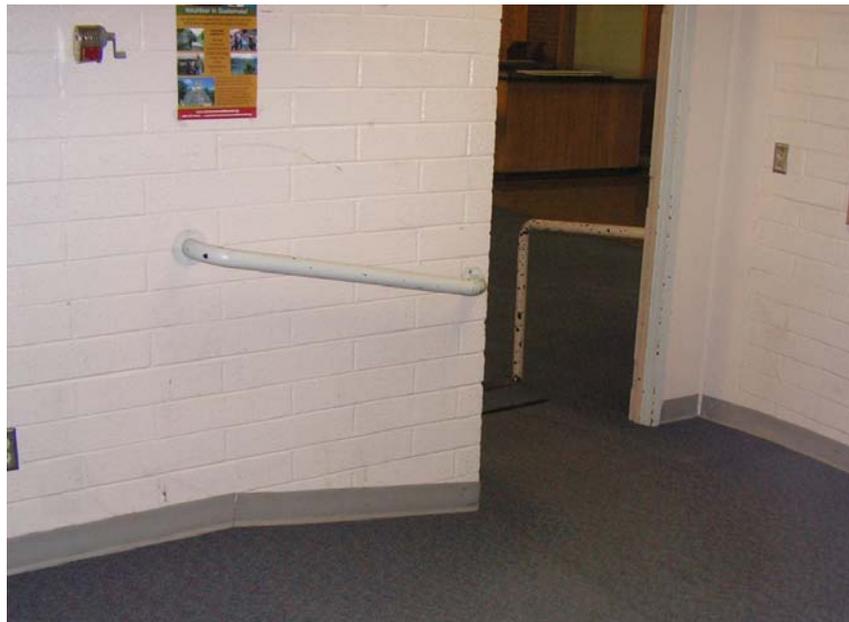
The floors of the main level housing wings are approximately 12 inches higher than the main lobby floor. Originally, a stair with two risers connected these different floor levels; the stairs have been replaced by small ramps that do not meet current codes.

Each housing wing floor contains 19 traditional 2-bed dormitory rooms, for a building total of (114) 2-bed rooms.

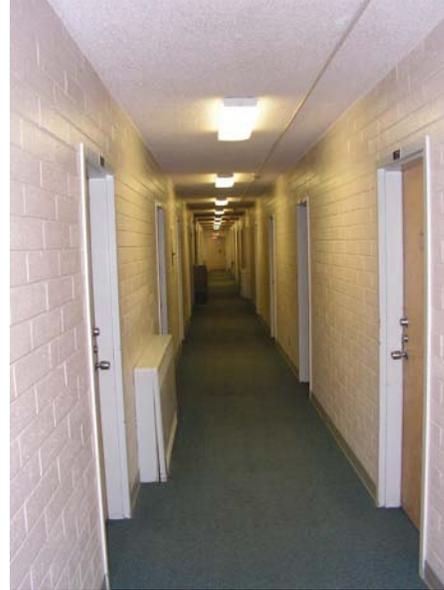
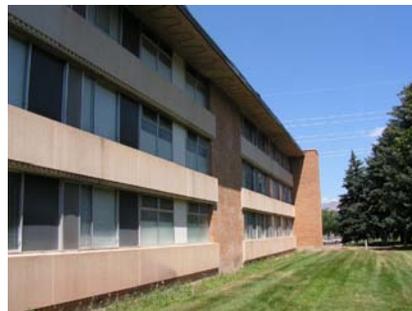
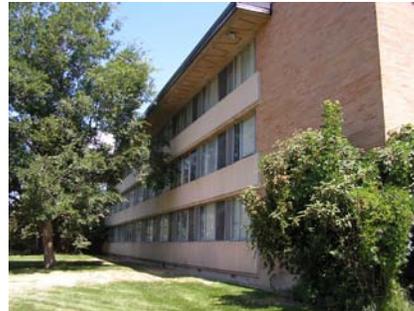
The building's exterior materials are Weber State standard buff brick and precast concrete panels. There is some efflorescence on the south-eastern elevation of the building.

- Remove efflorescence from exterior surfaces.
- Repoint exterior brick where needed.
- Investigate the water infiltration problems and correct these conditions.
- Replace the roofing on the north housing wing, with new metal flashings and roof access hatch assembly.
- Replace the housing wings exterior window units with new double-pane operating units.
- Replace the exterior glazing in the building's central portion with new double-pane glazing.

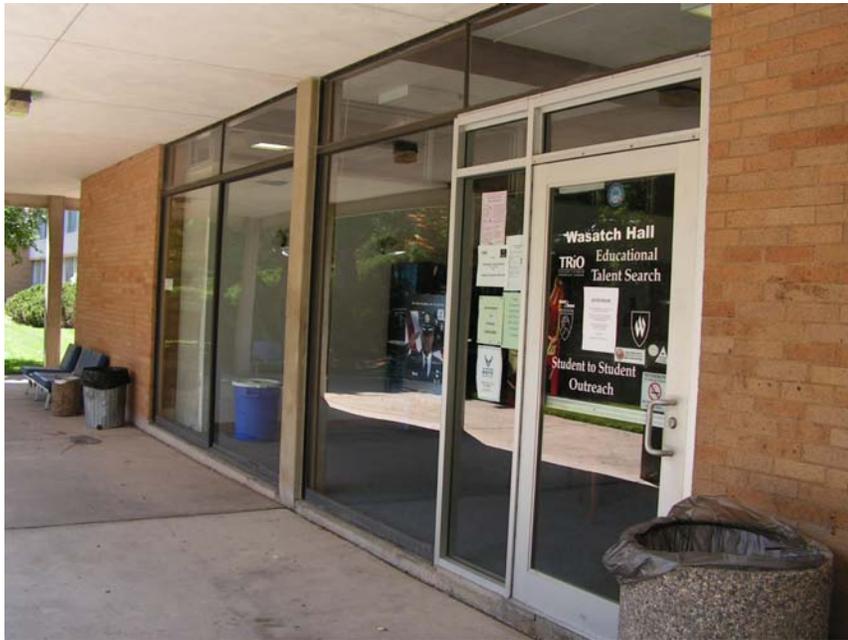
The roofs of the central portion and south housing wing were replaced with a Sarnafil roofing system in 2001 and are in good condition. The built-up roof of the north housing wing was installed in the 1980's and is showing signs of age.

The exterior windows in the housing wings are single-pane, sliding-glass units, some with failing hardware.

The large, sliding-glass doors on the east side of the main lobby are failing and are not currently used as doors.

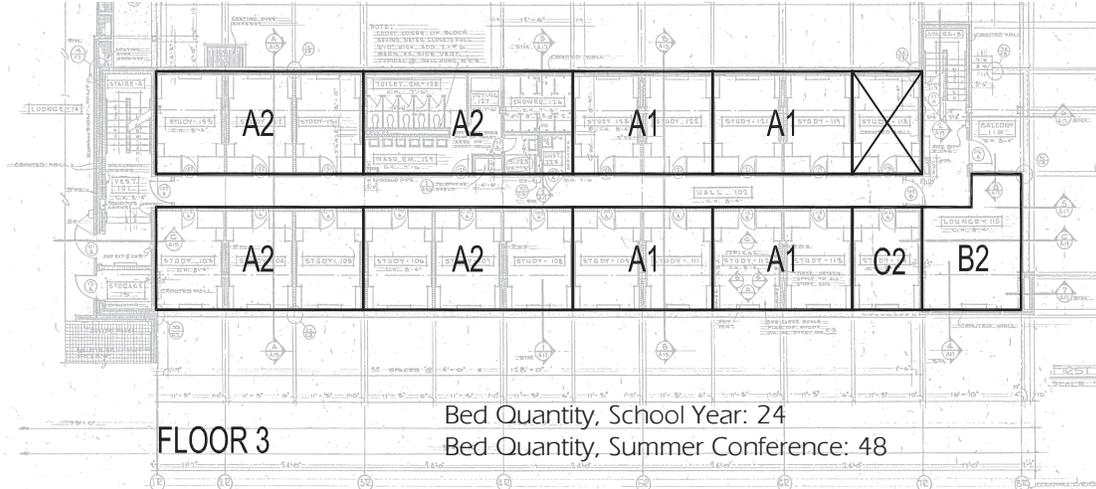
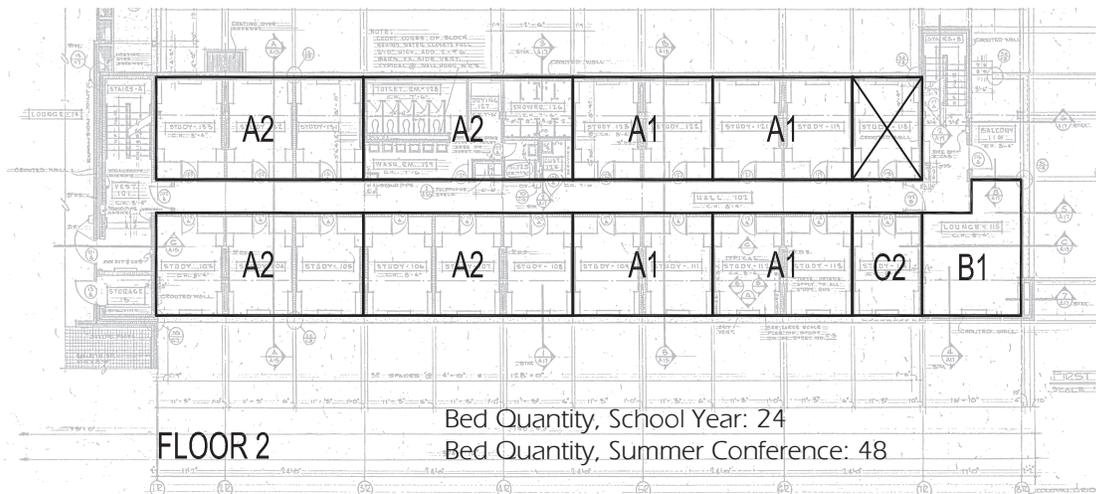
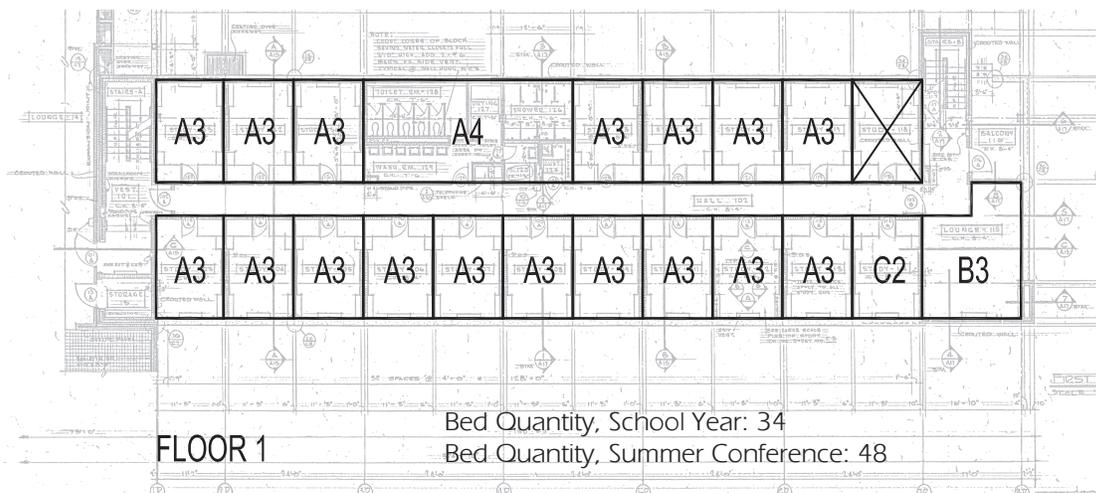
Housing Unit Test Fit Diagram

Note: Diagram represents north housing wing. South housing wing is a mirror image of this layout.

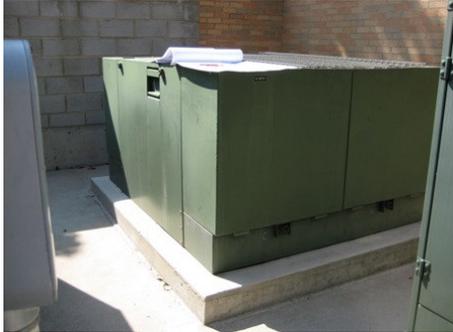
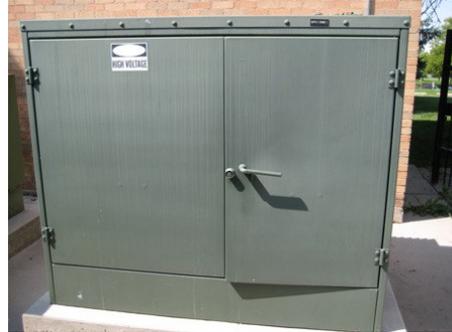
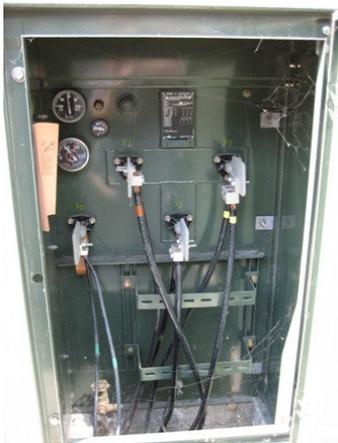
Power to the Wasatch-Lasal-Stansbury Hall chillers is provided through a pad mounted 12470V switch and 500kVA, 12470V Primary-480/277V Secondary Cooper pad mounted transformer, both were installed with the Chiller upgrade in 1999. Equipment is in good shape and should be reused as possible.

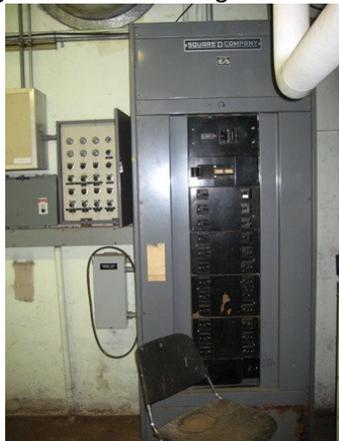
Main distribution panel is an 800A, 208/120V, 3-phase, 4-wire, Square D Power Style freestanding panel located in the Basement Mechanical Room. This panel is original to the building and is showing signs of corrosion on the enclosure.

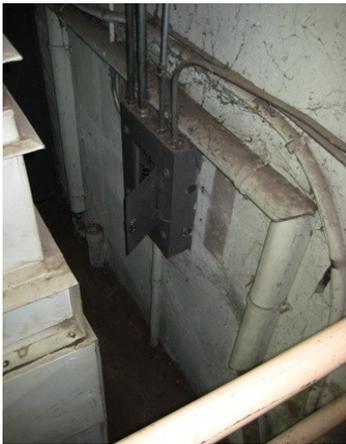
Panel “C-17” is a 100A, 208/120V, 3-phase, 4-wire, Square D exterior lighting branch panel and is located in the Basement Mechanical Room behind one of the air handlers. There is no access to this panel without climbing over railing.

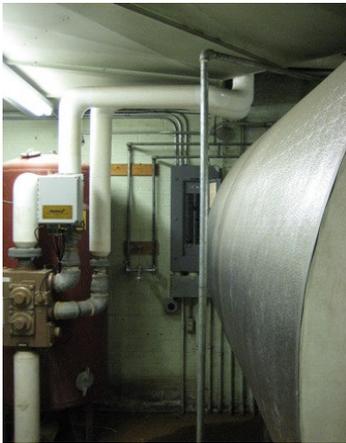
Panel “C-16” is a 225A, 208/120V, 3-phase, 4-wire, Square D power branch panel and is located partially behind large mechanical equipment.

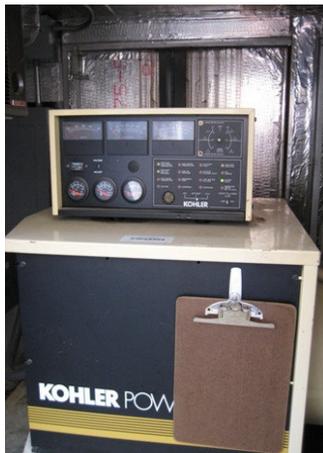
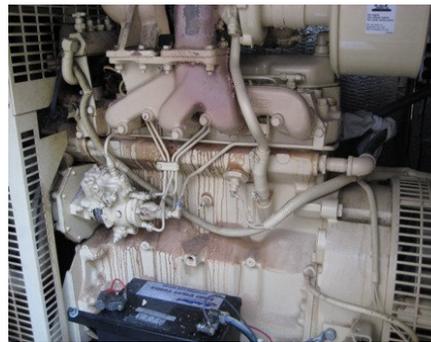
The Emergency Power System originates at a Kohler 50kW diesel engine generator located in its own weatherproof enclosure Northeast of Wastatch Hall adjacent to the Electrical Distribution Building. The engine feeds a 150A, 208/120V 3-phase, Siemen's distribution panel "EM". This panel is located in NEMA 3R enclosure next to the engine and has a 70A, 3-pole circuit breaker feeding Wasatch Hall, and (2) 50A, 3-pole circuit breakers feeding Lasall and Stansbury Halls. This Emergency distribution system was installed April of 1993 and is in good shape. The entire system should be reused as possible. The engine generator may have a leak in one of the gaskets that has stained the block. This should be investigated further with Generator Manufacturer.

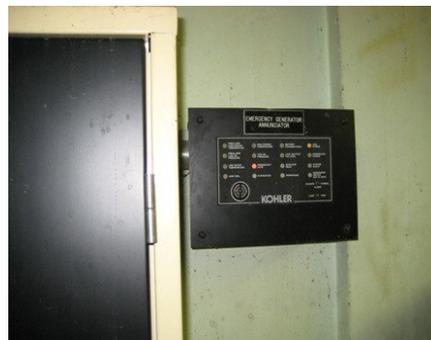
Wasatch hall has a 70A, 3-pole Automatic Transfer Switch located in the Basement Mechanical Room. The switch is tied to the 70A circuit breaker in panel "EM" and to a 70A circuit breaker disconnect that is tapped from bus of the Wasatch Hall main distribution panel. There is an engine annunciator panel next to the ATS. At the time of this report this annunciator had a warning light for "E-Stop".

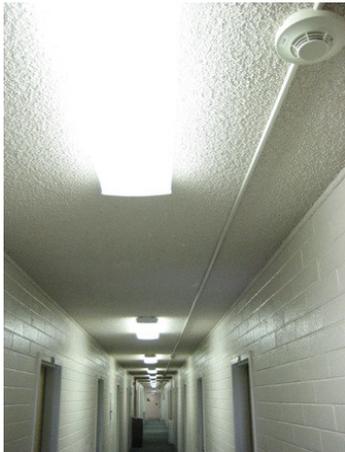
Interior light fixtures are a mix of surface and recessed mounted fluorescent fixtures with prismatic acrylic lenses and T-12 lamps in the Corridors and Lobby spaces. There are many fixtures that have cracked or otherwise damaged lenses. The lighting level in these spaces is sufficient. T-12 Lamps are inefficient and should be replaced with T-8 lamps with electronic ballasts.

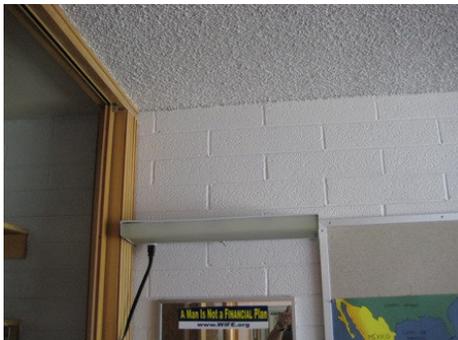
Dormitory Rooms have a two wall mounted linear wall fluorescent light fixtures each with integral toggle switch and power receptacles.

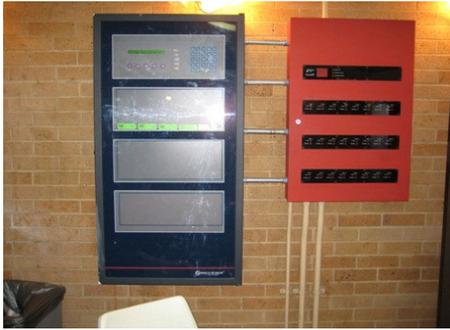
The fire alarm system was recently upgraded to new Notifier addressable system and is up to current codes. Dormitory rooms each have addressable smoke detectors.

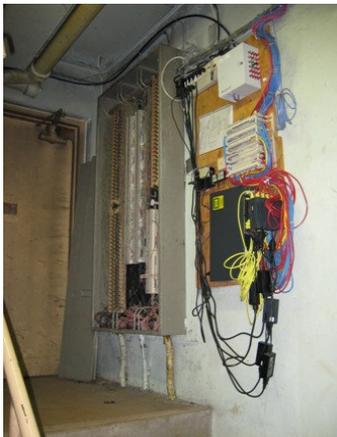
The telephone terminal board is located in the basement mechanical room. There is no ground bus bar or spare conduits available at this location.

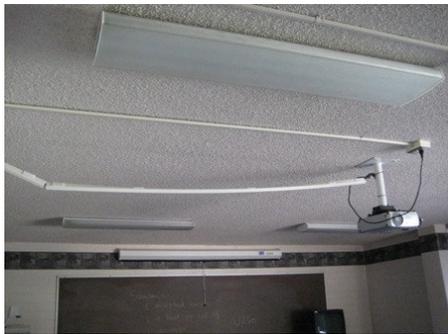
The classrooms have had projector systems installed. The raceways to these systems were surface mounted. Some of the raceway has pulled away from the ceiling and needs to be more permanently mounted.

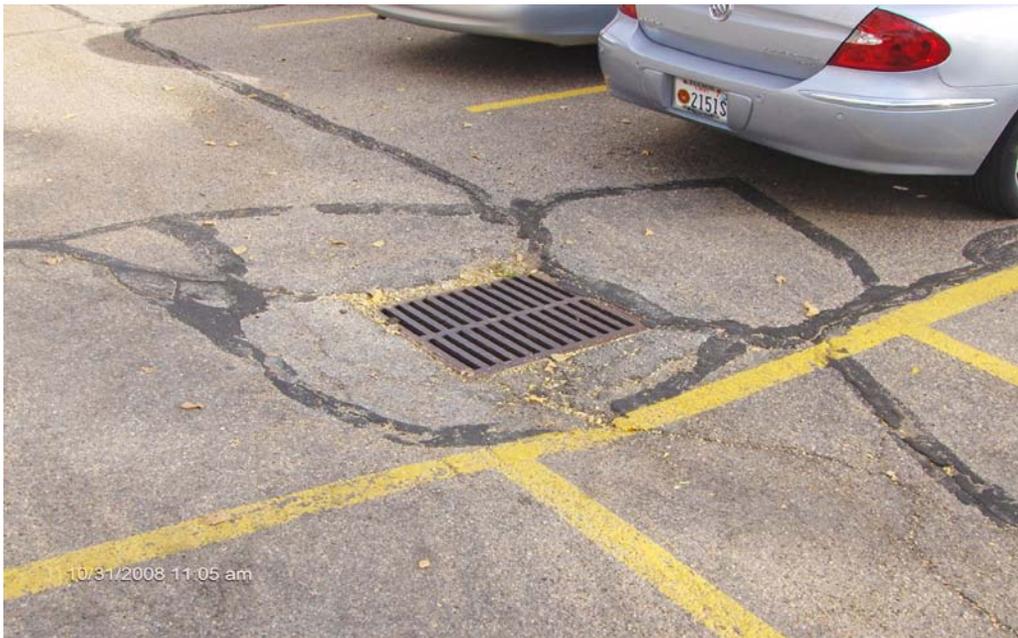
Fig. 2

West side parking lot conditions are fair to poor. The use of curb wall in lieu of curb and gutter in some area has contributed to the premature deterioration of the asphalt. The majority of the existing asphalt is moderately cracked and evidence of crack sealing is apparent. More significant is the condition of the asphalt where water has been collecting into pools. These areas are beginning to show evidence of alligator cracking and loss of underlying fines in the base material due to pumping. Without significant maintenance this parking lot would likely last only another 5-7 years. (See Fig. 2)

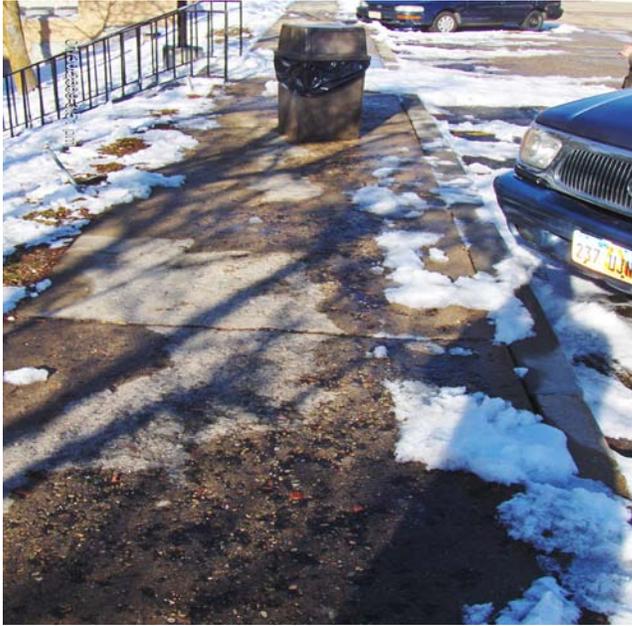
Fig. 3

The East Parking area suffers from many of the same conditions that the West parking lot suffers from, most notably the condition of the sidewalks and stairs. The sidewalks are almost all suffering from some significant level of deterioration. (See Fig. 3) Differential settlement between the curb and gutter and sidewalk presents a tripping hazard that is not easily corrected with grinding. Some sections have been rebuilt however they represent very little of the current East side infrastructure. Stairs and rails are in better condition with the possible exception of the handrails. The stairs and handrails may have to be considered for replacement even if Wasatch hall is preserved and renovated due to the A.D.A. access situation.

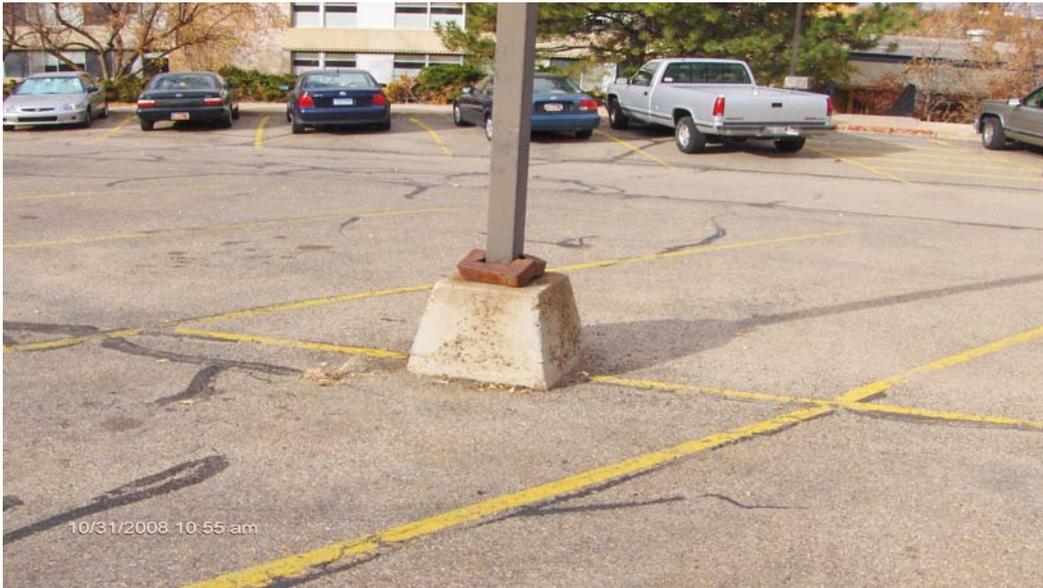
Fig. 4

The condition of the East side parking lot asphalt while slightly better than that of the West side is still fair. Moderate cracking is evident throughout the parking lot. The current parking lot design allows water to collect in low areas of asphalt with poor drainage. This allows ice to pool and freeze in the winter which will contribute to a shorter lifespan than would otherwise be expected. Without the benefit of knowing the section thickness of this parking lot and the traffic load it sees on a daily basis it is estimated that this parking lot has a 7-12 year lifespan before requiring a significant rebuild. It should also be noted that the light poles and bases in the East parking lot are in a significant state of deterioration. (See Fig. 4)

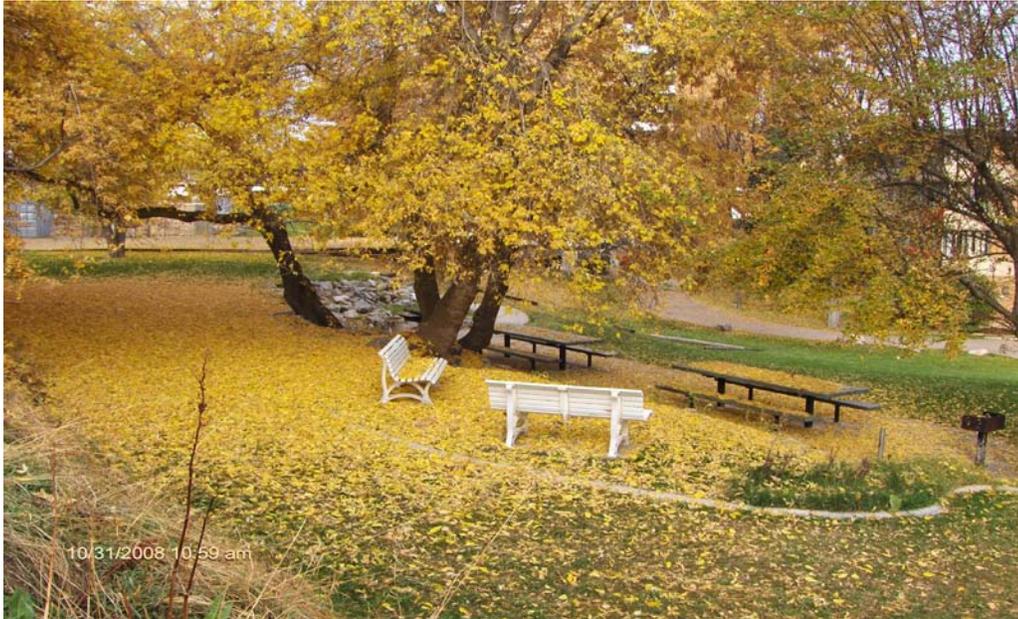
Fig. 5

Various amenities exist within immediate walking distance of all four buildings. Sand volleyball, basketball, and small to medium size areas of grass for general exercise are also available. Barbeque and grilling facilities along with benches and picnic tables are present. (See Fig. 5)

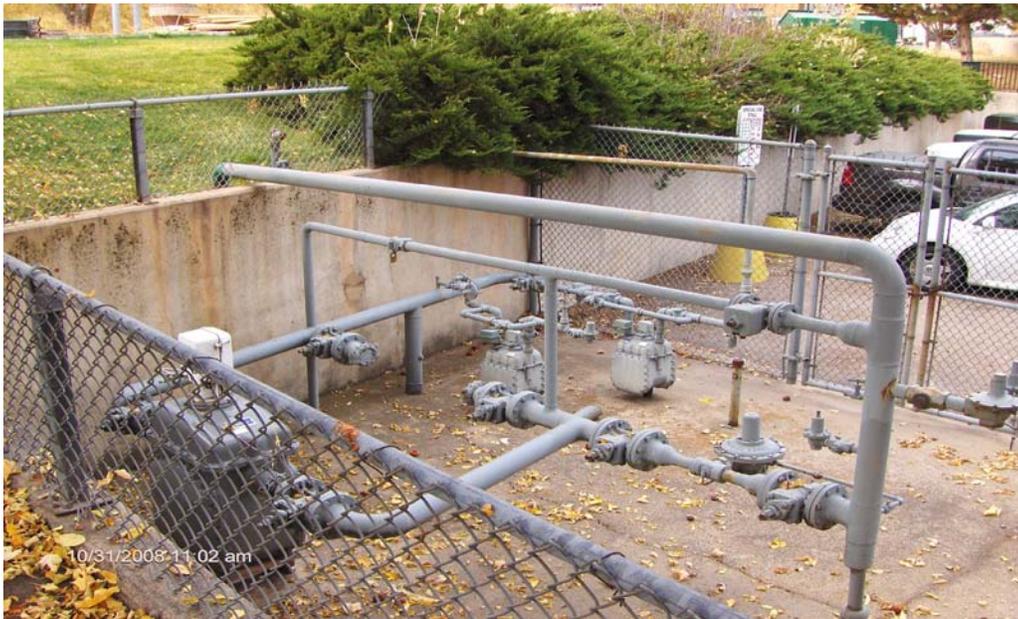
Fig. 6

Gas service is provided to all four buildings. Wasatch, Stansbury and LaSal Halls are each serviced by what appear to be a 2" line to the boilers and a 1-1/4" line for cooking and running clothes dryers. Promontory Towers is currently serviced by what is believed multiple lines of unknown size. The entire site is serviced by a 4" high pressure (30 psi) line according to WSU's utility drawings. The facilities staff has indicated that gas supply has been a problem for them in the past on rare occasions and at the request of Questar they have used alternative means for fire their boilers. This should be further explored once the full demand of the proposed facilities is known. Based on the information available at the time of this report about the layout of the existing gas utilities, a major reconstruction of the gas distribution infrastructure from the curb into all buildings should be anticipated during the course of construction. (See Fig. 6)
