## Addendum No. 2

Reference: Mechanical/Electrical/Plumbing Upgrades – Miller Administration Building  
Weber State University – Ogden, Utah  
DFCM Project No. 14031810

Project Architect: M. Shane Sanders, AIA  
DFCM Project Number: 14031810  
Project Number: 214016  
Date: 03.19.2015

**ASBESTOS, LEAD AND HAZARDOUS MATERIALS  
INSPECTION, SURVEY AND ASSESSMENT  
FOR  
MILLER ADMINISTRATION BUILDING  
WEBER STATE UNIVERSITY  
OGDEN, UTAH 84403**

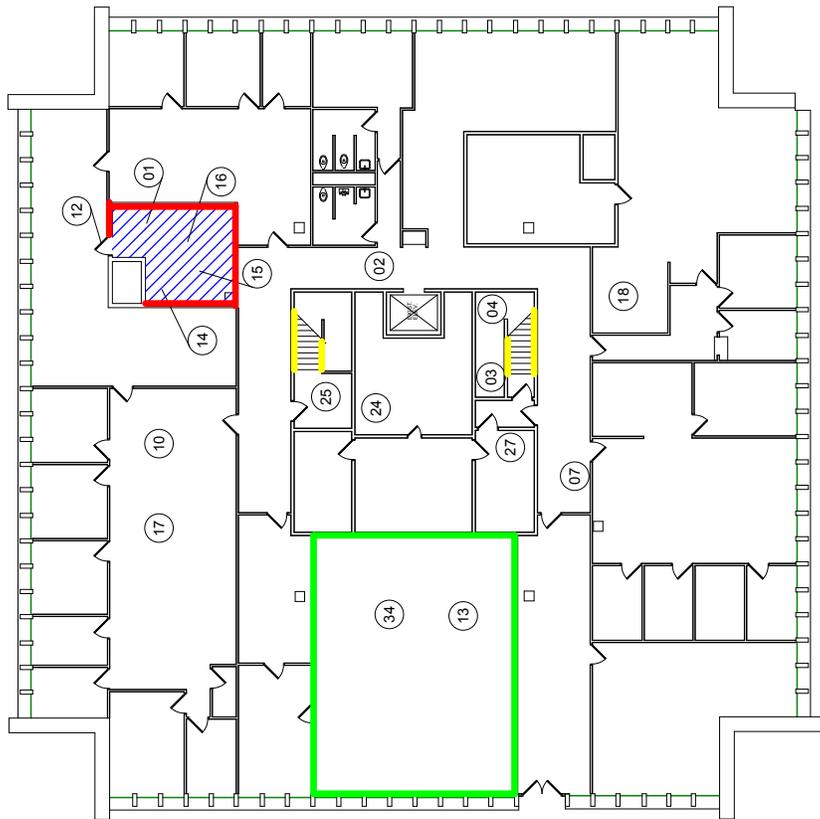
# FIRST LEVEL

- █ = CMU WALL COATING CONTAINS ASBESTOS
- ▨ = ASBESTOS CONTAINING FLOOR TILE & MASTIC
- █ = WALL INSULATION SEALANT CONTAINS ASBESTOS
- ## = SAMPLE LOCATION AND NUMBER
- █ = STAIR SKIRT CONTAINS ASBESTOS

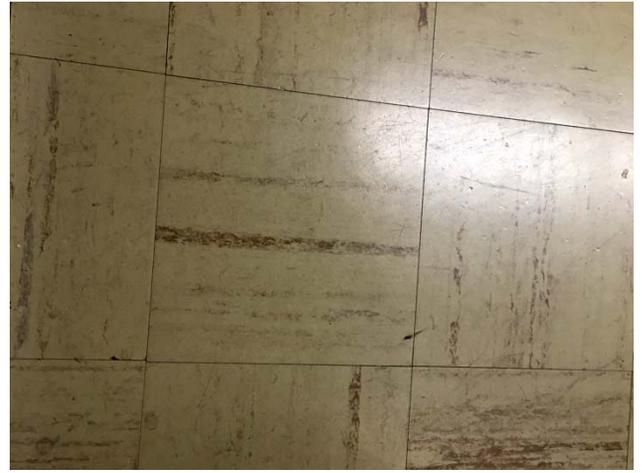
**PHOTO 2: 9" Vinyl Floor Tile & Mastic**

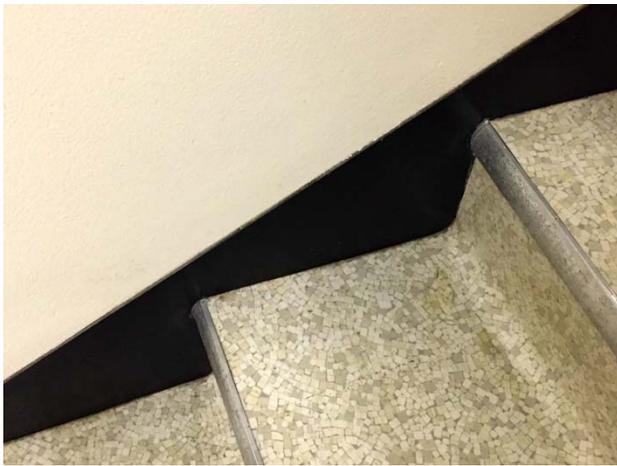
**PHOTO 3: Stair Skirt**

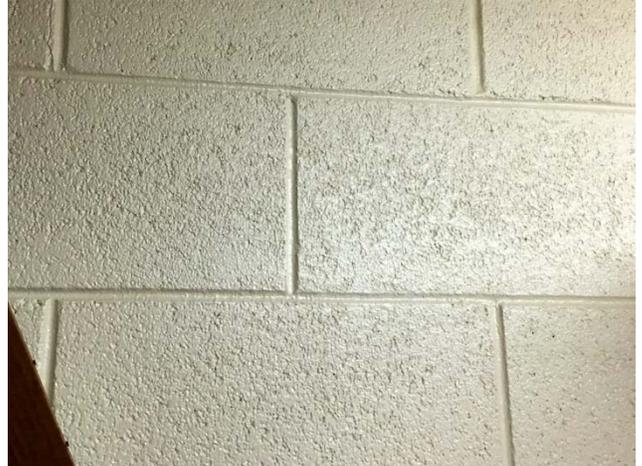
**PHOTO 4: CMU Wall Coating**

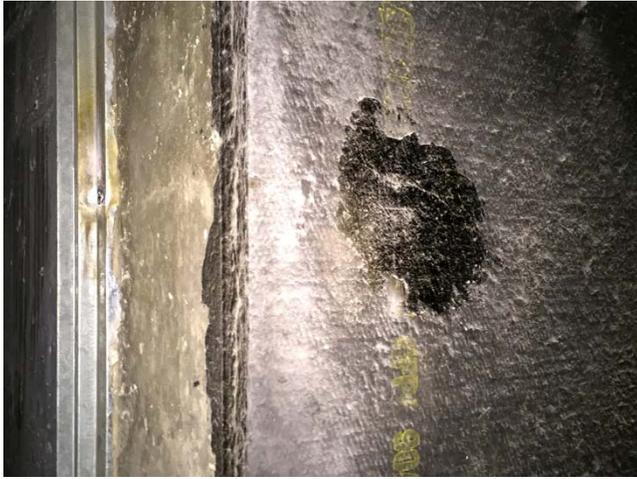
**PHOTO 5: Wall Insulation Sealant**

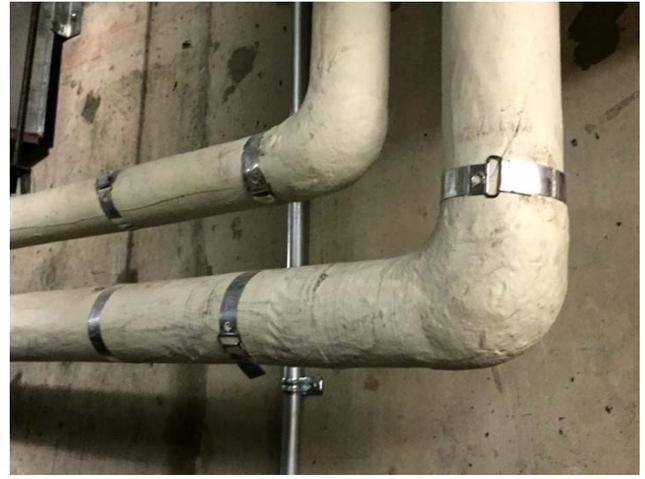
**PHOTO 6: TSI Plaster Elbow**

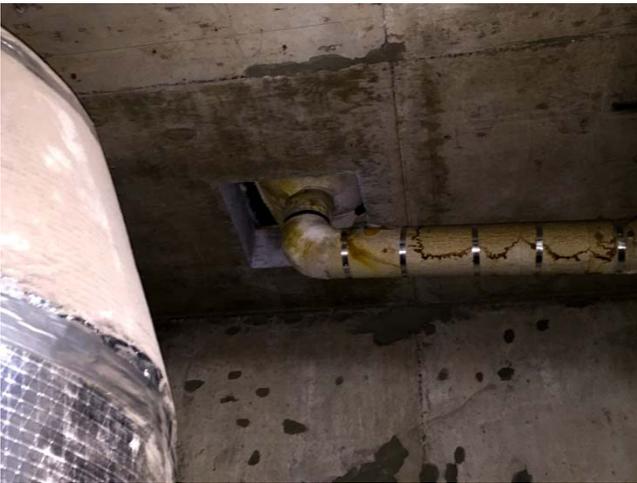
**PHOTO 7: TSI Roof Drain Insulation**

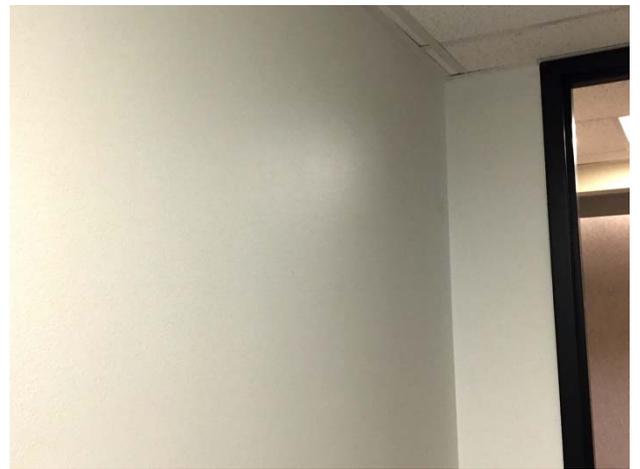
**PHOTO 8: Wall System**

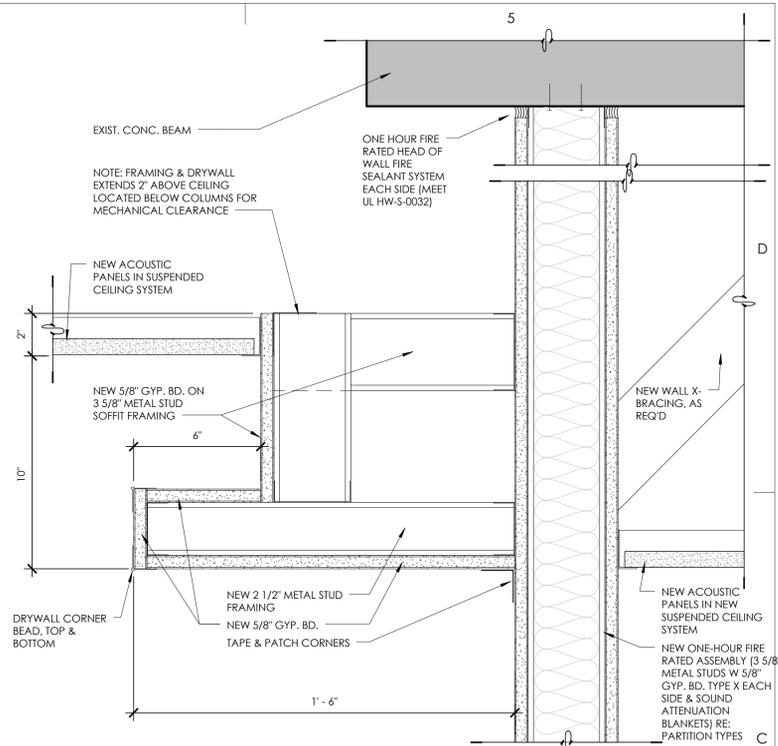
**C5 CEILING DETAIL @ LEVELS 1 FIRE RATED PARTITION**  
 3" = 1'-0"

ANSWER: This is the wall joint that abuts the existing wall that the drywall is to be removed by Environmental Abatement, Inc., **(Refer to Addendum #2, Architectural Addendum Item #2)**. A mudset molding will not be acceptable at this location, since there is asbestos material observed in the drywall compound in the building, **(Refer to Addendum #2, Architectural Addendum Item #1)**. Existing conditions will need to be reviewed, but fire sealing will be required in the vertical joint each side of the existing wall and a new metal molding is to be installed over the leading edge of the existing drywall. Options for the molding: Fry Reglet #2054 or Fry Reglet #1264 that is adhered to the existing drywall or additional option: Fry Reglet #DRAT-100 that is mudset to the new drywall and abuts the existing drywall. **(Refer to the attached detail C5 on drawing AE301)**

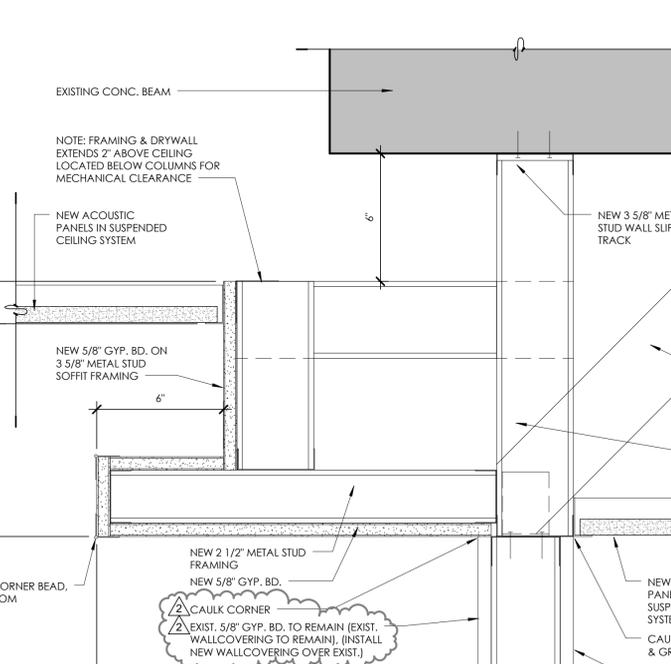
**A4 CEILING DETAIL @ LEVEL 2**  
 3" = 1'-0"

QUESTION: *"Looking on AE121 south corridor, South wall calls for an A type top of wall condition and also A4/AE541 in the same location. We are assuming the A4/AE541 detail would be required to hold the drop so my question is does the A4 condition need to extend from the drop to the end of the wall at the gyp ceiling condition or can the A or D condition Bracing only be used in these locations. This condition also occurs on AE121 & 122. "*

ANSWER: We have indicated the existing top of wall conditions, as close as we can determine with the limited site ceiling access in some building locations, by providing the top of wall / ceiling details on AE542. There are locations at the existing top of wall conditions that have existing wood nailers installed for mounting the ceiling grid perimeter angles. This occurs sporadically at various locations through out the building. We indicated the A4/AE541 detail for the new dropped ceiling at the corridor walls. The "A" Ceiling Detail on AE542 indicates top of wall locations that we have observed existing wood nailers installed. Note, there may be other locations that have this condition that is not accessible for field verification at this time. The intent is to try to leave the wood nailers, if possible, since they are mounted to the existing ceiling grid angles. The new wall bracing at the corridor wall would be similar to detail A4/AE541.

QUESTION: *"Ceiling Detail A4/AE541 calls for "Remove and replace existing 5/8" Gyp Bd. This detail is found on the RCP AE122 on AE101 indicates a skim coat over existing drywall. Which should I include?"*

ANSWER: The existing drywall is to remain and the existing wall covering is to remain. The skim-coating of the existing gypsum board is omitted from the project. The existing wall covering is to be repaired, prime painted and new wall covering installed. **(Refer to Addendum #2, Architectural Addendum Item #10 and Item #12, and Refer to the attached drawing AE541).**

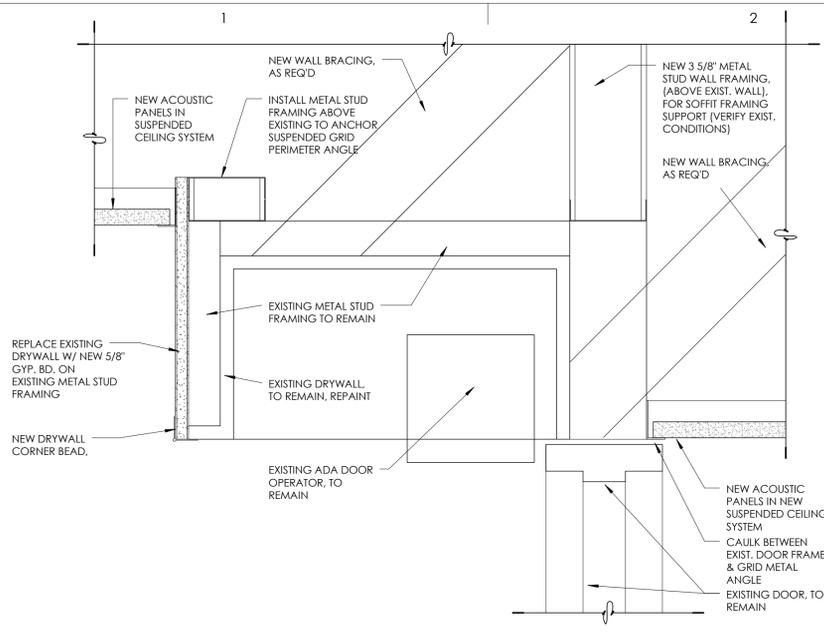
- 7 7/8" WALL MOULDING BERC2 CLIP, SCREWED ON ATTACHED WALLS & UNSCREWED ON UNATTACHED WALLS. (IBC)

(NOTE: SPECIAL INSPECTION REQUIRED FOR MOUNTING CLIPS AND SUSPENDED CEILING SYSTEM) (REFER TO SPECIAL INSPECTION, MATERIAL TESTING & STRUCTURAL OBSERVATION ITEMS SHEET G1004)

**1** Suspended Ceiling Seismic Bracing Detail  
3" = 1'-0"

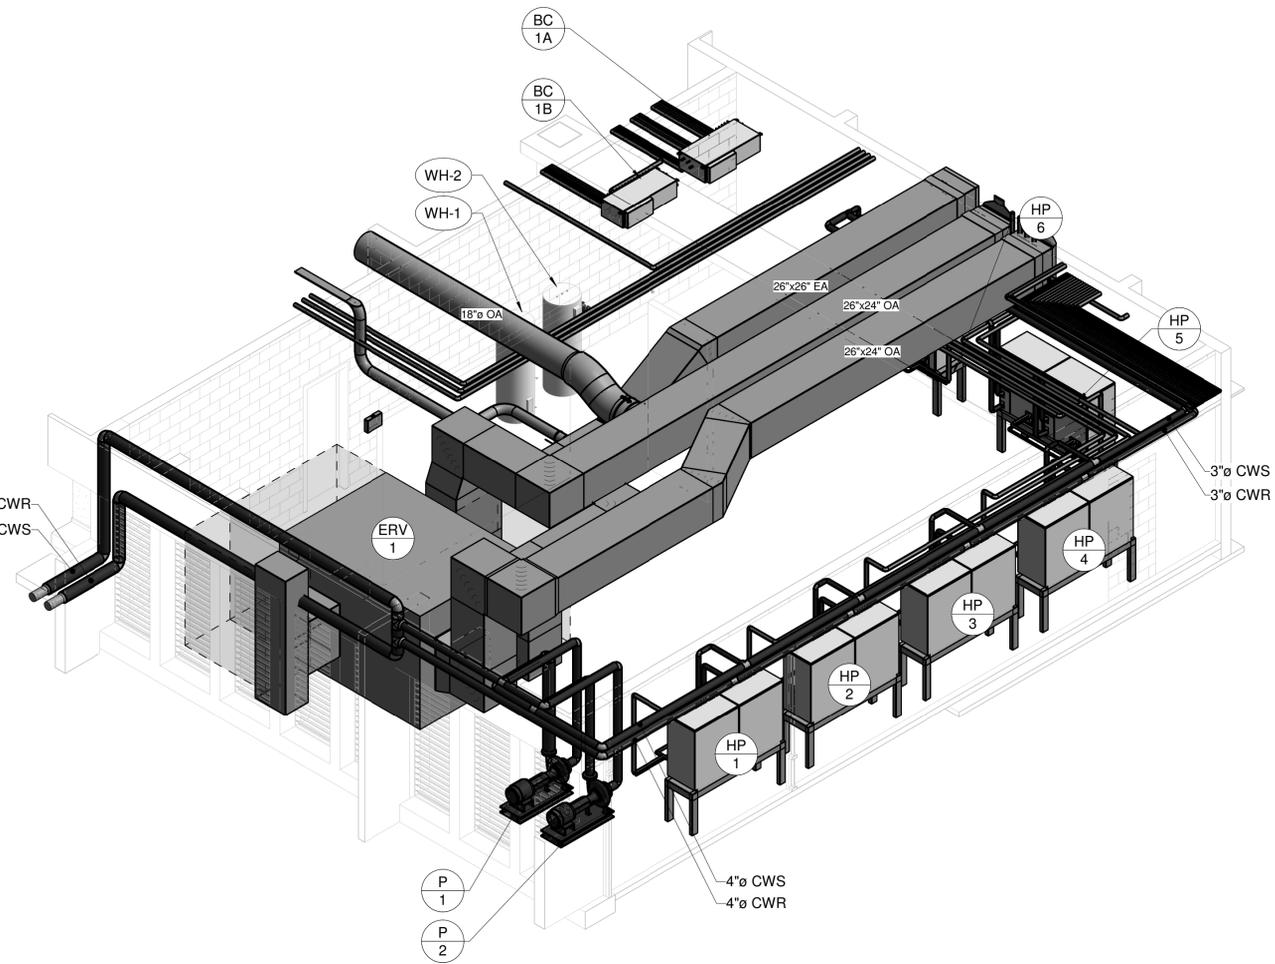
1 MECHANICAL ROOM ISOMETRIC

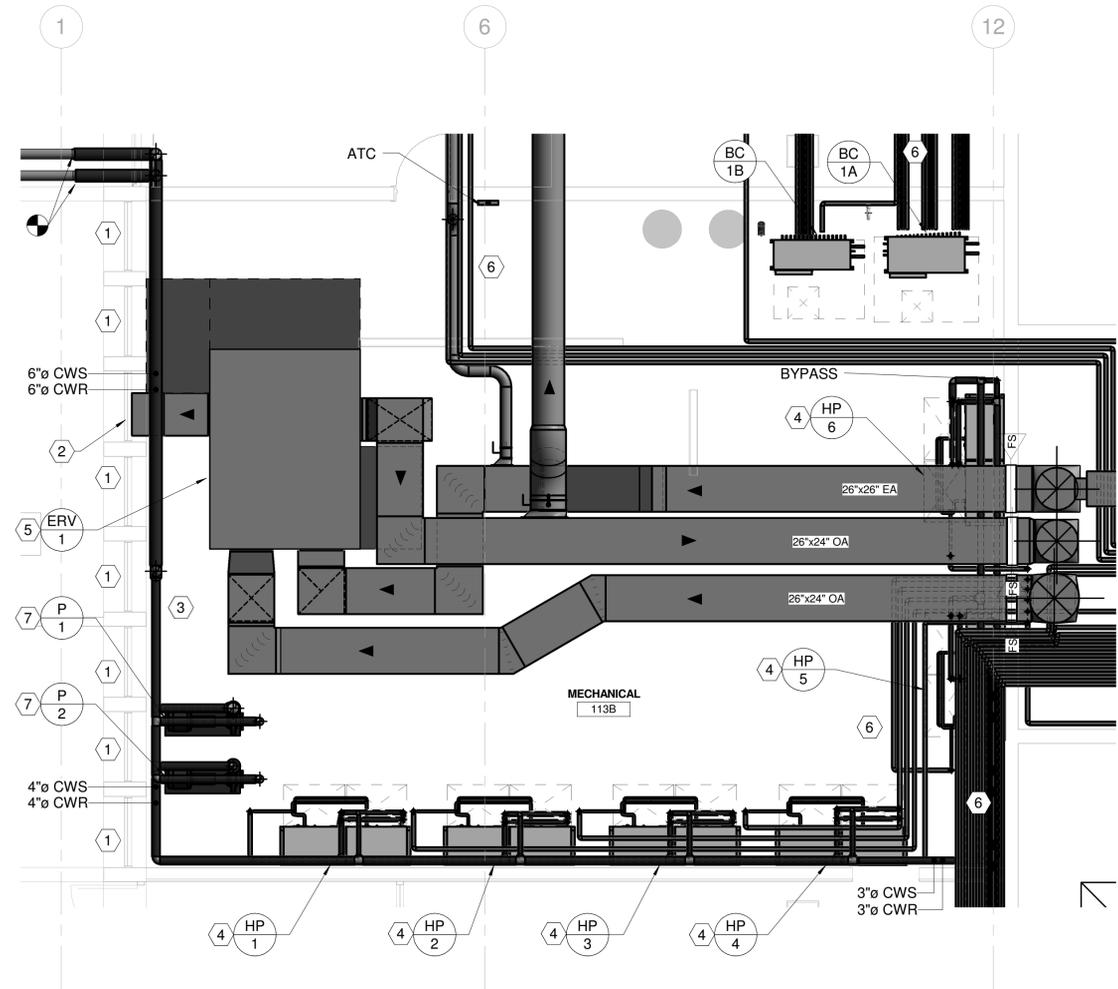
2 MECHANICAL ROOM LARGE SCALE PLAN  
 1/4" = 1'-0"

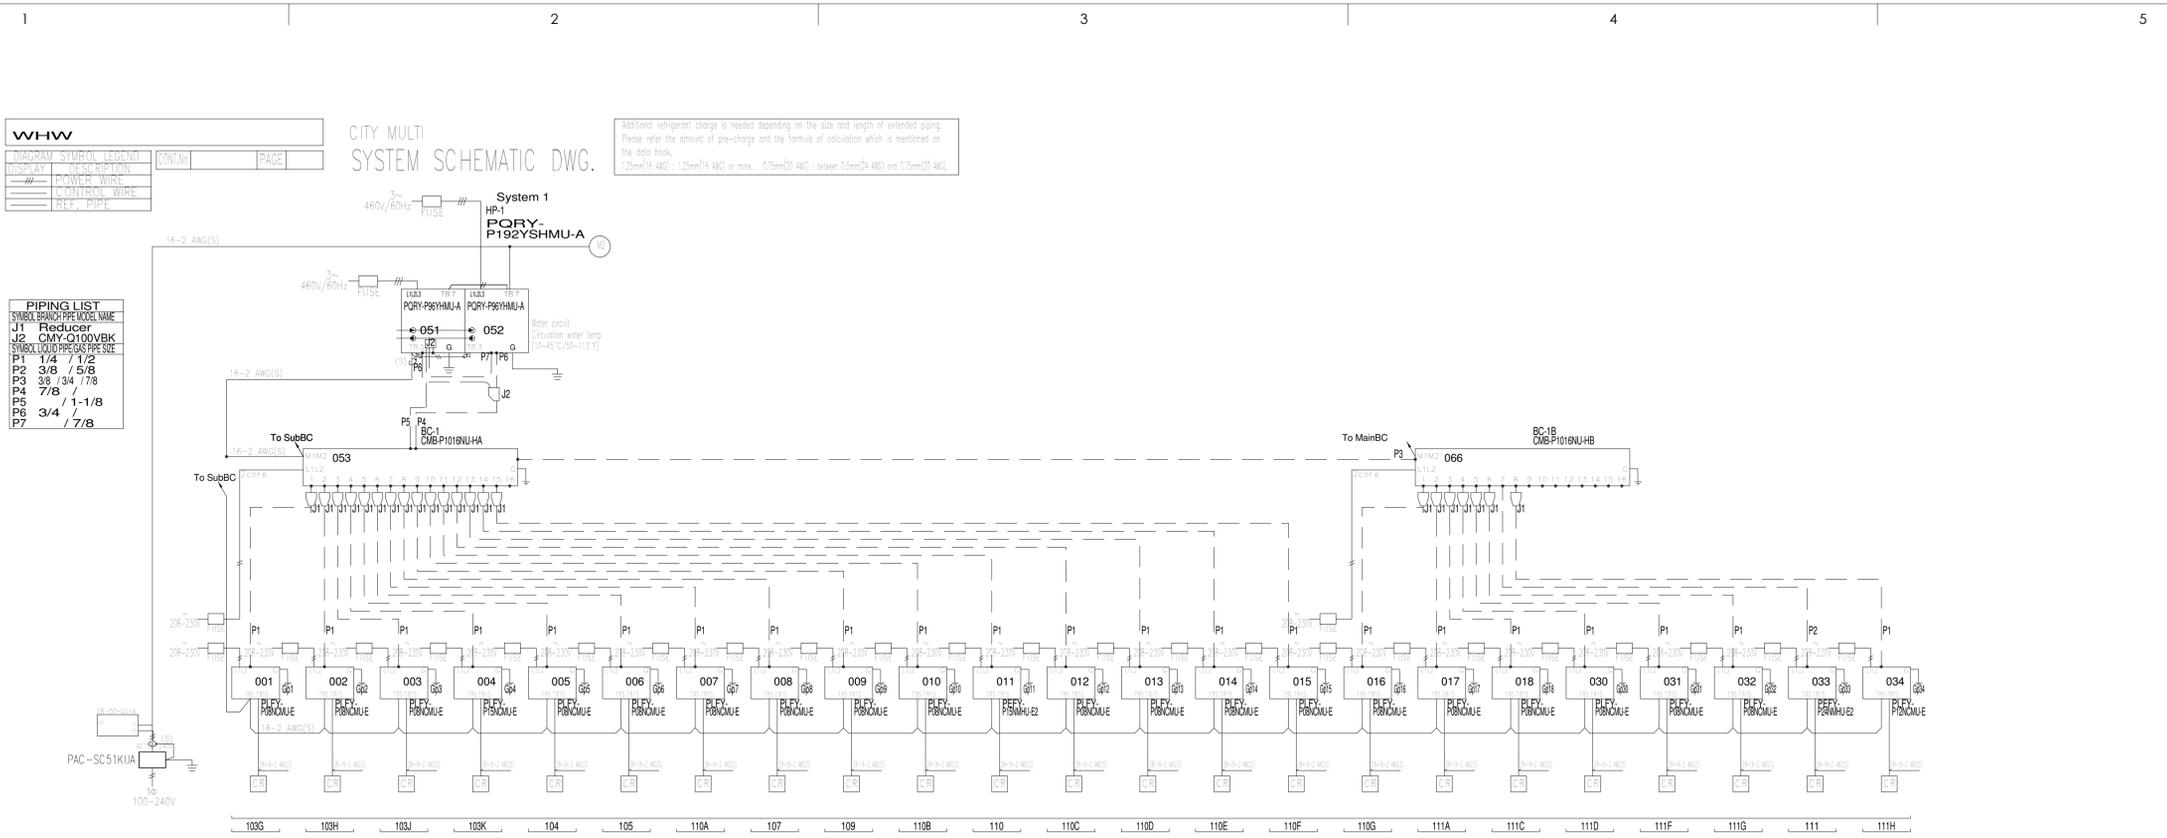
**C3 HP-1 DIAGRAM**  
SCALE: NONE

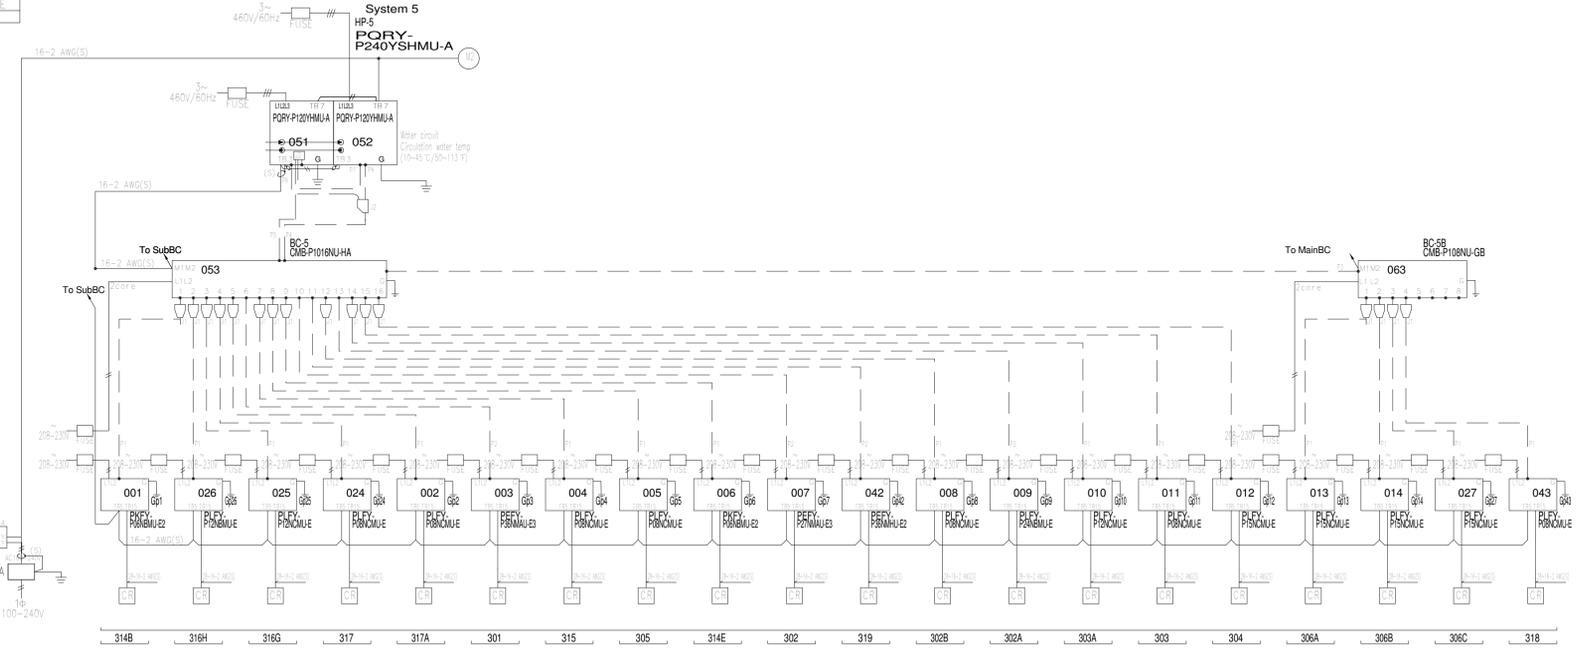
Additional refrigerant charge is needed depending on the size and length of extended piping. Please refer the amount of pre-charge and the formula of calculation which is mentioned on the data book.  
 1.25mm(1/8 ANG) : 1.25mm(1/8 ANG) or more, 0.75mm(3/32 ANG) : between 0.5mm(1/16 ANG) and 0.75mm(3/32 ANG).

**C3 HP-5 DIAGRAM**  
SCALE: NONE
