Re: 3-Year Asbestos Re-Inspection and PCB Testing
Provo Regional Center
Building Number 05374
150 East Center Street
Provo, Utah 84606
Terracon Project No. AL157595

3-Year Asbestos Re-inspection and PCB Testing

Provo Regional Center ■ Provo, Utah

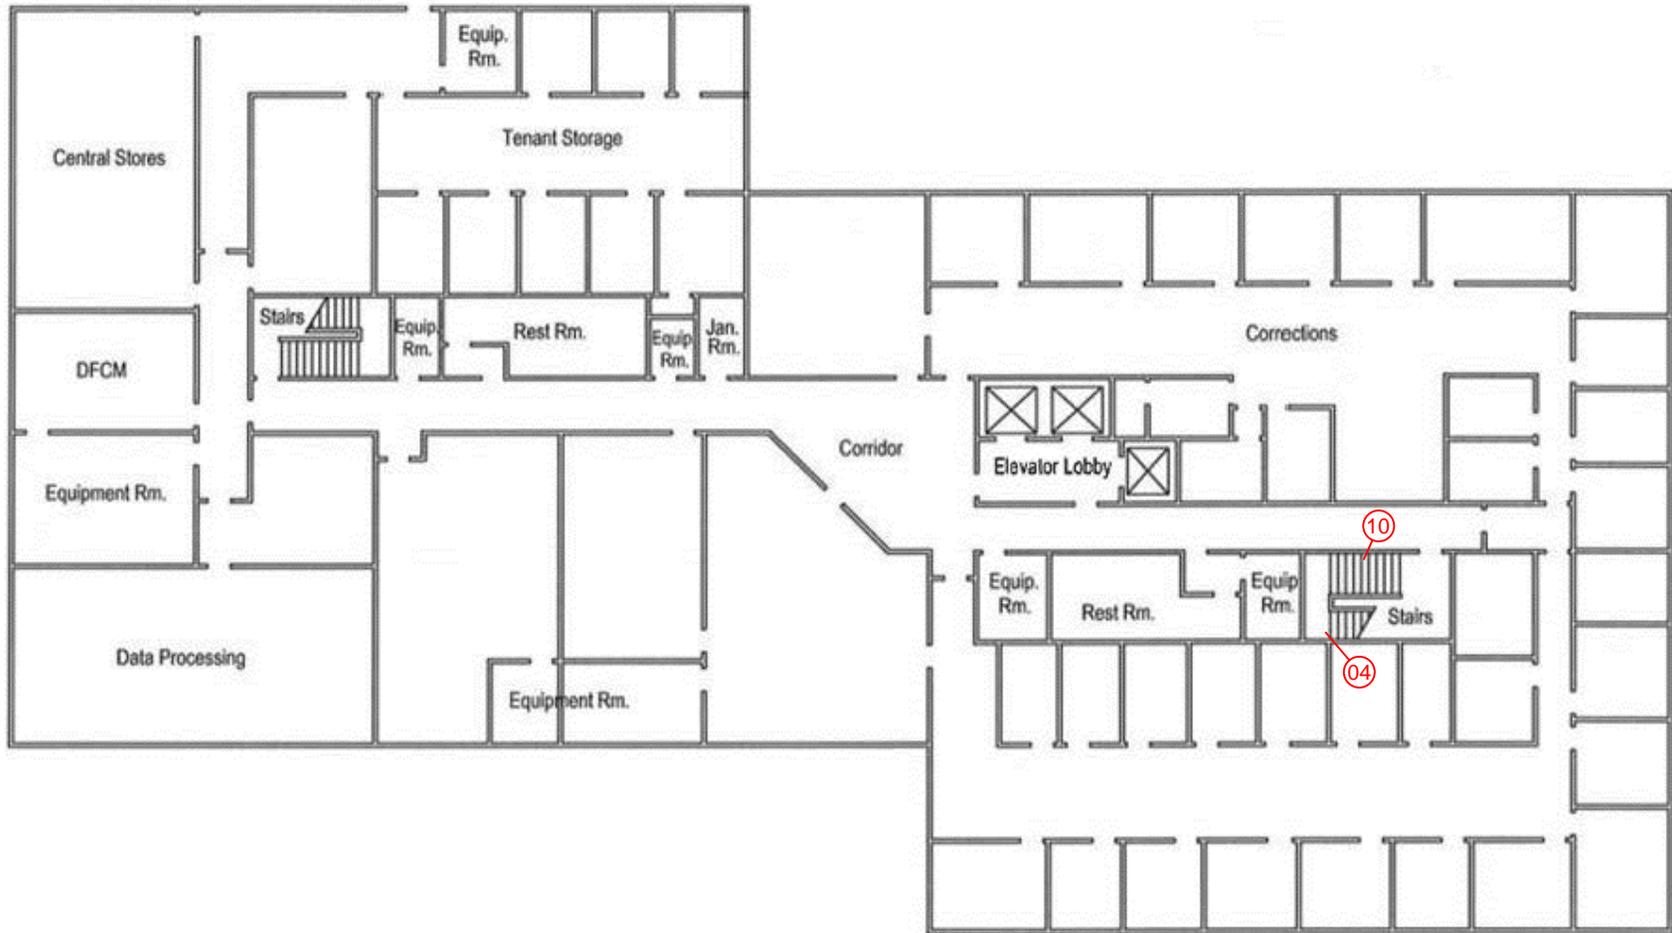
EX. No.	1
---------	---

Asbestos Sample Locations - Lower Floor
 Provo Regional Center Asbestos Reinspection
 150 East Center Street
 Provo, Utah

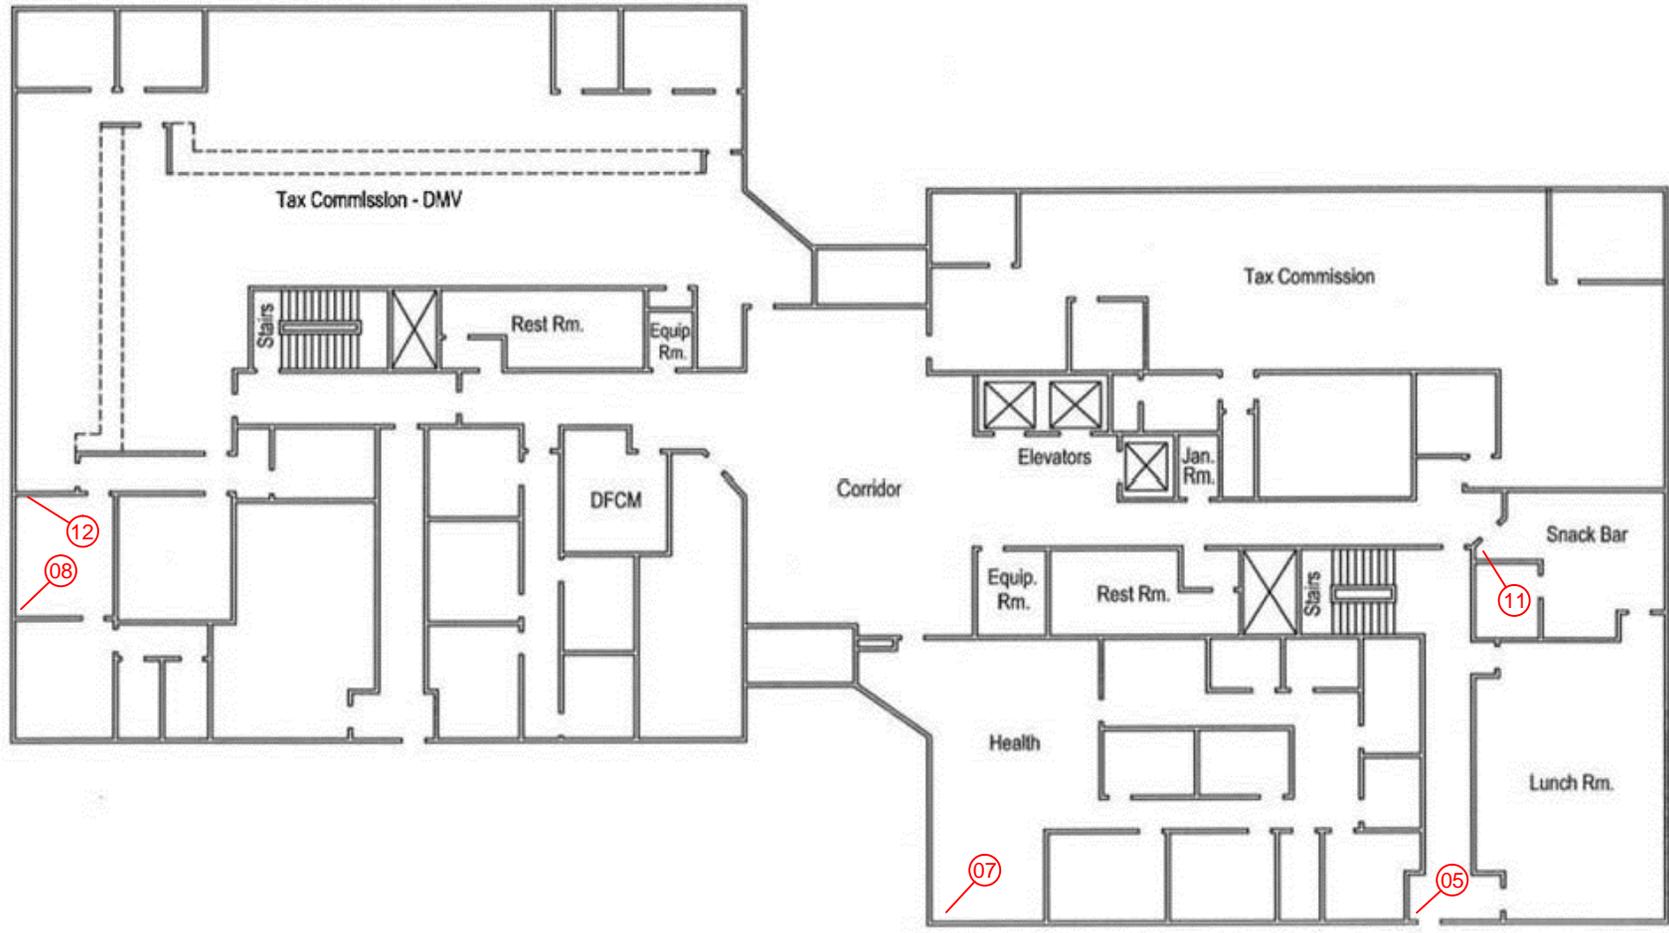
EX. No.
 2

Asbestos Sample Locations - First Floor
 Provo Regional Center Asbestos Reinspection
 150 East Center Street
 Provo, Utah

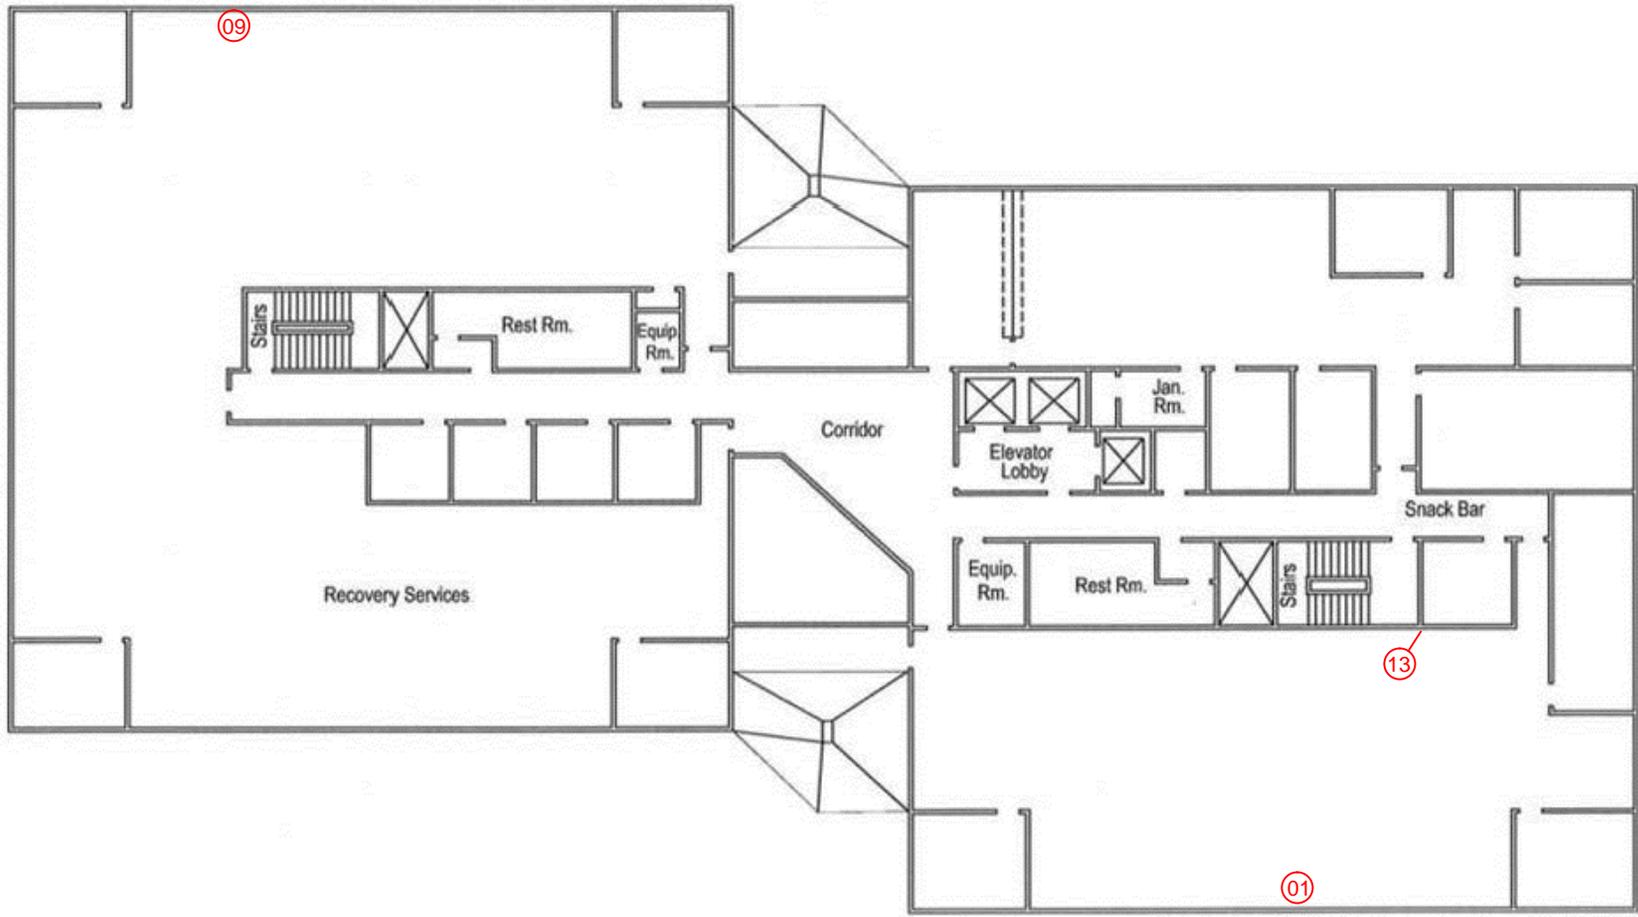
EX. No.
3

Asbestos Sample Locations - Second Floor
 Provo Regional Center Asbestos Reinspection
 150 East Center Street
 Provo, Utah

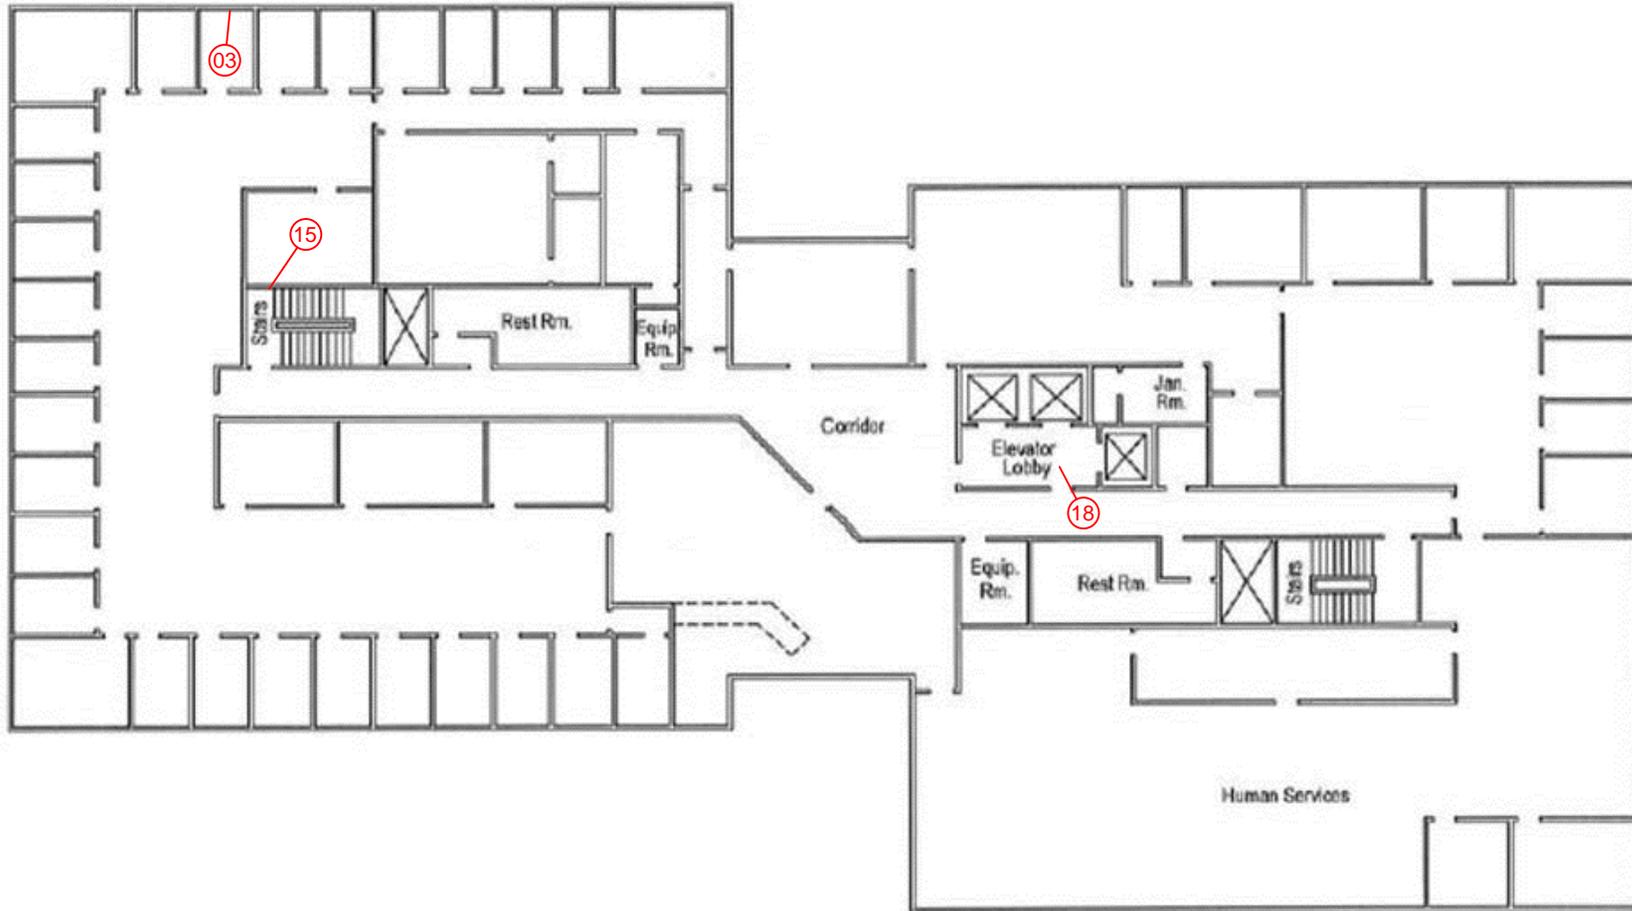
EX. No.
 5

Asbestos Sample Locations - Fourth Floor
 Provo Regional Center Asbestos Reinspection
 150 East Center Street
 Provo, Utah

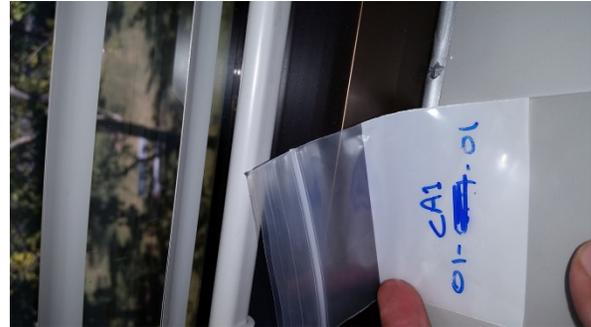
Lab H26229, Field 01-CA1-01 Silver Window Caulk
This is gray silicone caulking. **Asbestos is none detected.**

Photo #2 Sample 01-CA1-01.

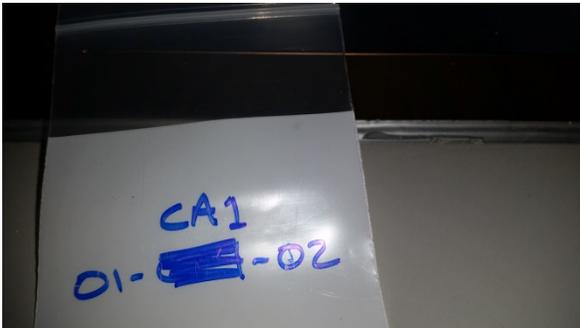
Lab H26230, Field 01-CA1-02 Silver Window Caulk
This is gray silicone caulking. **Asbestos is none detected.**

Photo #3 Sample 01-CA1-02.

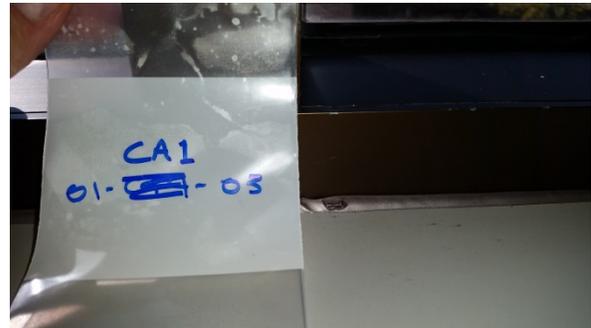
Lab H26231, Field 01-CA1-03 Silver Window Caulk
This is gray silicone caulking. **Asbestos is none detected.**

Photo #4 Sample 01-CA1-03.

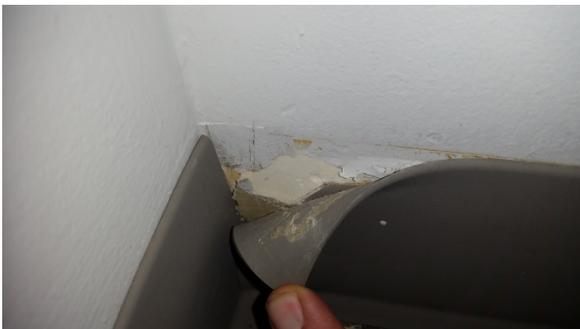
This sample contains three types of material: The first type is white limestone plaster with perlite; the second type is white paint layers; the third type is yellow resin mastic. This sample is non-homogeneous. **Asbestos is none detected.**

Photo #5 Sample 02-MG3-04.

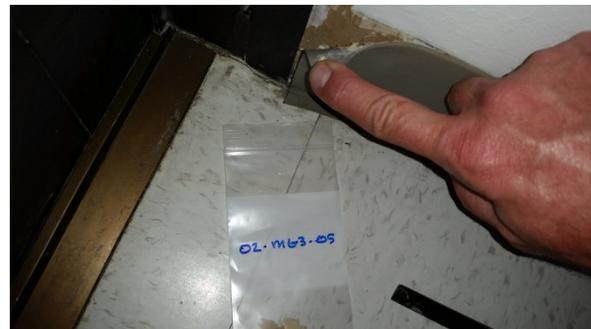
This sample contains three types of material: The first type is yellow resin mastic; the second type is white paint; the third type is tan plant fiber paper. This sample is non-homogeneous. **Asbestos is none detected.**

Photo #6 Sample 02-MG3-05.

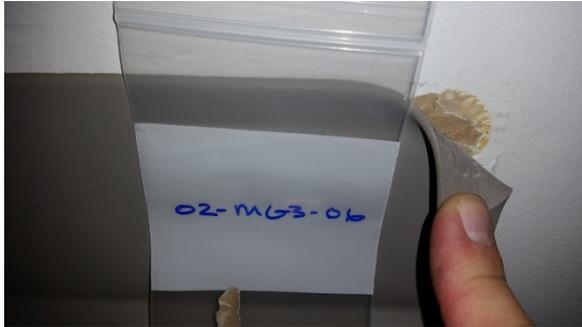
This sample contains three types of material: The first type is yellow resin mastic; the second type is white paint; the third type is tan plant fiber paper. This sample is non-homogeneous. **Asbestos is none detected.**

Photo #7 Sample 02-MG3-06.

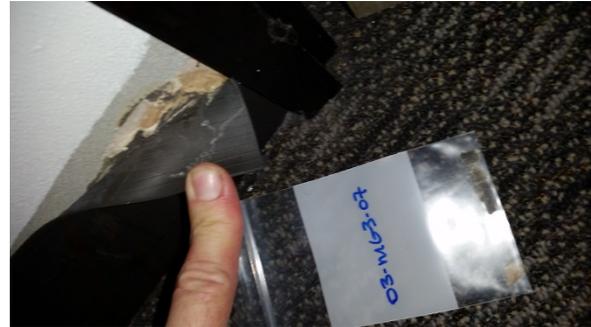
This sample contains two types of material: The first type is off white and yellow resin mastics; the second type is tan plant fiber paper. This sample is non-homogeneous. **Asbestos is none detected.**

Photo #8 Sample 03-MG3-07

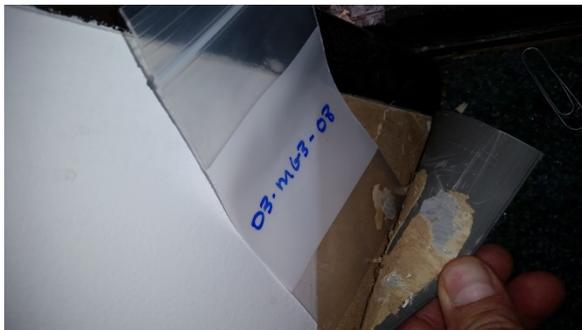
This sample contains three types of material: The first type is gray rubber and limestone; the second type is yellow resin mastic; the third type is tan plant fiber paper. This sample is non-homogeneous. **Asbestos is none detected.**

Photo #9 Sample 03-MG3-08.

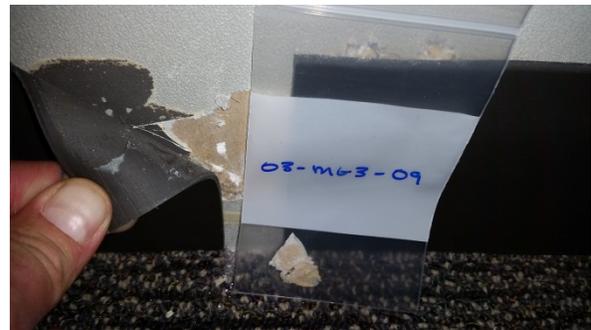
This sample contains two types of material: The first type is yellow resin mastic with black surface debris; the second type is tan plant fiber paper. This sample is non-homogeneous. **Asbestos is none detected.**

Photo #10 Sample 03-MG3-09

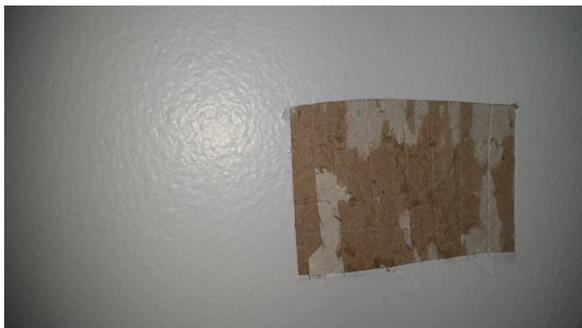
This sample contains two types of material: The first type is white paint; the second type is tan plant fiber paper. This sample is non-homogeneous. **Asbestos is none detected.**

Photo #11 Sample 04-PL1-10.

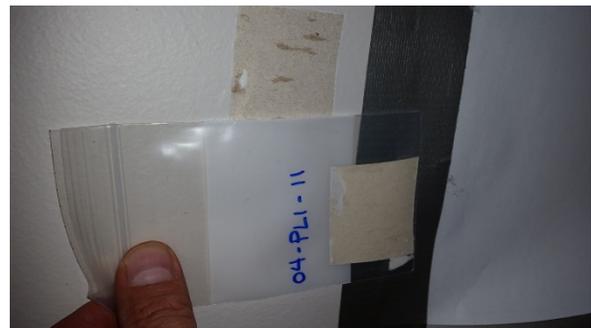
This sample contains three types of material: The first type is off white paint; the second type is white limestone plaster with mica; the third type is off white plant fiber paper. This sample is non-homogeneous. **Asbestos is none detected.**

Photo #12 Sample 04-PL1-11.

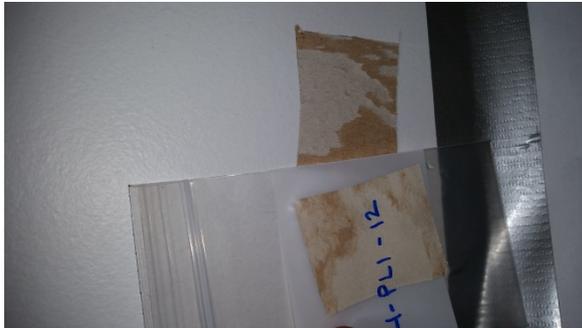
This sample contains two types of material: The first type is white paint; the second type is tan plant fiber paper. This sample is non-homogeneous. **Asbestos is none detected.**

Photo #13 Sample 04-PL1-12.

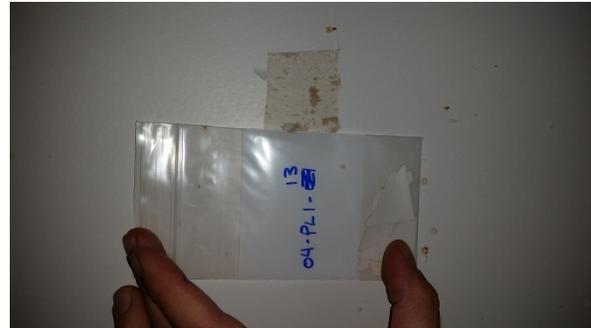
This sample contains two types of material: The first type is off white paint; the second type is off white plant fiber paper. This sample is non-homogeneous. **Asbestos is none detected.**

Photo #14 Sample 04-PL1-13.

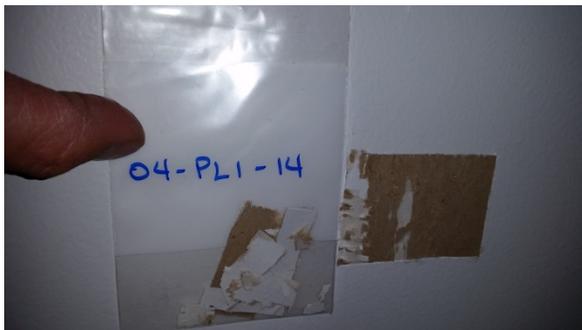
This sample contains three types of material: The first type is white paint; the second type is white limestone plaster with mica; the third type is brown plant fiber paper. This sample is non-homogeneous. **Asbestos is none detected.**

Photo #15 Sample 04-PL1-14.

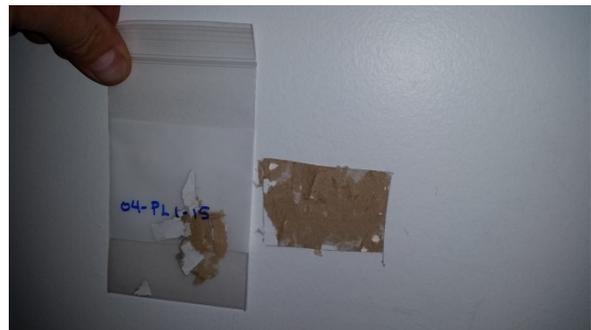
This sample contains three types of material: The first type is white paint; the second type is white limestone plaster with mica; the third type is brown plant fiber paper. This sample is non-homogeneous. **Asbestos is none detected.**

Photo #16 Sample 04-PL1-15.

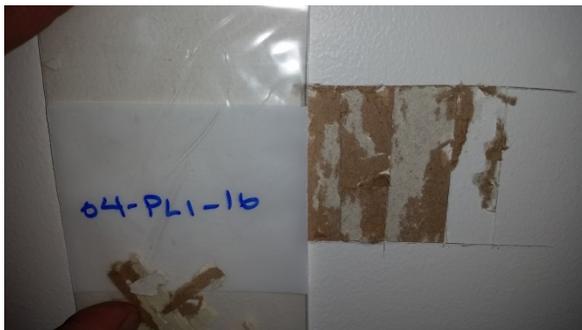
This sample contains three types of material: The first type is white paint; the second type is white limestone plaster with mica; the third type is brown plant fiber paper. This sample is non-homogeneous. **Asbestos is none detected.**

Photo #17 Sample 04-PL1-16.

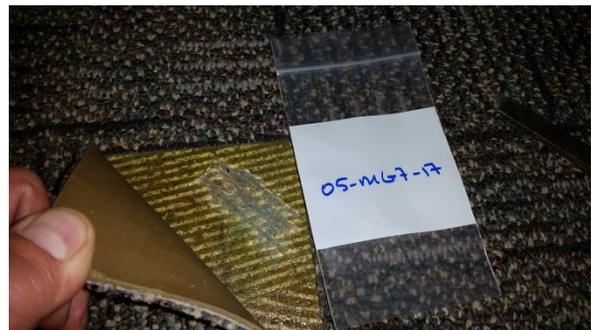
This is a non-homogenous mixture of yellow and green resin mastics with less than 1% synthetic fiber debris. **Asbestos is none detected.**

Photo #18 Sample 05-MG7-17.

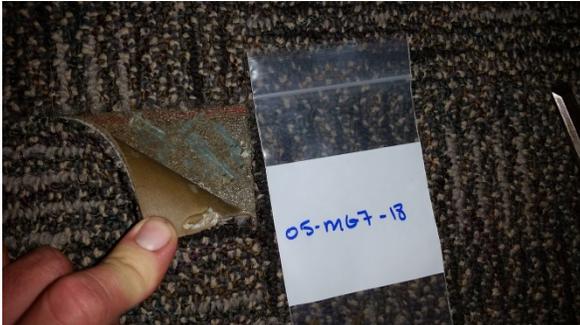
This is yellow resin mastic with less than 1% synthetic fiber debris. **Asbestos is none detected.**

Photo #19 Sample 05-MG7-18.

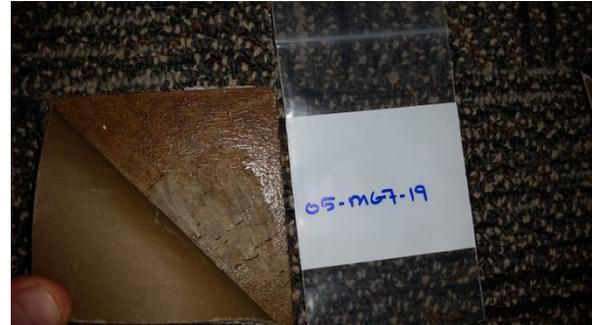
This is yellow resin mastic with less than 1% synthetic fiber debris. **Asbestos is none detected.**

Photo #20 Sample 05-MG7-19.
