William Spry Agricultural Building Replacement Study

November 23, 2015

Prepared for:
Utah Department of Agriculture and Food

Prepared by:
CRSA, GHS Geotechnical and Parametrix

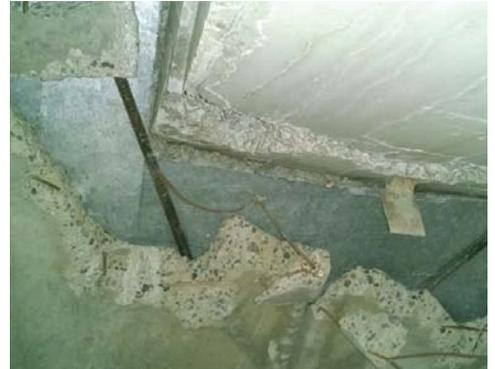
Deterioration of collector connections may result in the structure’s inability to transmit forces to the resisting structural elements.

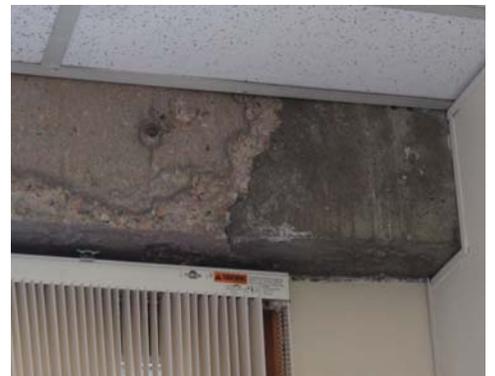
The William Spry Building’s concrete frame construction has not held up well over the years, particularly its ability to shed moisture from exterior surfaces. The result is that:

- Water leaks are causing continued harm to building structure
- Cracking and spalling concrete reflects ongoing corrosion issues which may ultimately render the structure compromised
- The estimate to repair the extent of concrete deterioration and complete seismic upgrade is \$1.4 million

An example of concrete deterioration

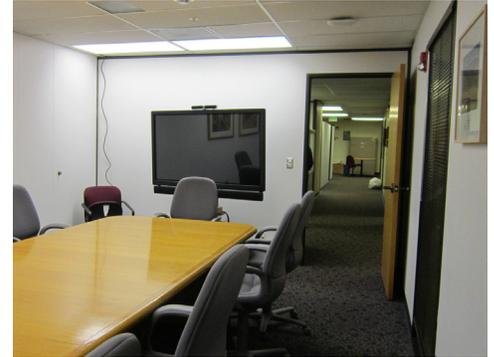
- Internal wall system is consistently constructed of movable partitions, although flexible reuse or reconfiguration has not been accommodated
- Partitions do not extend above the ceiling system, thus provide very limited sound isolation
- In spaces where sound is amplified or secure information is being conveyed, partitions should extend to the structural deck and meet State Sound Transmission Criteria (STC) ratings

Important rooms - such as the Commissioner's Conference Room - are constructed of movable partition walls and do not provide the necessary acoustic isolation required.

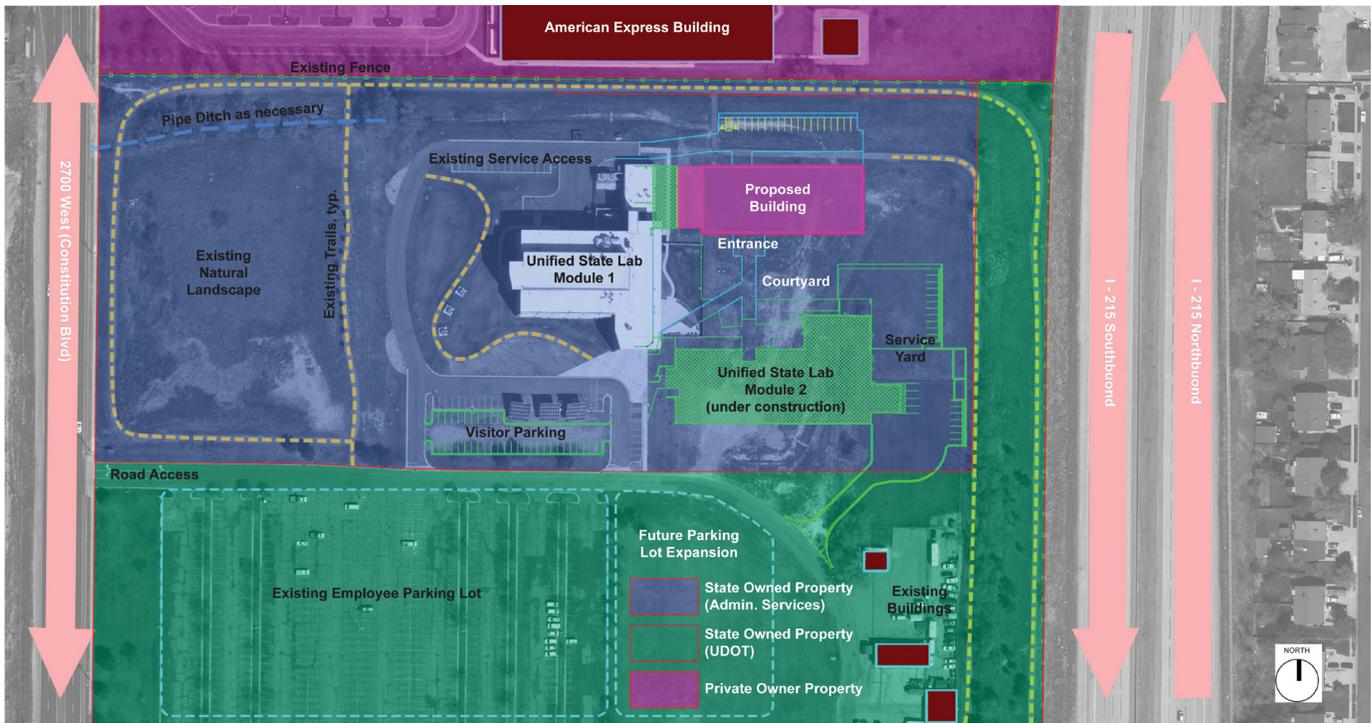
USL Campus Proposed Site Plan

The proposed location for a building to accommodate the Department of Agriculture and Foods is illustrated below. The building would abut Module 1 and share expanded central plant facilities at the northeast corner of Module 1. Primary public access is from the southwest as visitor and staff parking is located south of Module 1. Pedestrian circulation to the building is planned to be accommodated in the developed plaza area between Modules 1 and 2 and the new building. This creates a difficult to locate and very long walk for visitors. Distant parking coupled with the poor visual access to the new building from the access road is a concern for the development on this available site. Other concerning factors include the limited access north of the new building site and NIST Standards for Metrology highly suggesting that newly developed facilities should not be developed adjacent to “heavily traveled highways”.

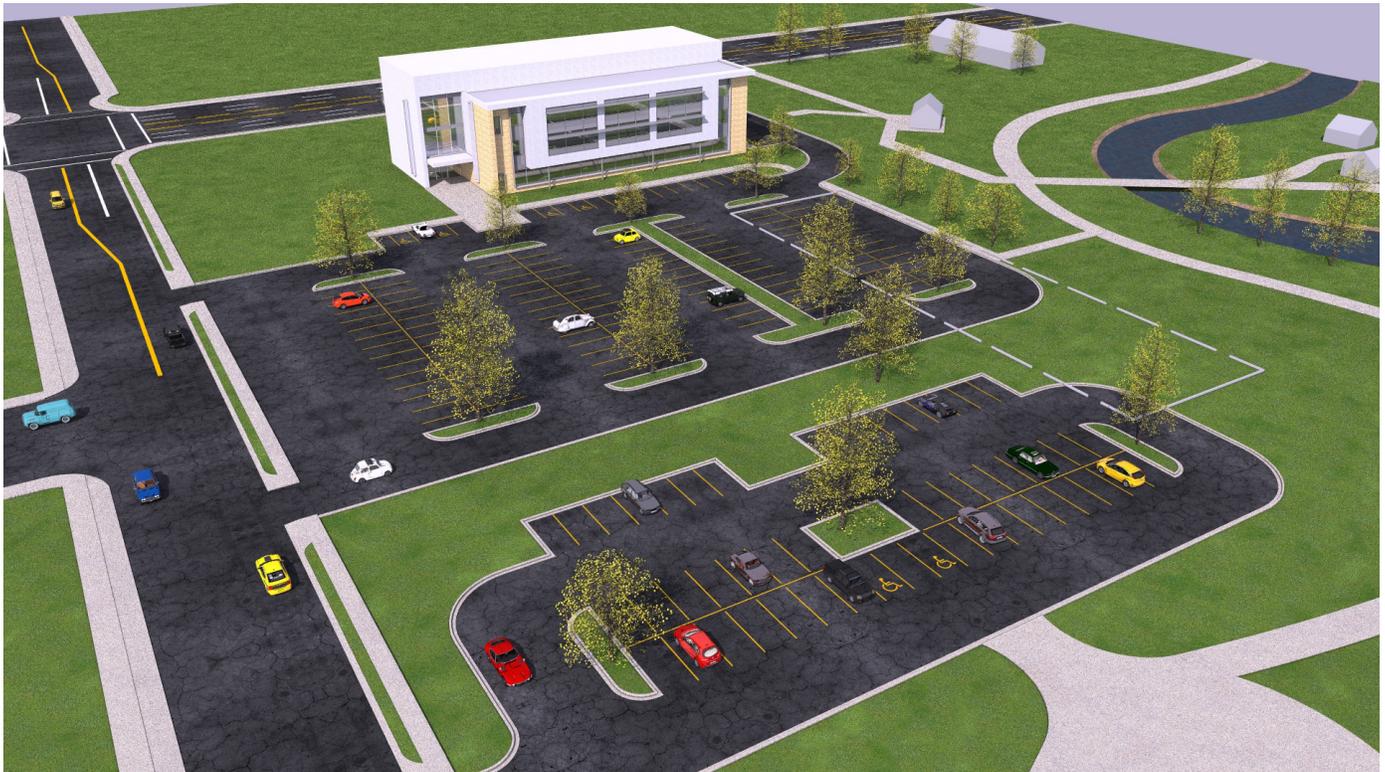
Bird's eye graphic depiction of the concept design for Site 1 Redwood Road

SITE 1 - REDWOOD ROAD
CONCEPT DESIGN

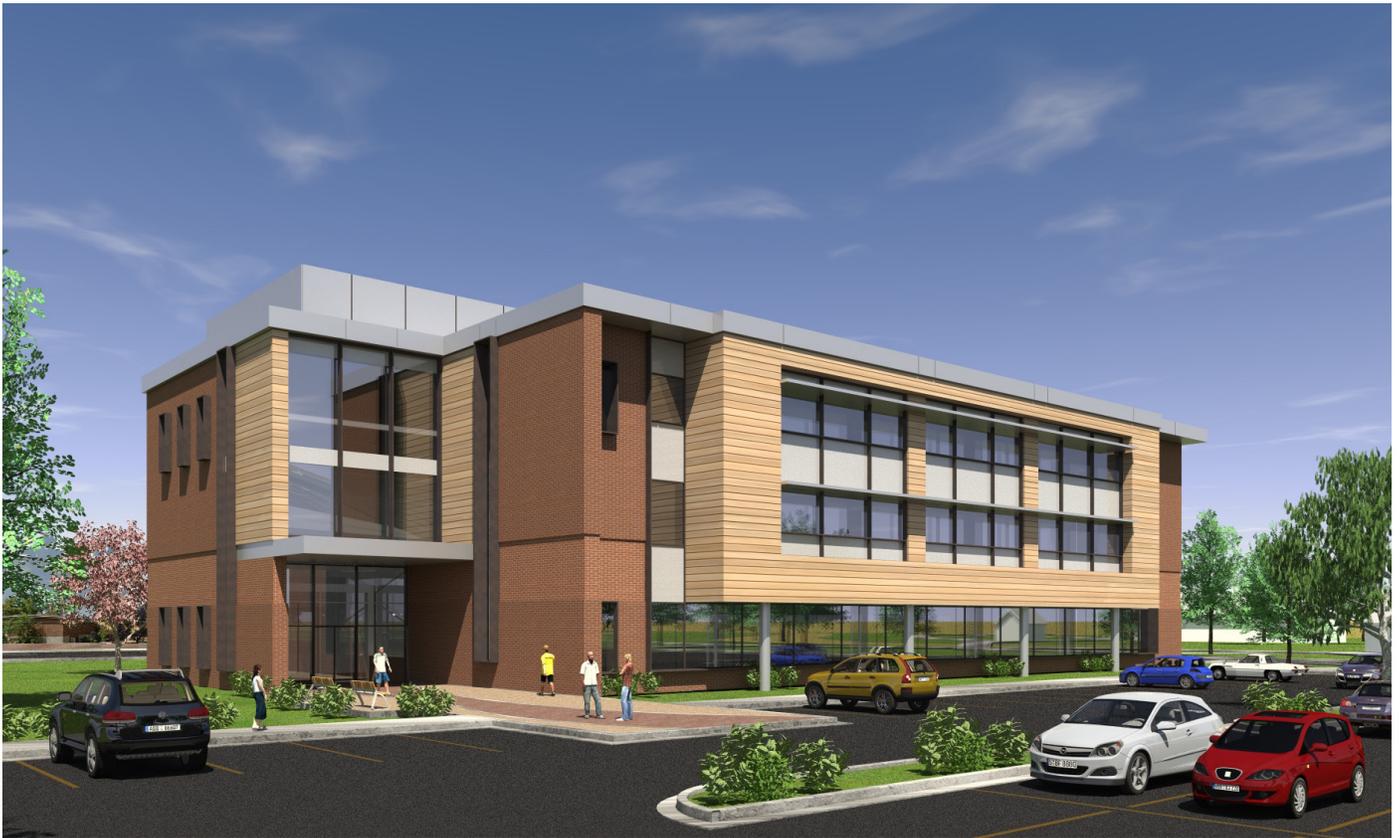
Redwood Road Campus Proposed Conceptual Design

The Redwood Road and North Star Drive site consists of a large parcel immediately west of Cottonwood Park and south of the Jordan River. The site, just over five acres, will accommodate the construction of a replacement facility while the existing William Spry Building remains on site. The site development plan, below, illustrates the possible placement of a new Department of Agriculture facility, adjacent, dedicated parking of 130 stalls and a separated lot configuration to accommodate 50 stalls of parking for the public park.

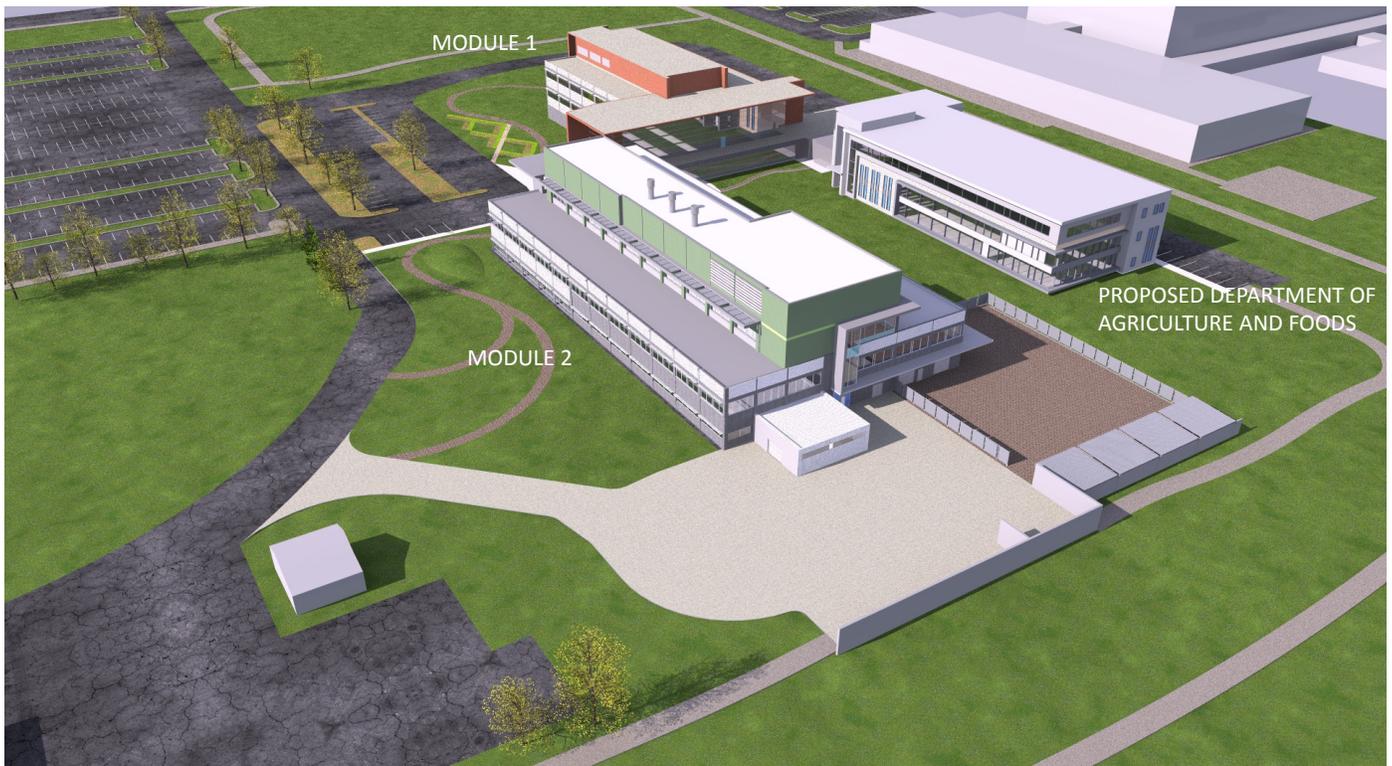
Bird's eye graphic depiction of the concept design for Site 2 Unified State Labs Campus

**SITE 2 - UNIFIED STATE LABS CAMPUS
CONCEPT DESIGN**

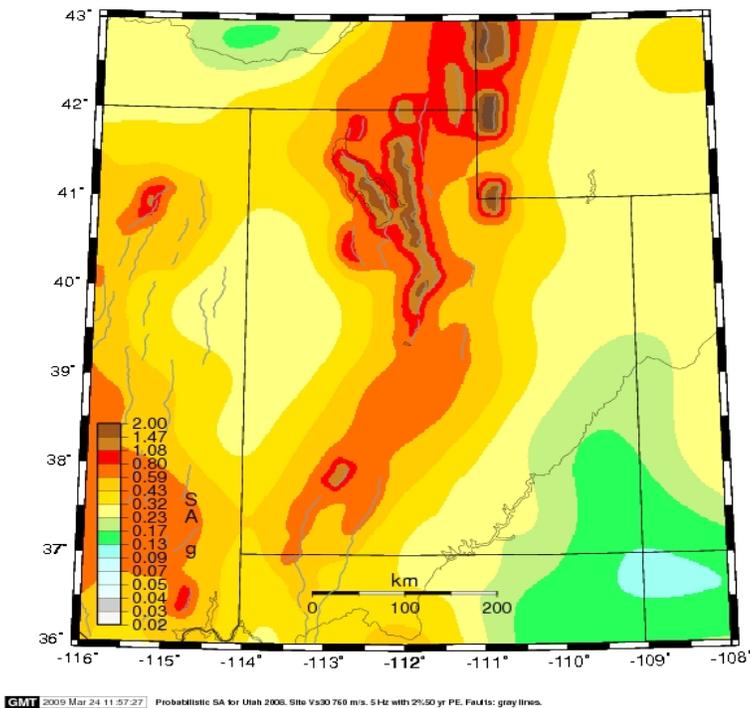
Figure 1 - USGS Acceleration Map (MCE)

The figures above indicate horizontal accelerations could be in excess of about 1.2 times its own weight since its period is approximately 0.25 seconds. The site was determined to be located in an area of high seismicity according to ASCE/SEI 41-13. A copy of the short period USGS contour map can be seen in Figure 1.

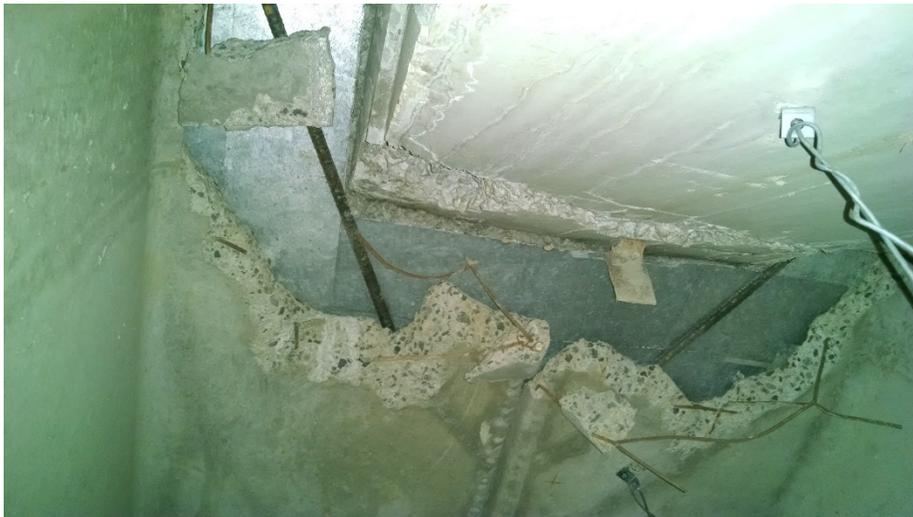
Figure 2 – Deterioration of Collector Connections

5. Deterioration at Collector Connections: See figures below. Deteriorated collector connections may result in the structures inability to transmit forces to the resisting elements. The load path deficiency can produce local collapse during a seismic event.

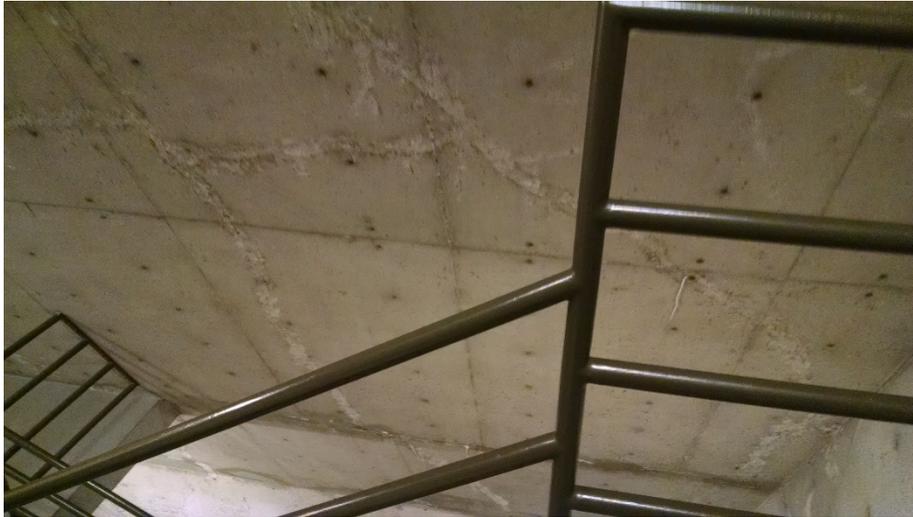
Figure 3 – Cracking at Concrete Shear Walls

3. Shear Stress Check: The shear stress in the concrete shear walls is greater than $2\sqrt{f'_c}$. As such, the shear failures may occur before flexural failures. Shear failures tend to result in more instabilities of the structure than do flexural failures.

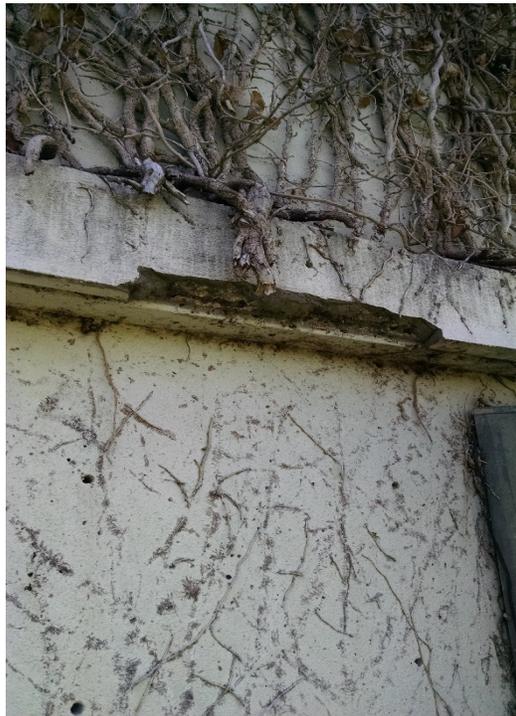
Figure 4 – Spalling of Concrete Beams

6. Damage to Structural Members: Cracking and spalling of concrete was noted during our visit. This reflects ongoing corrosion issues which may ultimately render the structure compromised, particularly for transient events such as earthquakes. A routine maintenance program for repair of the building exterior should be employed to limit further deterioration and to keep the building serviceable.

The primary purpose of this report was to identify deficiencies with the seismic structural system. However, deterioration, corrosion, and spalling of the exterior concrete was noted during our site visit. A routine maintenance program for repair of the building exterior should be employed to limit further deterioration and to keep the building serviceable.
