## ADDENDUM NO. 1

Reference: Demolition and Electrical – Gibson Science Center  
Southern Utah University – Cedar City, Utah  
DFCM Project No. 07297730

**HAZMAT (ASBESTOS & LEAD BASED PAINT)  
SURVEY AND ASSESSMENT**

*Southern Utah University  
Life Science Building  
Cedar City, Utah*

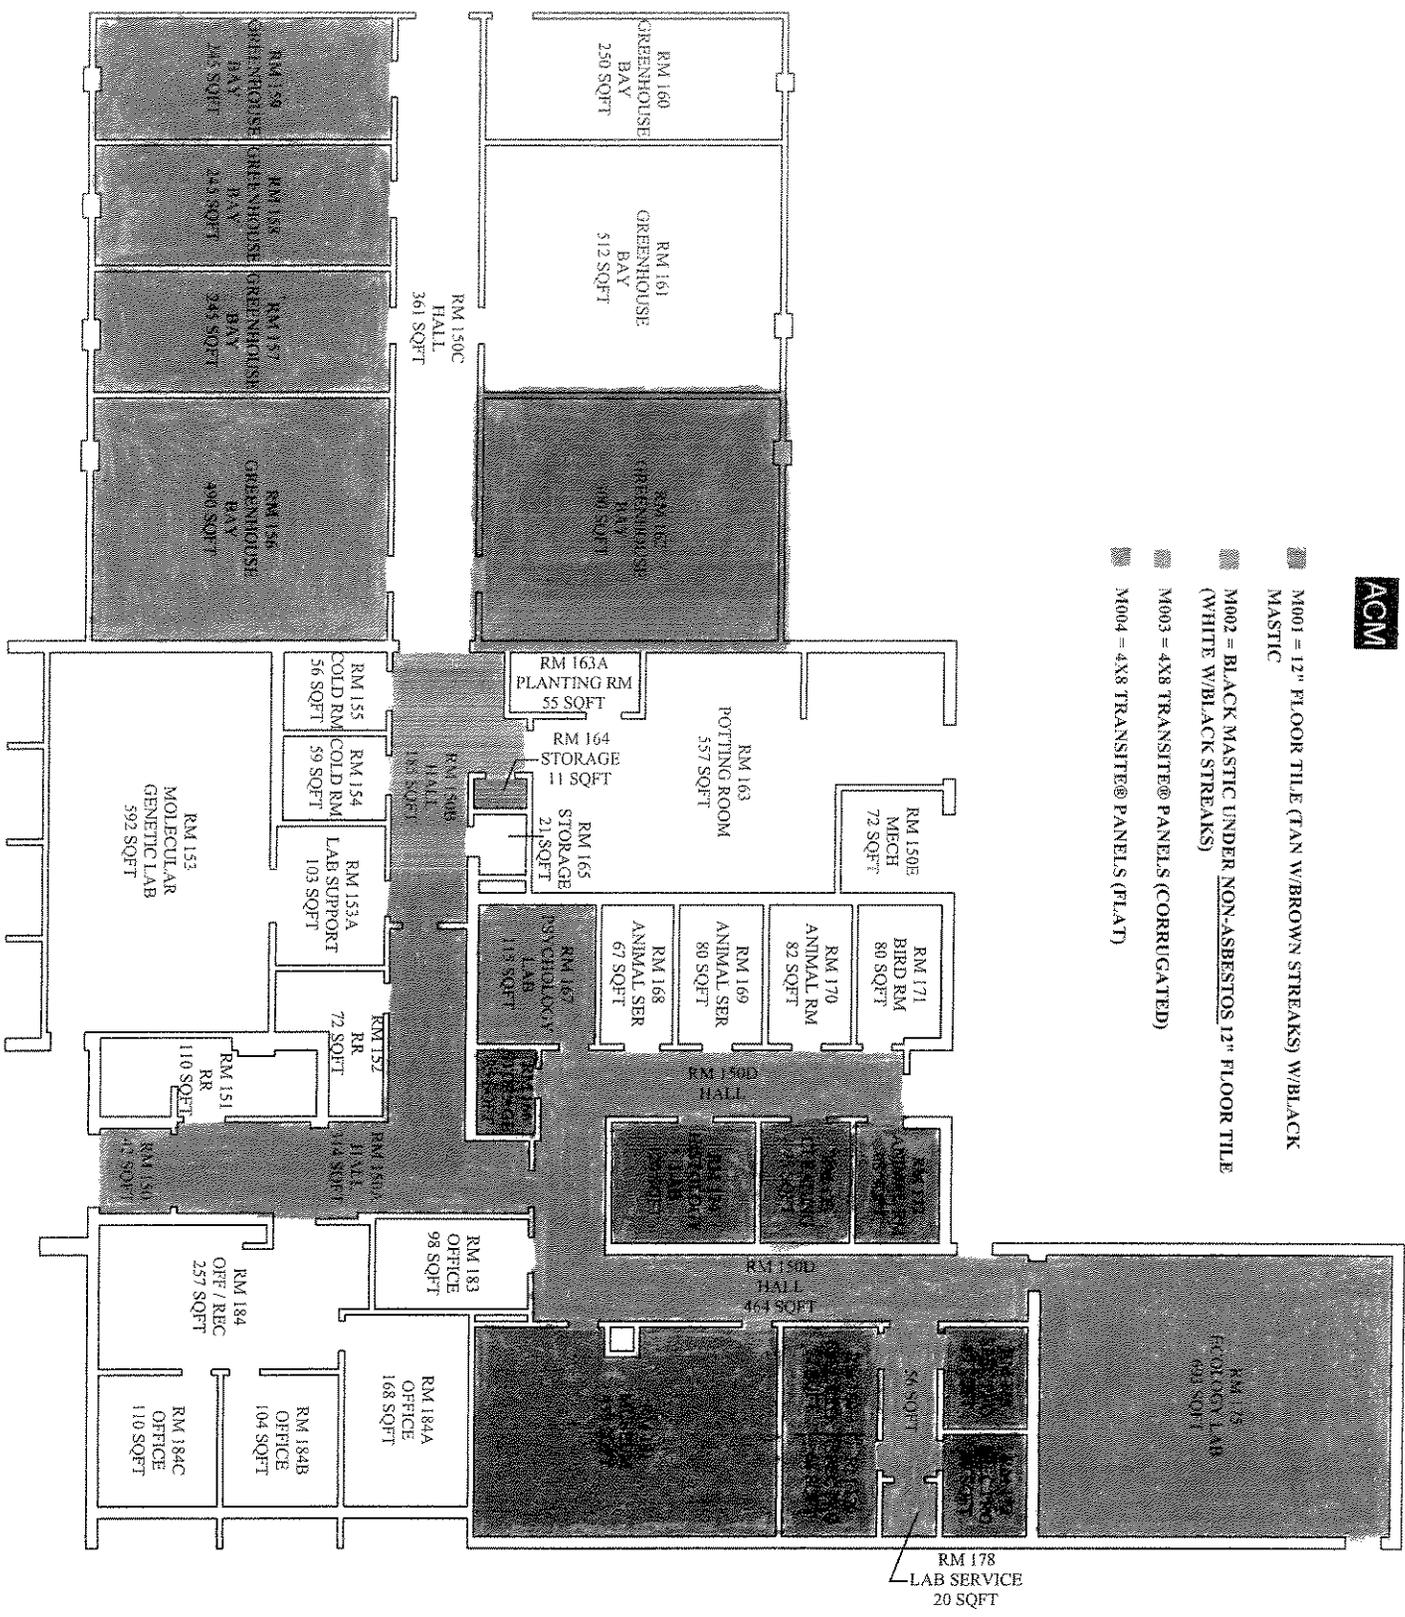
**ACM**

- M001 = 12" FLOOR TILE (TAN W/BROWN STREAKS) W/BLACK MASTIC
- M002 = BLACK MASTIC UNDER NON-ASBESTOS 12" FLOOR TILE (WHITE W/BLACK STREAKS)
- M003 = 4X8 TRANSITE® PANELS (CORRUGATED)
- M004 = 4X8 TRANSITE® PANELS (FLAT)
