## Addendum No. 1

Reference: Addition/Renovation Fine Arts Complex  
Utah State University - Logan, Utah  
DFCM Project No. 14385770

Subject: **Addendum No. 1**

RENOVATION & ADDITION | LOGAN, UTAH  
**FINE ARTS COMPLEX**

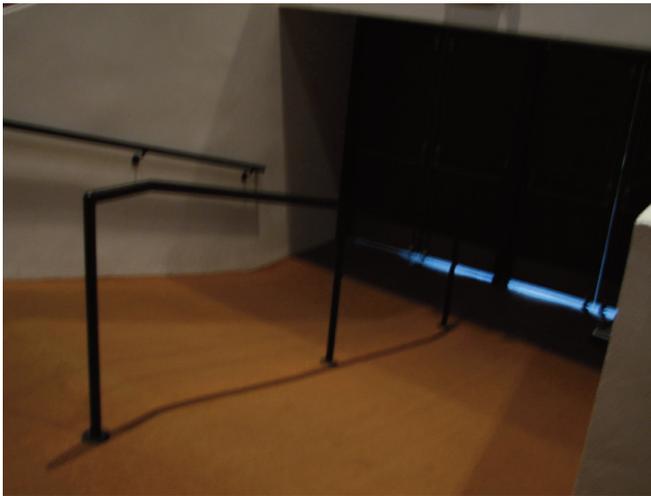
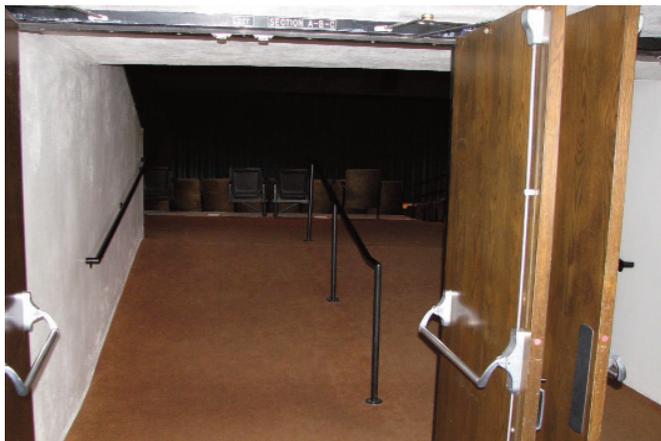
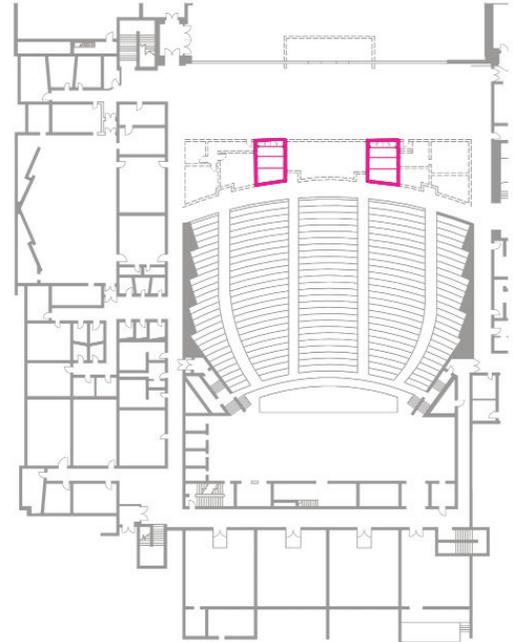
The current lobby entrance ramps are steeper than current code allows for general public use and especially for ADA use. It is, therefore, recommended that these ramps receive elongated treads and risers matching the current slope of the ramps. This will provide a code compliant access into the hall for the general public and will discourage the use of these ramps for individuals with ADA access needs.

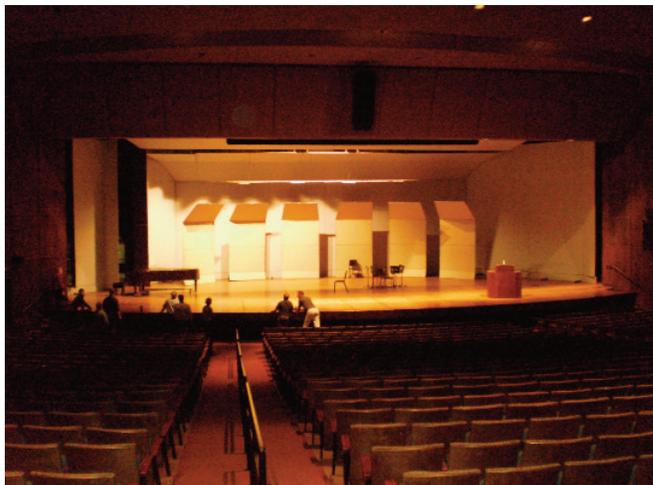
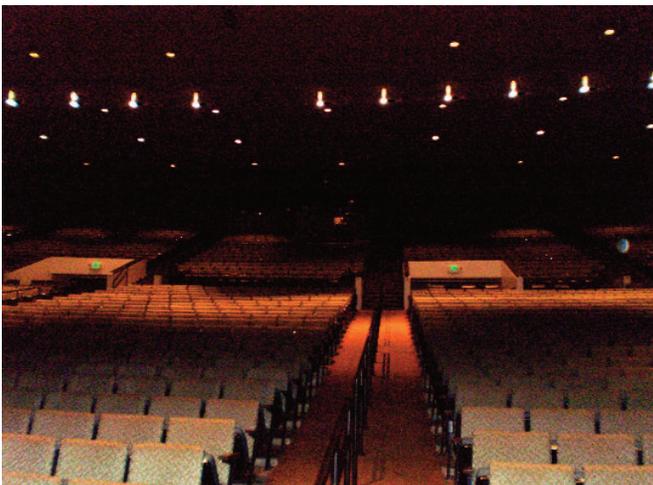
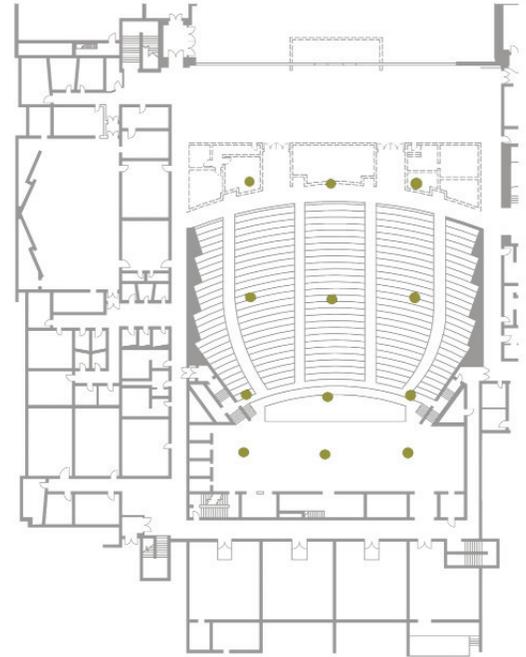
**K21 Lights, Worklights**

Existing work lights are inefficient and maintenance intensive; none exist in the auditorium currently. It is proposed that the University add worklights in the house and stage areas. As a standalone project this could be \$25,000, for lighting and controls, house and stage.

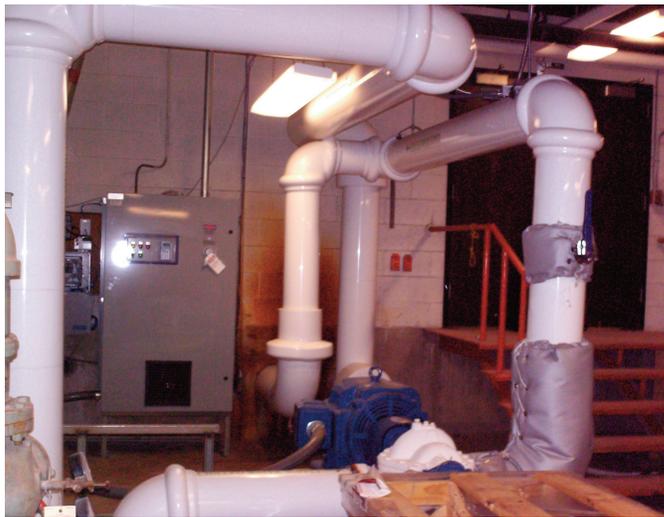
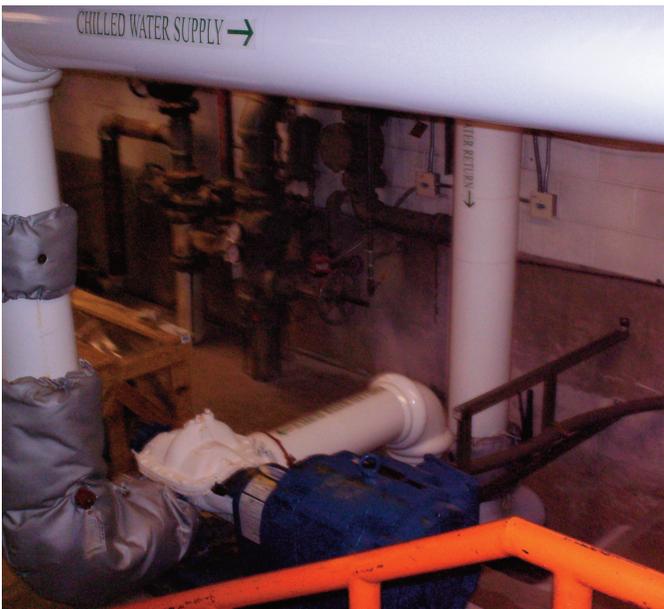
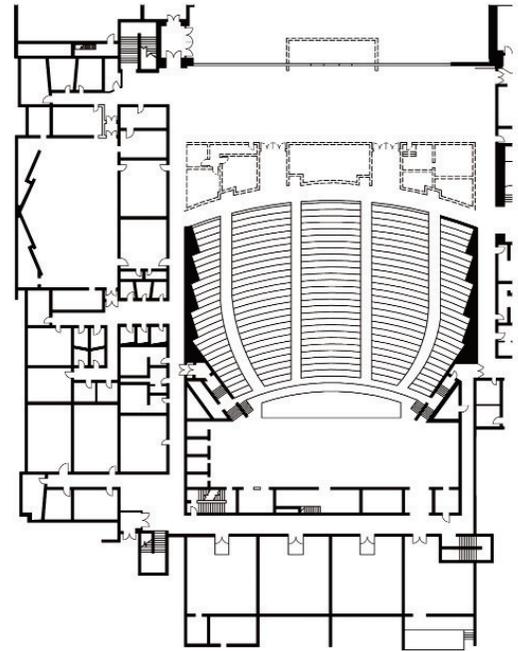
**K22 Domestic Potable Water Piping**

The conventional waste and wet systems appear to be in good condition. These systems could last another 20 to 30 years. As galvanized domestic hot and cold pipes age they are susceptible to rusting and pitting. This is not uncommon in galvanized domestic water lines. The rust can plug faucet aerators, pipe strainers and discolor fixtures. Pitting is a major cause of leaks. Furthermore the galvanized piping is not sufficiently seismically restrained.

This is a lump sum given by VBFA for the replacement of the current galvanized domestic hot and cold piping. Cost is for piping and patching as needed.

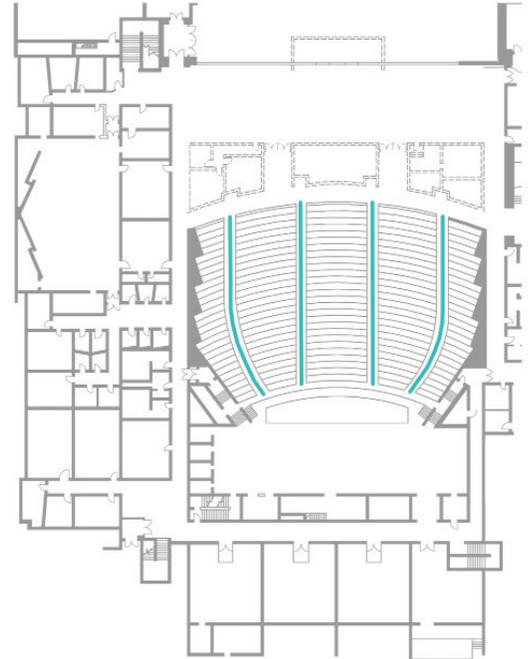
## K25 Lights, Aisles

Most seats have malfunctioning lights which has become a liability issue for the university. Therefore, it is recommended to replace the older incandescent lights with more efficient LED aisle lights. The total replacement would be for 34 devices and the addition of 6 steplights with controls and power supplies.

This is a lump sum given by Spectrum Engineers to replace 34 devices and add 6 step lights with controls and power supplies.

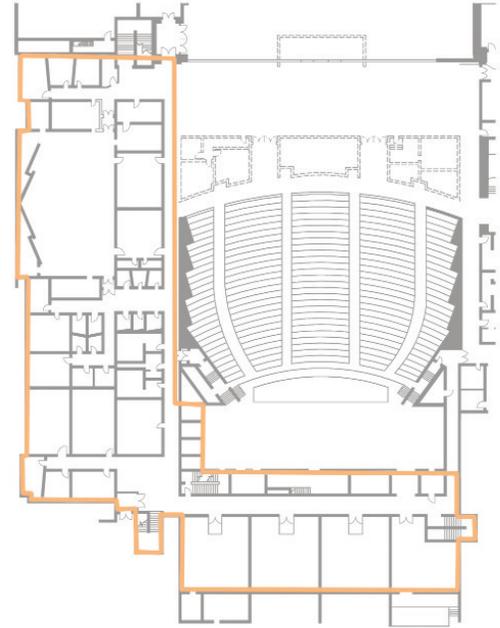
**K26 General lighting – classroom wing**

The general lighting throughout the Kent classroom wing will need to be replaced with more efficient fixtures which will be seismically braced as well. This would include all areas on both floors of the classroom wing, which exist mostly in lay-in ceilings that are recommended for replacement as well.

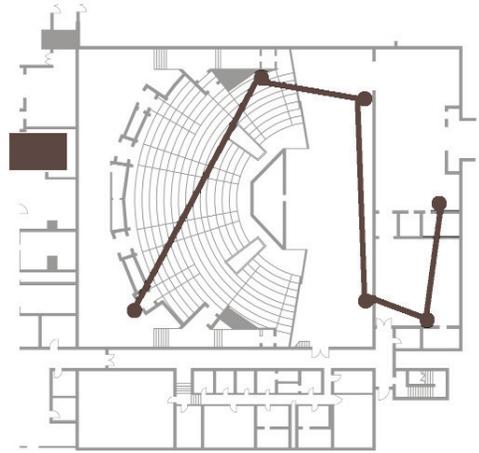
### M1 Upgrade Air Handlers, Controls

It can be assumed that items such as fan motors, tube bundles in heat exchangers and some air handler coils have been replaced over the years. In general, the air handlers are in good condition; the heat exchangers are in fair condition; the dual duct boxes are in poor condition; the ductwork is in fair condition, the hot and chilled water piping systems are in good condition; the hot water and chilled water pumps are in fair condition.

The single zone air handler has passed its average useful life. The mezzanine air handlers serving the Morgan Theater portion may be removed via crane and replaced with new custom built air handlers.

This is a lump sum given by VBFA to upgrade the pneumatic controls to DDC and replace the mezzanine air-handler.

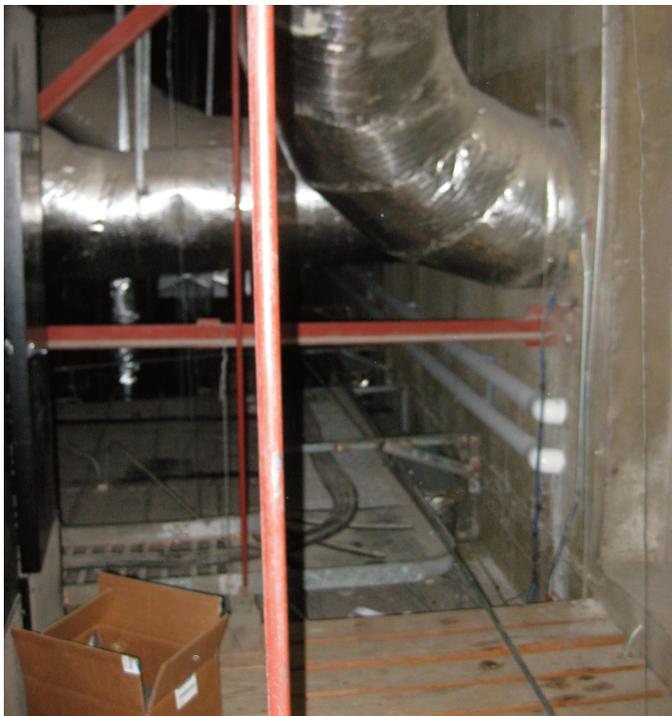
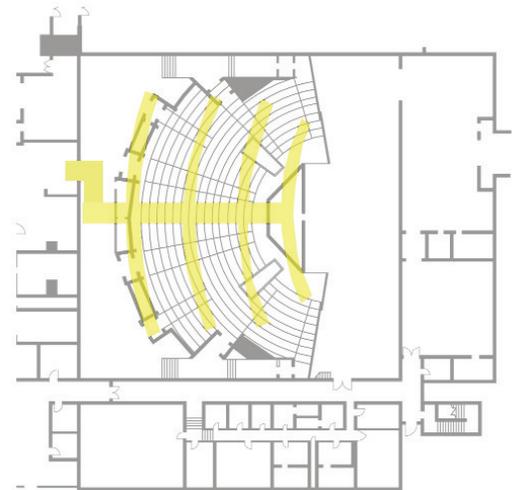
### M3 HVAC Seismic Bracing (ducts)

The ductwork in the Morgan Theater will need to be seismically braced as this is both a life safety issue as well as an acoustic issue with the ducts in some areas resting directly on the ceiling itself transmitting vibration noise throughout the space.

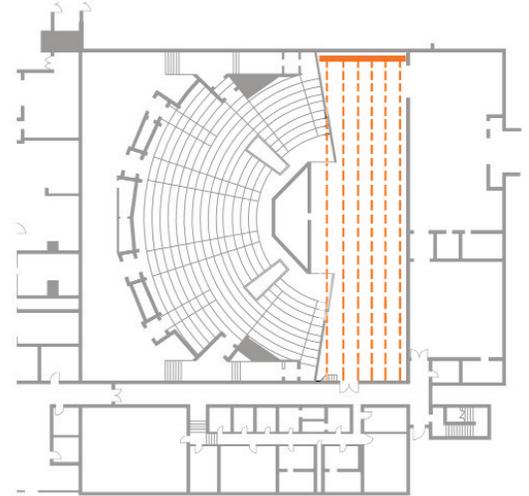
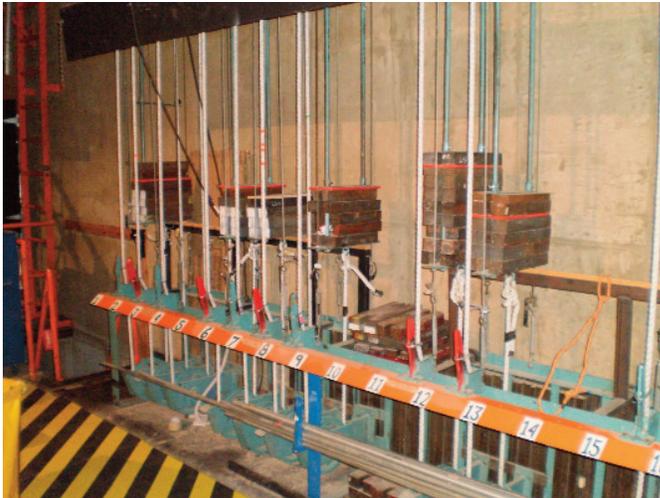
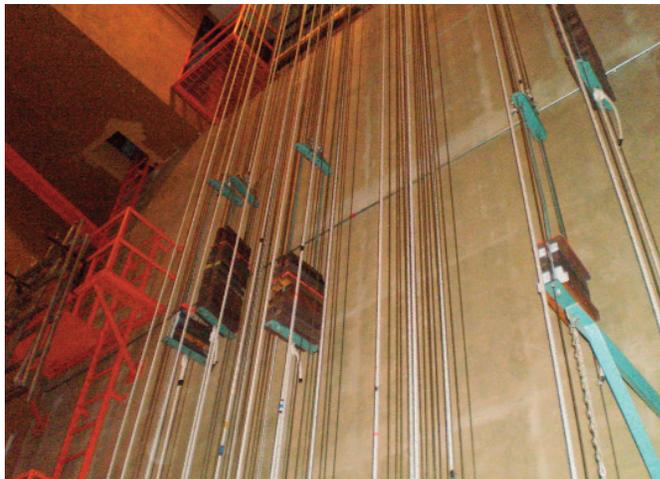
## M6 Stage Rigging

Existing rigging is not safe and is labor intensive to operate as well as insufficient for present theatrical needs. Manual rigging replacement of existing lines would be approx. \$170,000 with the augmentation to all lines possibly adding \$50,000. Either of these requires the addition of a loading bridge (approx. \$25,000 minimum) plus steel to anchor it.

This is a cost range given by Spectrum Engineers to replace the existing stage rigging with updated manual rigging. It also includes the addition of a new loading bridge.

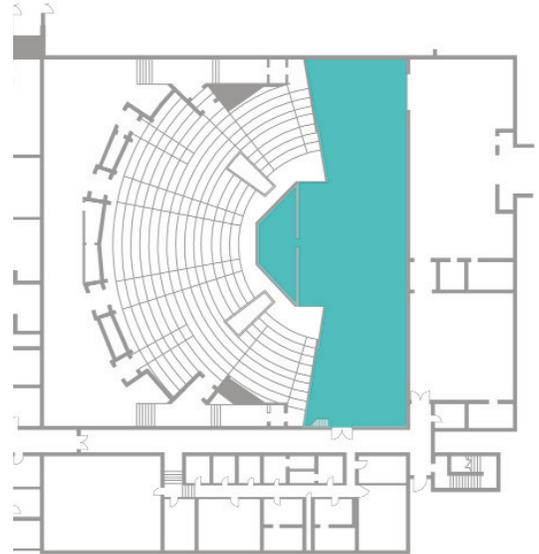
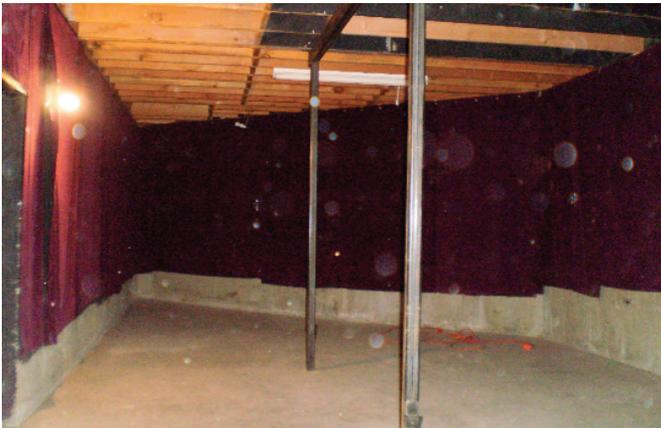
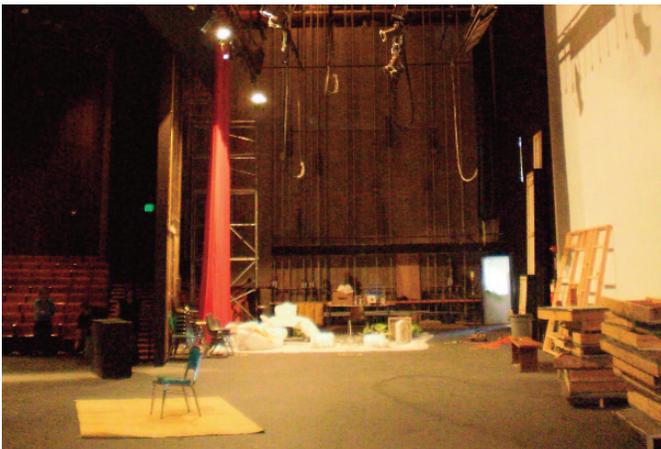
### M7 Stage Floor replacement

The existing Morgan Theater stage floor is adequate for the time being but not desirable. It is not compliant with current fire codes, although the addition of fire sprinklers (M20) will improve this. Also, the orchestra pit underneath the thrust stage is currently unusable due to the difficulty of removing the floor system. It is the University's desire to be able to utilize the orchestra pit more efficiently. It would also be recommended that the new stage floor be sprung and of a material that could be replaced regularly as stage sets are commonly screwed to the floor. By making the stage a sprung floor, theater and particularly dance productions will have improved performance while reducing potential injuries to performers.

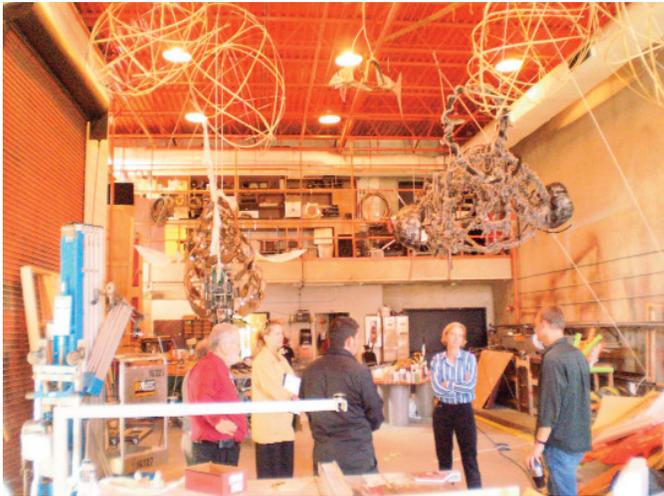
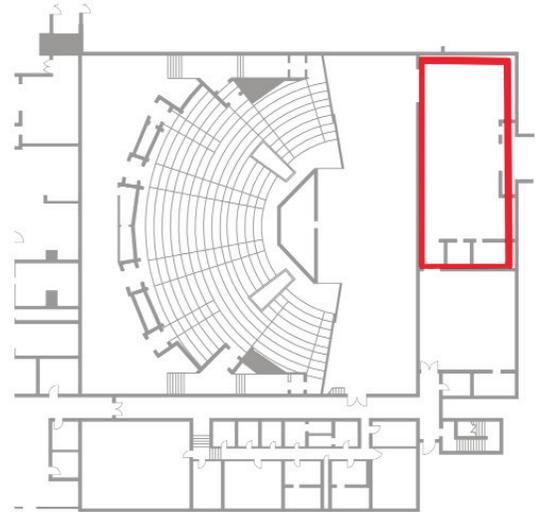
The HVAC system serving the scene shop located behind the Morgan Theater stage is not adequately equipped to serve present operations. There is no paint booth or sawdust collection system. Currently a pit with sidewall exhaust grilles is used for painting purposes, or weather permitting, the item being painted is sometimes moved outside. There is no sawdust or ventilation system serving the various woodworking areas and machines. The costume shop also requires ventilation in the dye-shop.

Provide complete shop HVAC system for scene shop and costume including a paint booth, sawdust collection system and dye-shop exhaust system.

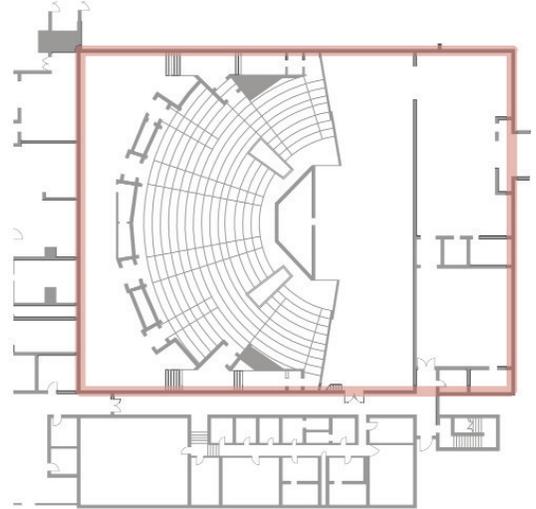
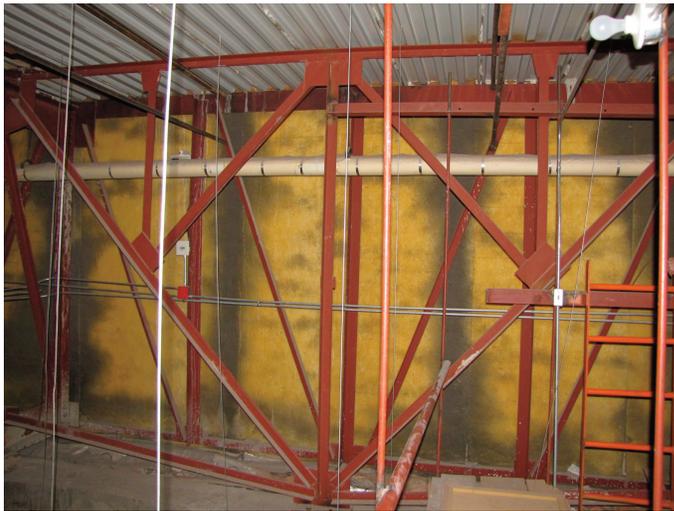
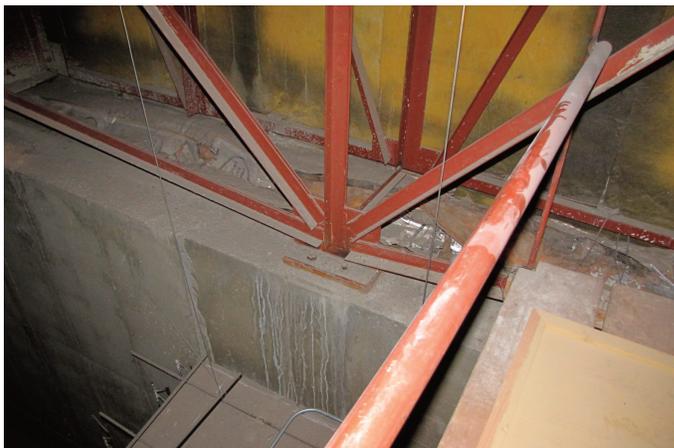
**M14 Walls, Exterior, Shear Transfer**

The steel roof deck diaphragm connection to the walls appears to be inadequate for current code requirements in the area of the Morgan Theater. The system now consists of blocking trusses between the cantilevered ends of the main girder trusses and rod x-bracing along the wall parallel to the girder trusses. It appears that the connection of the blocking trusses to the concrete walls needs to be strengthened and the rod x-bracing needs to be replaced with angle or tube x-bracing. There also appears to be a need to add deck transfer along the east wall of the Morgan Theater Stage from the concrete wall to the roof diaphragm.

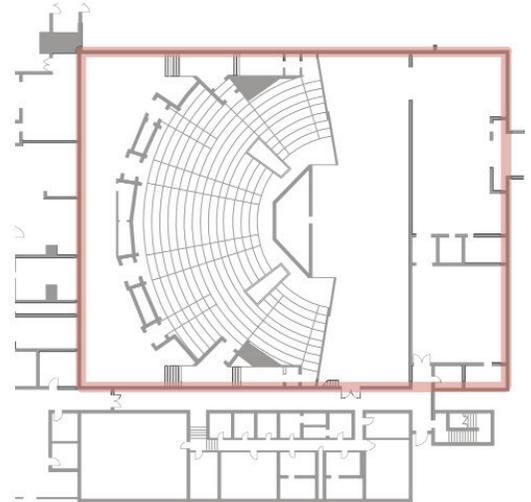
Note that before construction begins this information must be verified with a detailed investigation to determine if our as-built assumptions are correct and to determine if the assumed deck capacities are valid for the in place welds.

Based on the above assumptions it is recommended that the roof decks be strengthened by adding a strip of custom bent and cut 16 gage sheet metal at the ends of the diaphragm (similar to a product called Sheartranz by Verco). This will give the deck the added capacity it needs to meet the calculated demands.

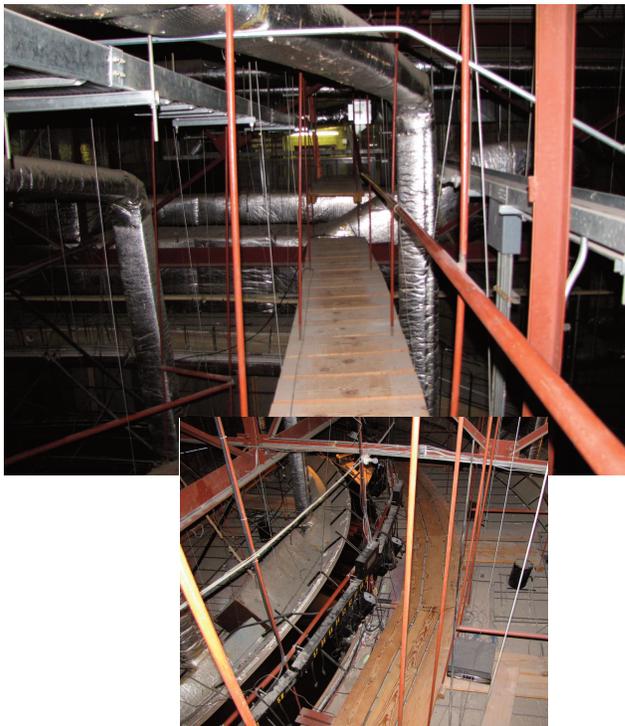
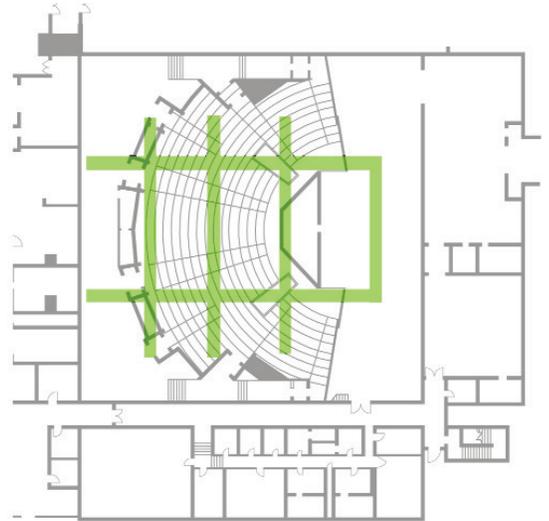
## M16 Catwalks

The current catwalks above the house in the Morgan Theater are made of wood and are not secured in a safe or adequate fashion for safe navigation. The wood material would not meet current fire codes in an A-occupancy of this size if it were constructed today. They also do not have any type of railings and are, therefore, a fall hazard. These catwalks are recommended to be replaced with steel catwalks with continuous guardrails and secured seismically according to current codes.

The current IBC code does not require catwalks to be fire-rated. They only need to be built in accordance with the materials allowed by the code, depending on the type of construction for the building. However, due to minimal nature of the construction of the current catwalks and that there are currently no railings in place anywhere, it is highly recommended that the catwalks be replaced with steel catwalks and handrails constructed as per the current IBC code and OSHA.

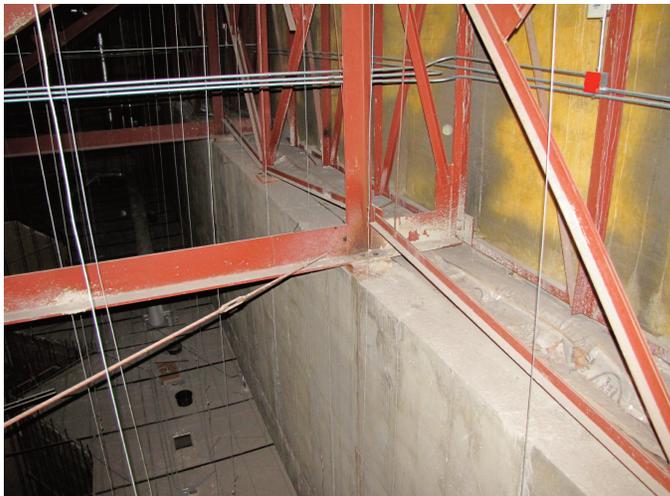
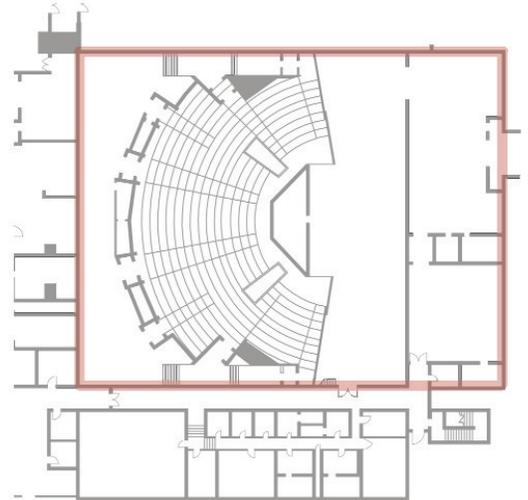
**M17 Walls, Exterior, Seismic Bracing**

In the Morgan Theater the longitudinal walls are braced by the connection of the main girder to the tops of the concrete walls. This connection appears to be inadequate for out of plane seismic forces per current code requirements and needs to be strengthened.

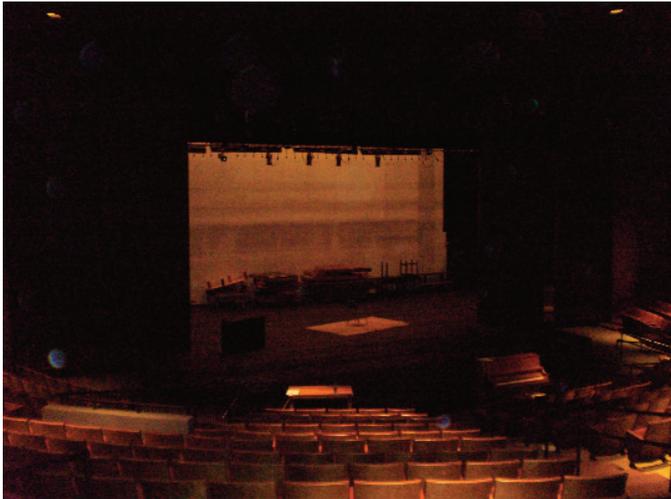
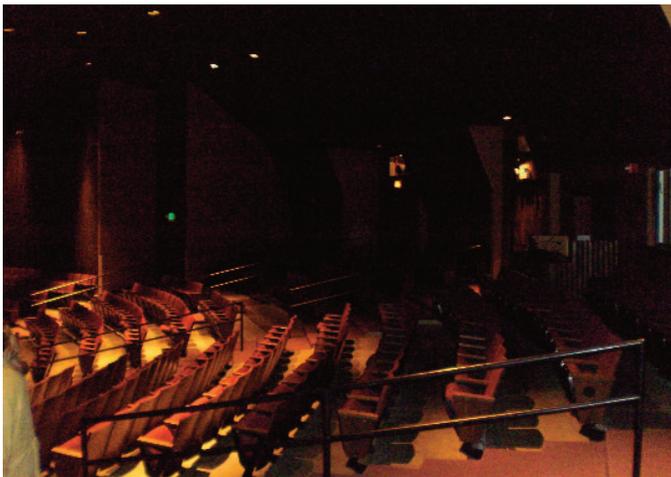
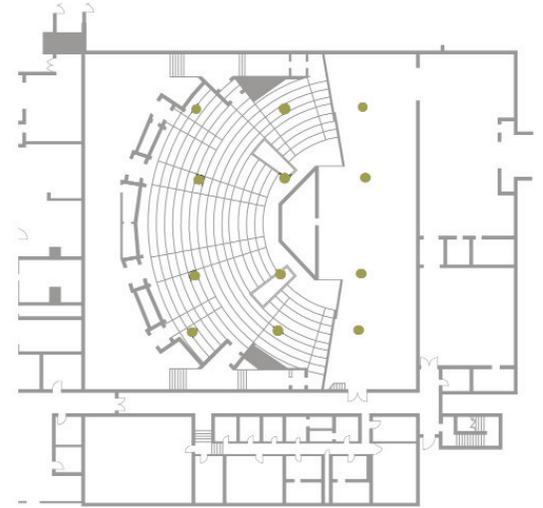
**M18 Lights, Worklights**

Add worklights in house and stage. There are two existing worklights on the stage but they don't work well and are very inefficient. The University indicated that this would be an important energy issue.

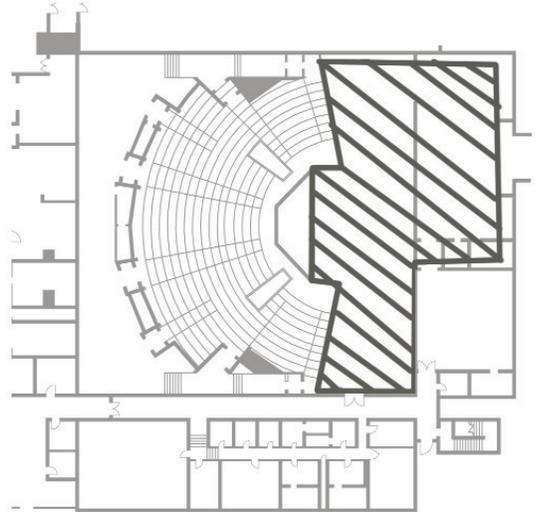
*Note: Basement area beneath stage*

Fire Sprinklers currently exist under the Morgan Stage but are past their life expectancy. It is highly recommended to upgrade the heads on the system.

Automatic sprinklers currently exist in the basement and shop areas in the Morgan Theater, however, they need to be updated per current code. IBC now classifies this venue as an A-1 occupancy and would, therefore, require automatic sprinklers. The current IBC code also requires all stages to be sprinkled. In addition, the current DFCM design guidelines say "it is desirable that all buildings constructed by the State of Utah be equipped with an automatic sprinkler system to provide added life safety for the occupants and to protect the building from fire loss." Therefore, it is recommended that sprinklers be provided in all spaces within the FAC.

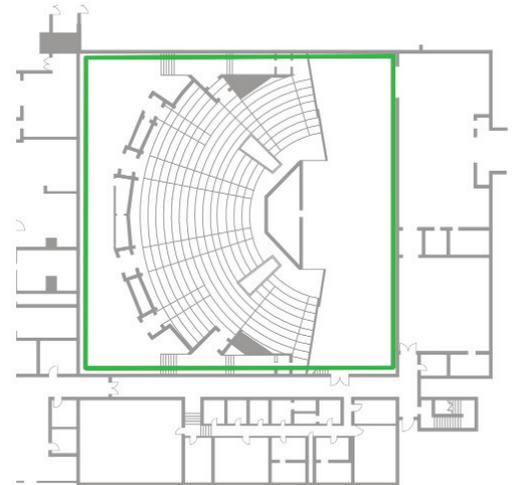
There are no automatic sprinklers currently in the Morgan Theater proper. The current IBC code would classify this venue as an A-1 occupancy which requires automatic sprinklers. The current IBC code also requires all stages to be sprinkled. In addition, the current DFCM design guidelines say "it is desirable that all buildings constructed by the State of Utah be equipped with an automatic sprinkler system to provide added life safety for the occupants and to protect the building from fire loss." It is recommended that sprinklers be provided in all spaces within the FAC.

As automatic sprinklers have been recommended for the whole complex, the Morgan Theater Hall and Stage areas should be updated with new automatic sprinklers. The shop area and basement below the stage already have sprinklers that will be upgraded under project M19. It is recommended that the sprinklers be added to the Hall and Stage areas during the ceiling replacement recommended as project number M21.

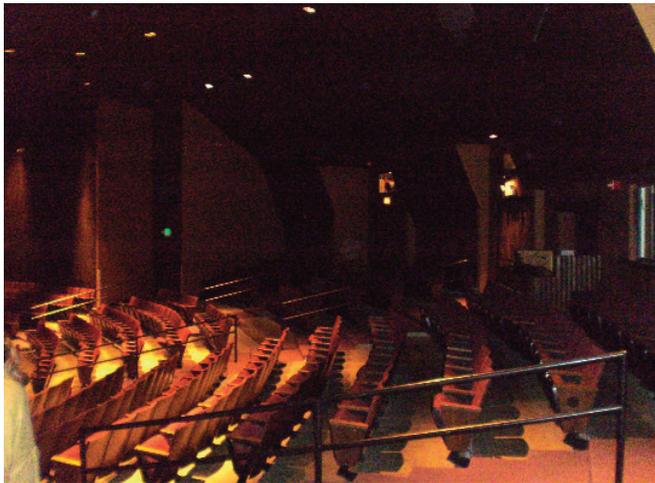
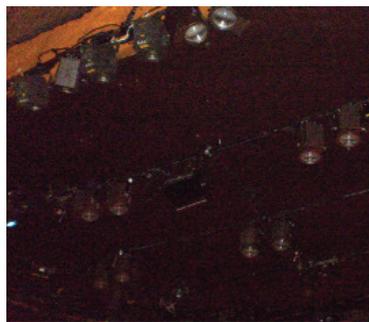
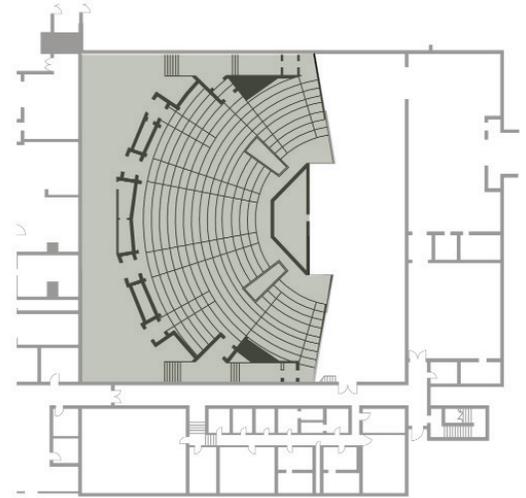
The suspended ceiling system in the Morgan Theater lacks any kind of bracing for seismic loads. Based on experience from past earthquakes, this ceiling would most likely fail during a major earthquake and could receive significant damage in a moderate earthquake. As a result, this ceiling poses a major life safety hazard to the building's occupants. It may be possible to seismically brace this ceiling in place but it makes more sense to replace this ceiling since it does not meet the acoustic properties desired for the space.

In the redesign and replacement of this ceiling, it will be important to design it jointly with the new audio system (M4) in mind, as the original acoustics of the Morgan Theater were designed for un-amplified voice performances.

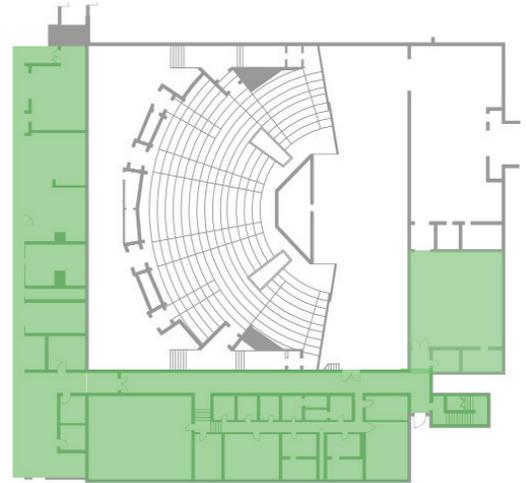
There are no sprinklers currently in the Morgan Theater dressing and support areas. The current IBC code would classify these auxillary spaces as part of the Morgan Theater’s A-1 occupancy and require sprinklers. Also, the current DFCM design guidelines say “it is desirable that all buildings constructed by the State of Utah be equipped with an automatic sprinkler system to provide added life safety for the occupants and to protect the building from fire loss.” It is recommended that sprinklers be provided in all spaces within the entire FAC.

It is recommended that the dressing room and support areas adjacent to the Morgan Theater receive new automatic sprinklers as recommended throughout the whole complex. These areas include the two stories of space just south of the Morgan Theater house area with classrooms and dressing room areas, as well as the two story costume shop and costume storage areas just east of the stage area. The scene shop already has a sprinkler system that will be upgraded under another project number (M19). It is recommended that the sprinklers be done concurrently when the ceilings, lighting and HVAC seismic upgrades are done, because access above ceiling will be optimal.

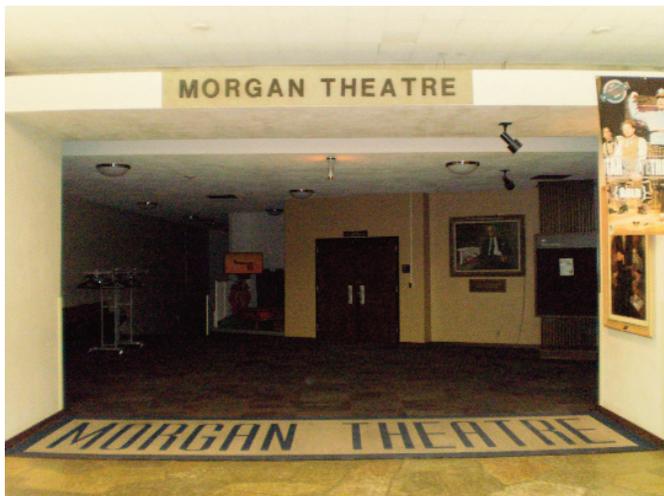
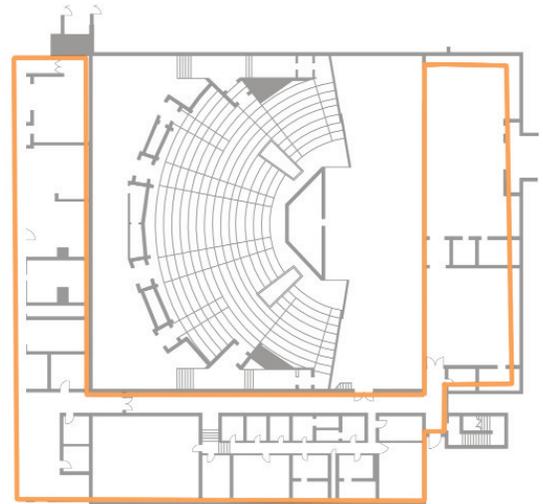
### M24 Lighting, General

The general lighting throughout the Morgan Theater auxiliary areas will need to be replaced with more efficient fixtures. This would include all areas surrounding the house and stage, excluding the house and stage areas themselves. Typically all classrooms, dressing areas, restrooms, costume shop and storage areas, scene shop, etc.

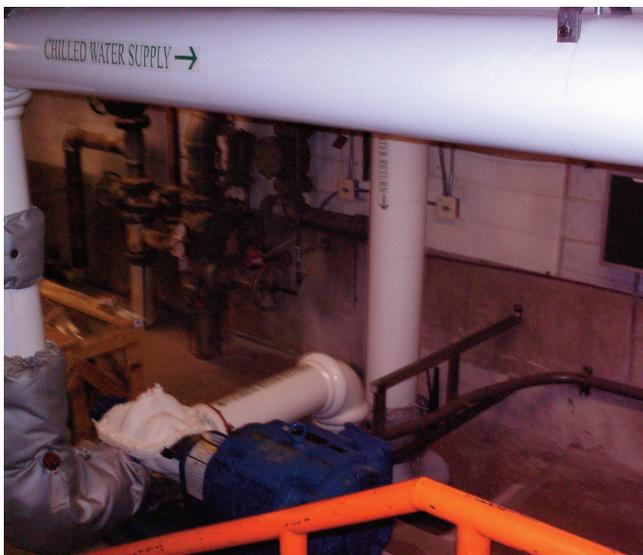
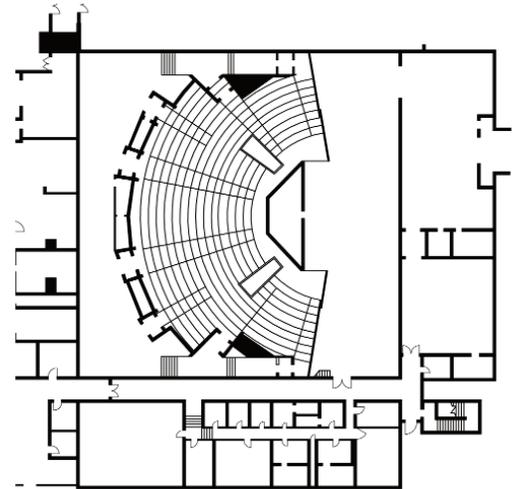
### M26 Domestic Potable Water Piping

The conventional waste and wet systems appear to be in good condition. These systems could last another 20 to 30 years, though as galvanized domestic hot and cold pipes age they are susceptible to rusting and pitting which is not uncommon. The rust can plug faucet aerators, pipe strainers and discolor fixtures. Pitting is a major cause of leaks. Furthermore the galvanized piping within the Morgan Theater is not sufficiently seismically restrained.

This is a lump sum given by VBFA for the replacement of the current galvanized domestic hot and cold piping. This cost includes the cost of patching.

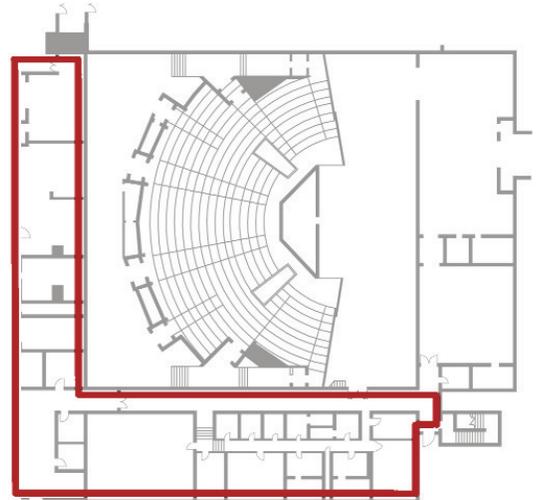
The current ceilings are not seismically braced and are recommended to be replaced. During the replacement, current seismic codes will be used in the design which will address this life safety issue.

Replace lay-in ceiling tile in ceilings with new seismically braced system.

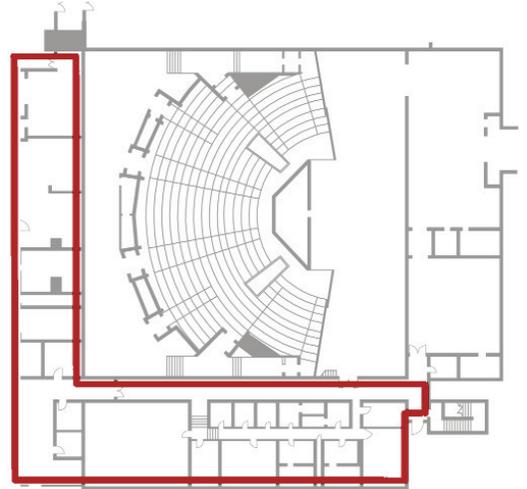
**M28 Seismic Bracing (ducts), classrooms**

The ductwork in the classroom areas of the Morgan Theater will need to be seismically braced as this is both a life safety issue as well as an acoustic issue with the ducts in some areas resting directly on the ceiling itself transmitting vibration noise throughout the building.

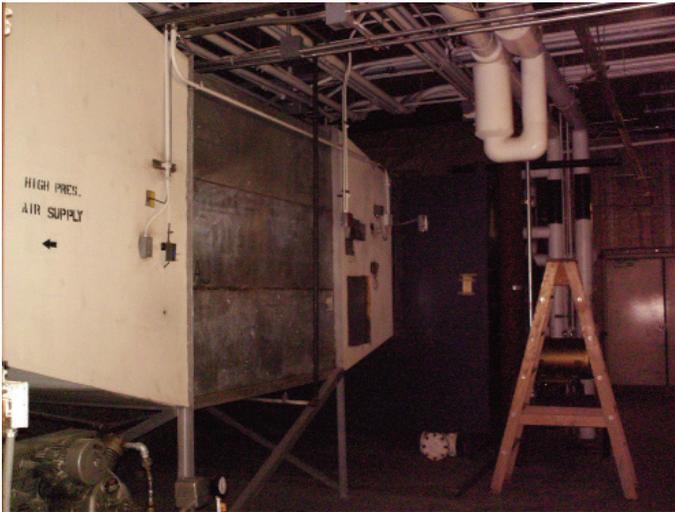
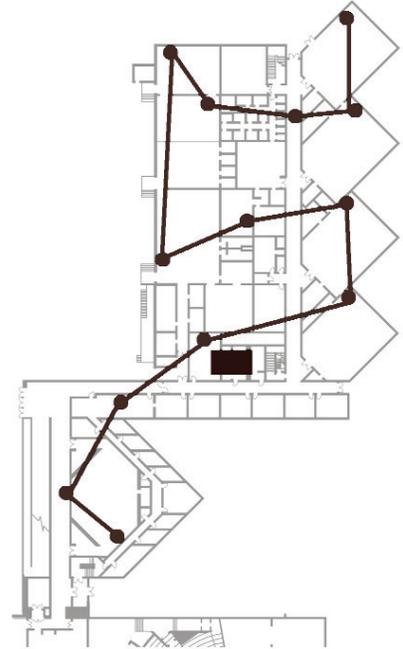
The building is served by two separate air-handlers. The air-handler serving the south offices is a constant volume air-handler. Constant volume re-heat boxes provided separate thermostatic control. The air handler serving the classroom bay is constant volume multi-zone with (5) thermostatic zones.

The existing pneumatic controls should be upgraded to DDC. The motorized actuators and dampers should be replaced as well. The existing chiller is also undersized and has outlived its useful life. The chiller should be replaced with a new larger chiller that will accommodate both air-handlers. See item V7 for chiller cost and description.

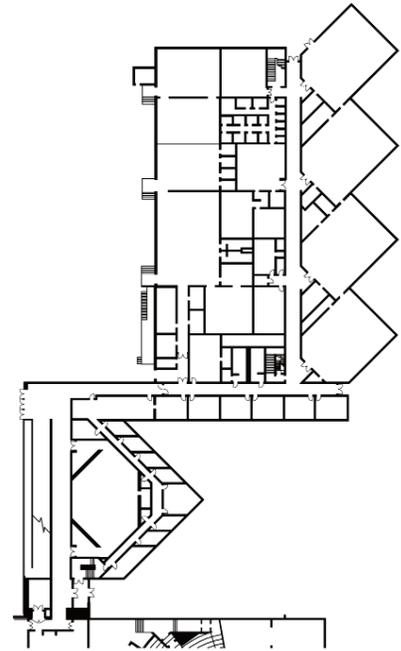
There are no sprinklers currently in the Visual Arts wing of the complex. While the current IBC code would not require automatic sprinklers for the 'B' occupancy area of classrooms, the current DFCM design guidelines say "it is desirable that all buildings constructed by the State of Utah be equipped with an automatic sprinkler system to provide added life safety for the occupants and to protect the building from fire loss." It is recommended that sprinklers be provided in all spaces within the FAC including the Visual Arts Wing.

Add new sprinklers/replace any current sprinkler heads (outlived useful life of 20-yrs.) This project should be considered when addressing ceiling, lighting and even mechanical/electrical upgrades (contingent to some extent).

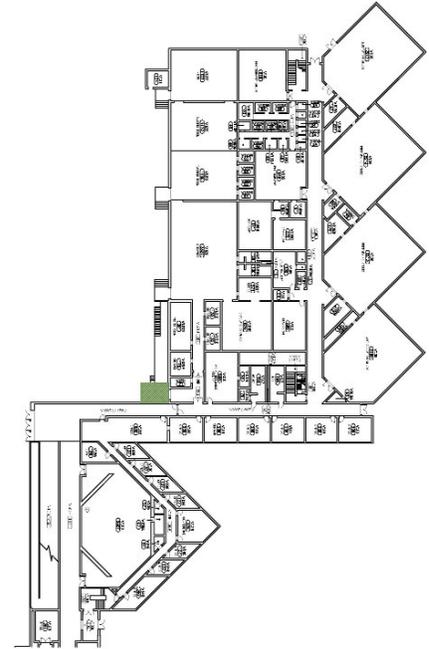
The Visual Arts wing does not currently have any ADA access to the second level by elevator. The only access is by way of the lobby ramps, which are currently steeper than current ADA code allows. It is recommended that a stand-alone elevator be added to the Visual Arts wing to not only satisfy current ADA access for the second level, but to assist in moving large art pieces and/or furniture around in the building. Due to the difference in height of the floor levels in the Visual Arts wing and the Kent and Morgan Theaters, this elevator would need to be stand-alone and could not be combined with the elevator currently recommended for the Kent and Morgan Theater areas.

It is recommended that a stand-alone elevator (separate from the one discussed in item G4) be added to the Visual Arts wing which would greatly improve the ADA accessibility to the second level of the building. This would only need to run from the main floor to the second floor, not to the basement level, as per the University's request.

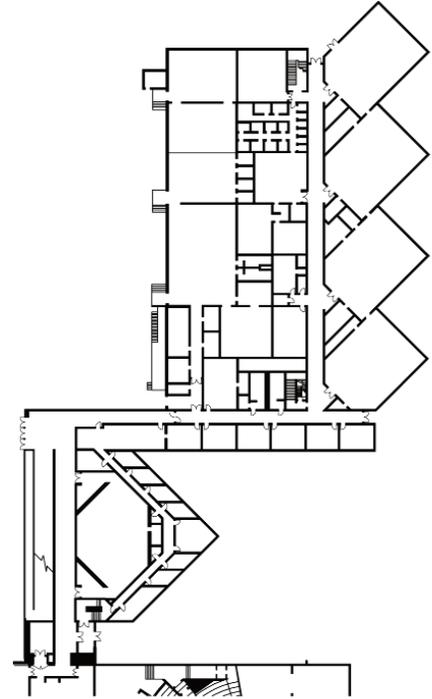
## V5 Water Piping

The conventional waste and wet systems appear to be in good condition. These systems could last another 20 to 30 years. As galvanized domestic hot and cold pipes age they are susceptible to rusting and pitting. This is not uncommon in galvanized domestic water lines. The rust can plug faucet aerators, pipe strainers and discolor fixtures. Pitting is a major cause of leaks. Furthermore the galvanized piping is not sufficiently seismically restrained.

This is a lump sum given by VBFA for the replacement of the current galvanized domestic hot and cold piping. This number includes the cost of patching.

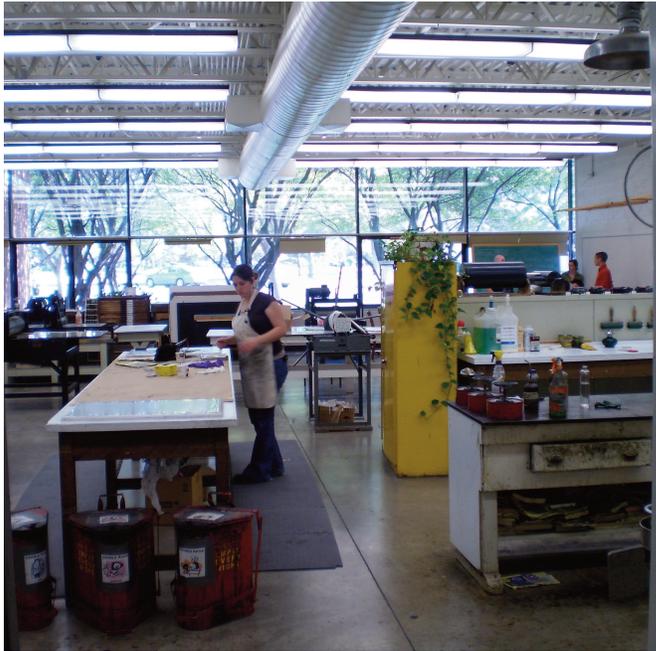
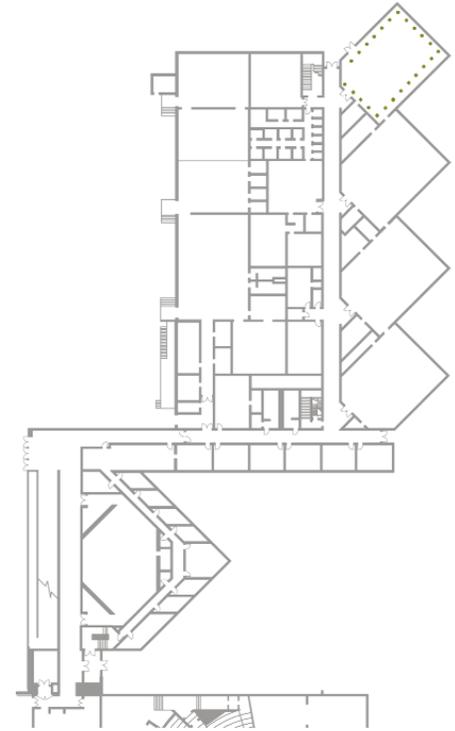
## V6 Lighting, Gallery

It is recommended that the University replace and/or augment the gallery lighting and controls (studio 102).

This is an estimated cost given by Spectrum Engineers for the replacement/augmentation of gallery lighting and controls. The gallery is 2,400 s.f. at \$15/s.f. for lighting which equals \$36,000; and \$20,000 for controls for a total of \$56,000.00.

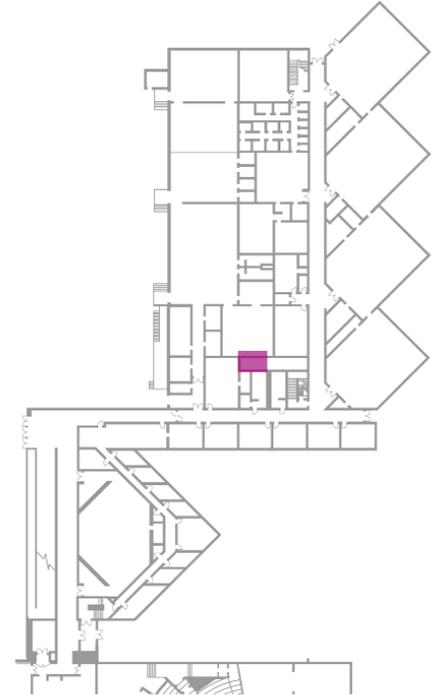
**V7 Air Conditioning, add to bldg**

The Visual Arts wing currently has no air conditioning. It is recommended that this be added by replacing the existing chiller, cooling tower, condenser water pumps, chilled water pumps, air-handler cooling coils and water treatment.

This is a lump sum given by VBFA for the replacement of the current chiller, and its associated systems mentioned above, in the building allowing the addition of air conditioning for the Visual Arts wing.

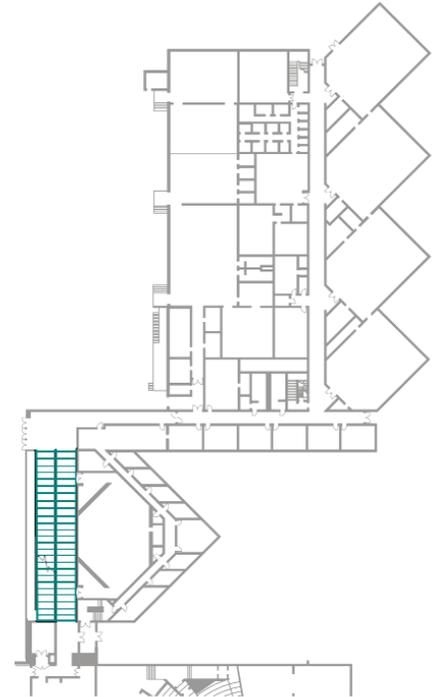
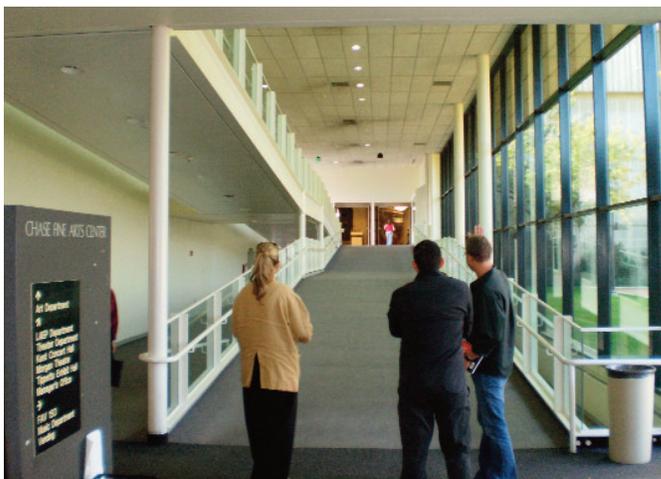
The ramps in the lobby of the building are steeper than current ADA code allows. It has been recommended that these ramps either be replaced, re-configured or be superseded by adding an elevator in the courtyard serving the Kent and Morgan Theaters (see G4).

This is an estimate based on the possible replacement of the entire ramp system with either a new ramp system or a stair system if the proposed elevator is added to the area. Some of the costs/sf include: slab on grade demo - \$3/sf, new slab on grade install - \$3/sf, new suspended slab install - \$13/sf, new column install - \$2/sf, and a \$4/sf contingency. The estimated square footage of the area is 5,400 s.f. Note: elevator is needed for this option. Issues are all ADA issues. This includes new handrails.

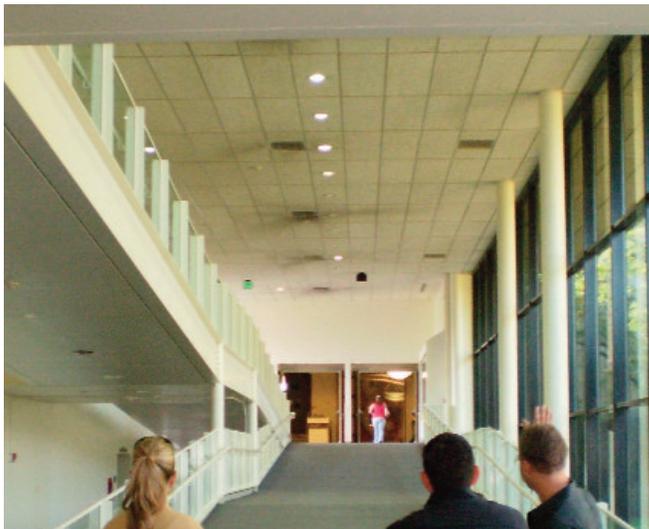
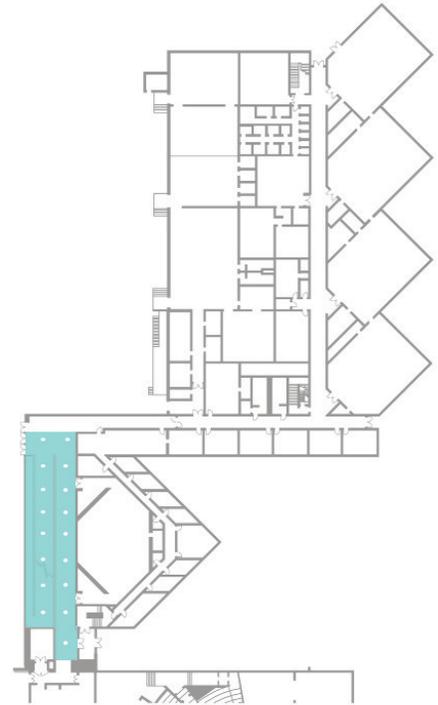
**V9 Ramp Area Ceiling/Lighting Replacement**

The ramp area of the Visual Arts wing leading into the lobbies of the Morgan and Kent currently has a non-standard size ceiling grid and tiles, which are not seismically braced. It is recommended that the ceiling grid be updated to a new 24" x 24" acoustic tile grid, seismically braced, and that the current lighting be replaced with newer, more efficient, lighting. This would also dress up this space as the ceiling tiles are discolored and dirty.
