## Addendum No. 1

Reference: Addition/Renovation Fine Arts Complex  
Utah State University - Logan, Utah  
DFCM Project No. 14385770

Subject: **Addendum No. 1**

RENOVATION & ADDITION | LOGAN, UTAH  
**FINE ARTS COMPLEX**

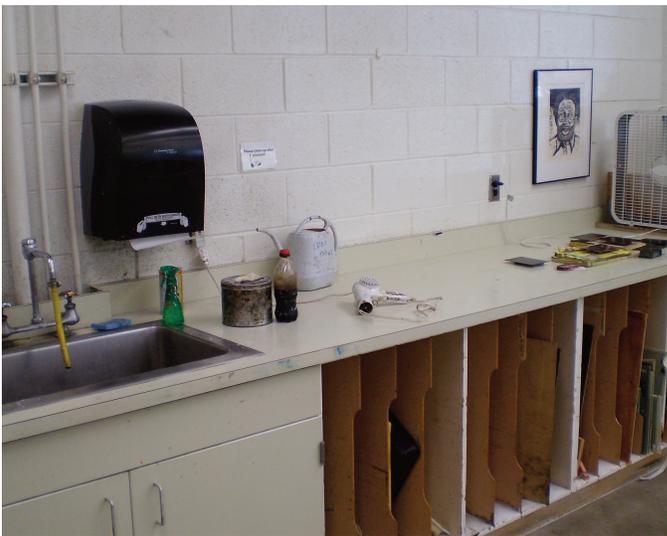
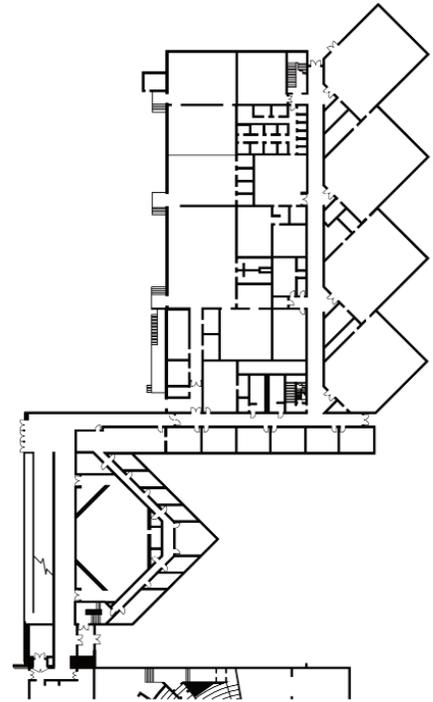
### V10 Power

The existing 120/208V distribution in the Visual Arts building is inadequate for the many computers that are used today in the visual arts computer labs. This project will upgrade the 120/208V distribution for additional capacity and panelboards.

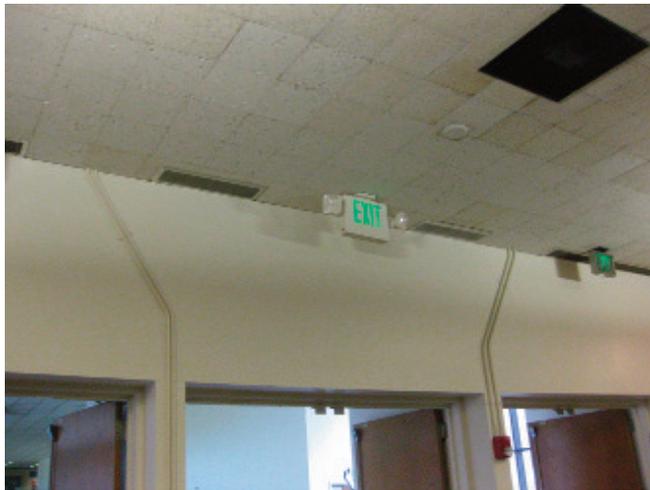
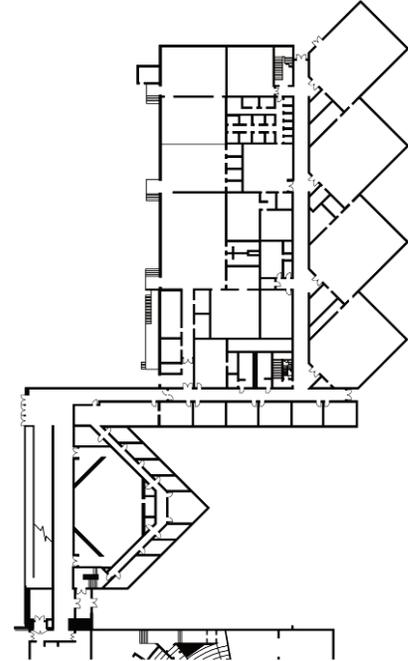
The lay-in acoustic tile ceilings throughout the Visual Arts wing will need to be replaced with a newer, seismically braced system. These are mostly classrooms and this does NOT include the entry ramp area leading into the Morgan and Kent Theaters. That will be addressed under item V10.

The current ceilings in the Visual Arts wing are not seismically braced and are recommended to be replaced. During the replacement, current seismic codes will be used in the design which will address this life safety issue.

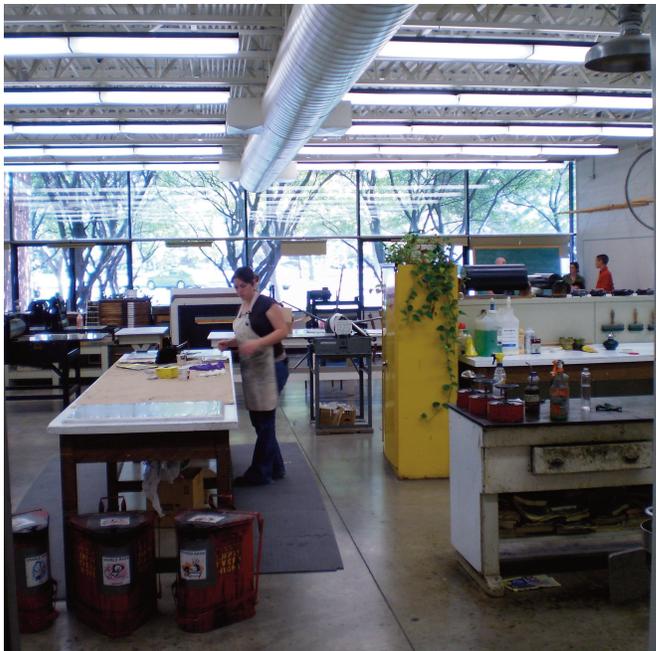
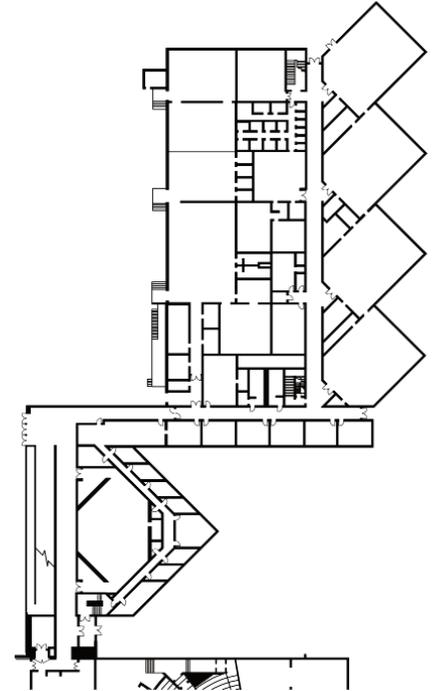
## V12 Lighting

The general lighting throughout the Visual Arts wing will need to be replaced with more efficient fixtures. These are mostly classrooms and this does not include the entry ramp area leading into the Morgan or Kent Theaters. That will be addressed under item V10.

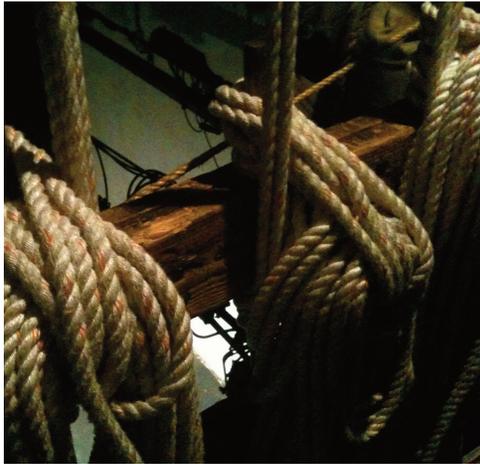
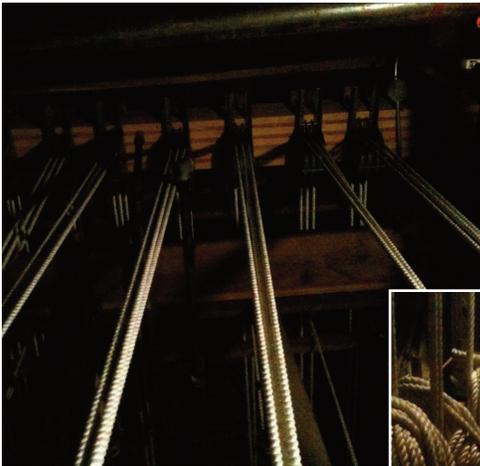
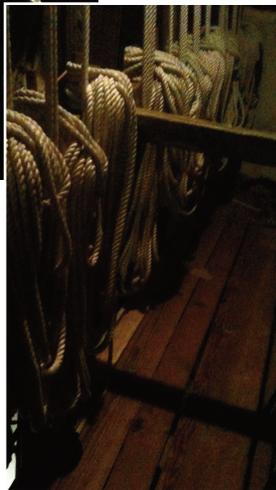
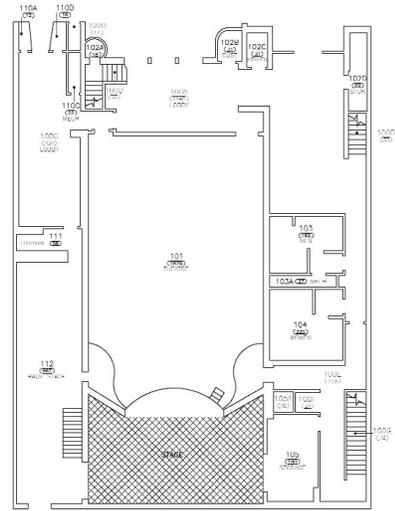
## L1 Fly System

The fly system in the Lyric Theater needs to be replaced. It needs to also remain a manual rigging system as it is a teaching facility for students needing to learn to operate the older systems.

This estimate is a difficult one. The fly system appears to hang from the roof structure of the building and the replacement of the system would most likely trigger a structural upgrade for the roof. This is the reason for the range in cost.

One of the reasons for this, and the biggest safety concern/current code violation of the fly systems, has to do with the rigid guide system for the arbors. Currently there are no rigid guides for any of the arbors on either fly system. Neither fly system was originally designed in such a way as to easily accommodate a rigid guide system. The recommendations we have received suggest that it will be more cost effective to rebuild the fly systems with rigid guides rather than try to adapt a rigid guide into the existing systems.

To bring the fly systems up to a safe, usable standard all loft/head/floor blocks, lift lines, hand lines and rope locks need to be completely replaced. A rigid guide system must be installed for each potential line set (standard spacing is to have the line sets on 1' centers for the length of the rail), which will
