**HISTORIC PRESERVATION PLAN
FOR THE
GEORGE THOMAS BUILDING
UNIVERSITY OF UTAH**

**Prepared by
Anne Oliver, M.S.**

September 19, 2013

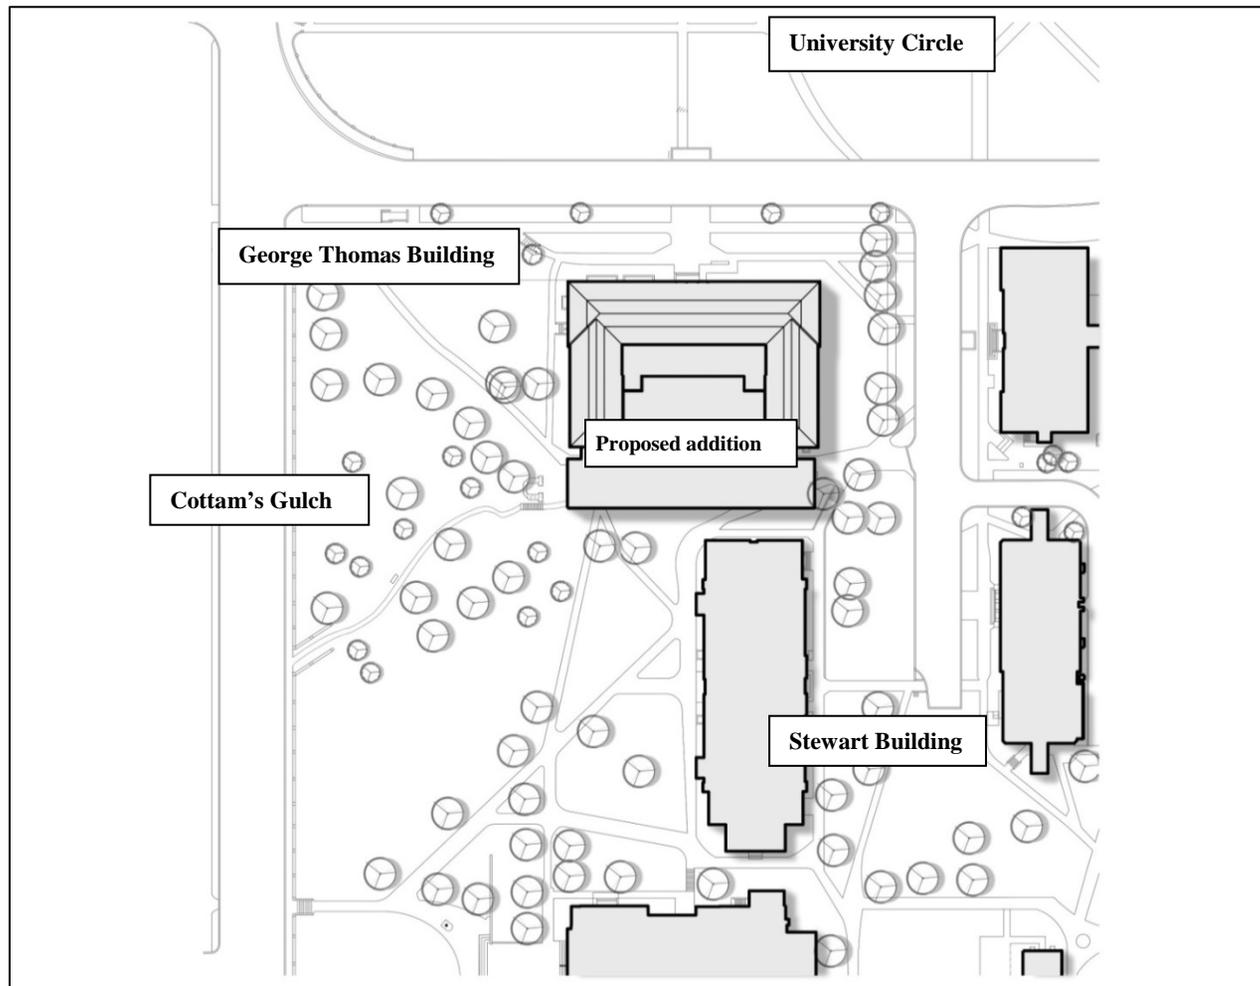
Figure 1. Proposed site plan as prepared by EDA Architects, 2013.

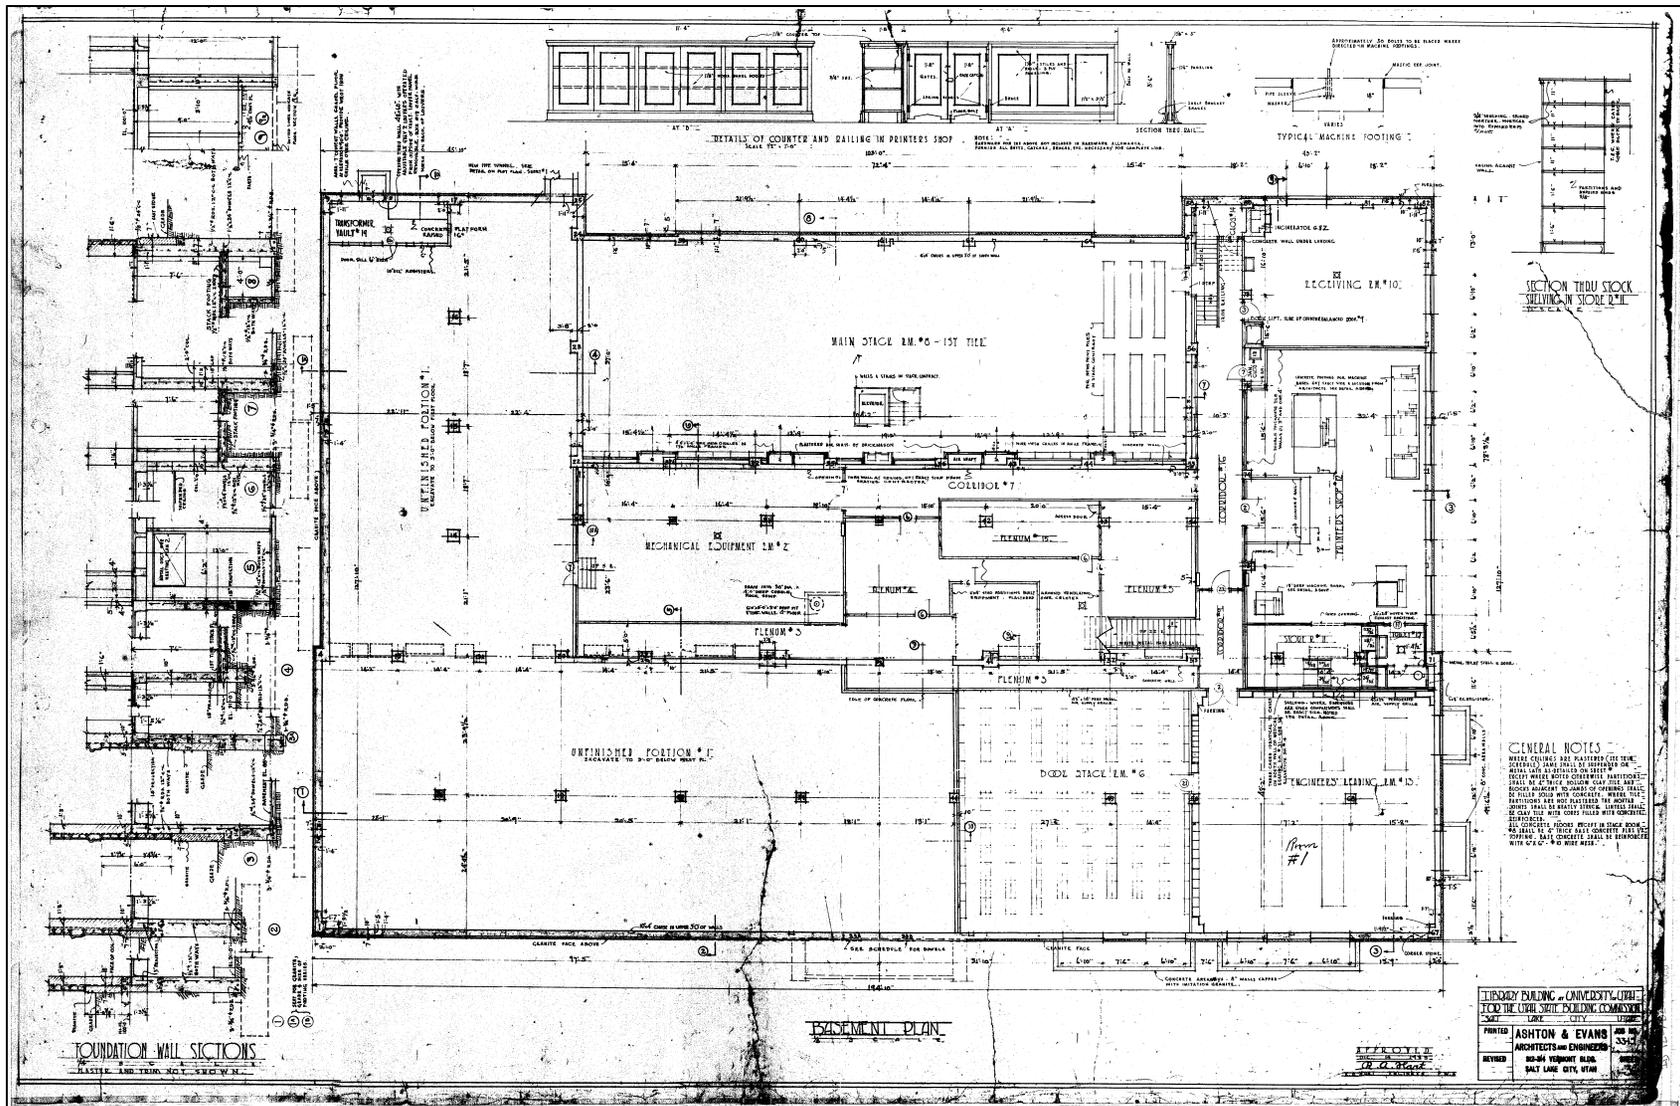
Figure 2b. Original basement plan for the George Thomas Library prepared by Ashton and Evans, 1933.

The main staircase led up the delivery hall (Room 57) on the second floor, which in turn provided access to the grand, two-story main reading room (Room 56) and a periodical room on the east side (Room 55). Offices, support rooms, and the stacks completed the floor (see Figure 2d). The third floor comprised two graduate reading rooms on the east side (Rooms 75 and 76), study cubicles, and seminar rooms, many overlooking the roof of the stacks (see Figure 2e). Much of the basement was unfinished, but in the northwest corner was the engineering library (Rooms 6 and 13) and, to the south, a printer’s shop (Room 12) and a receiving room (Room 10; see Figure 2b).

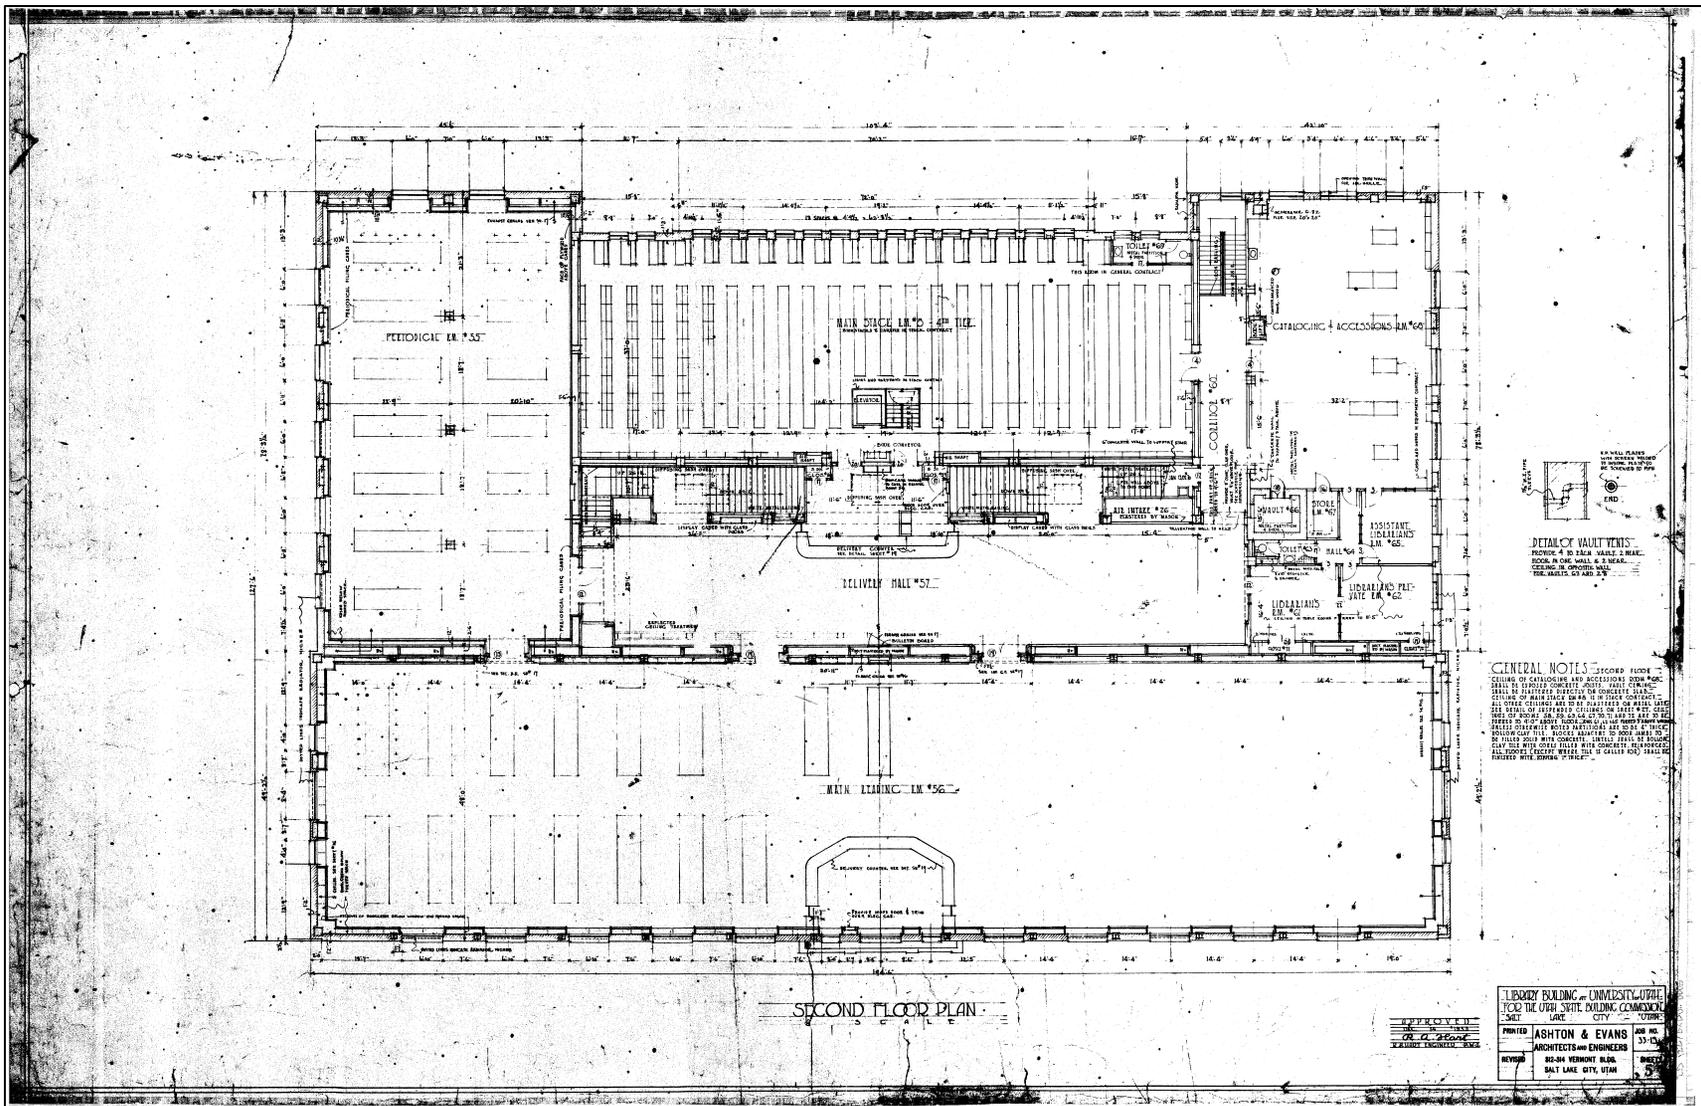
Figure 2d. Original second floor plan for the George Thomas Library prepared by Ashton and Evans, 1933.

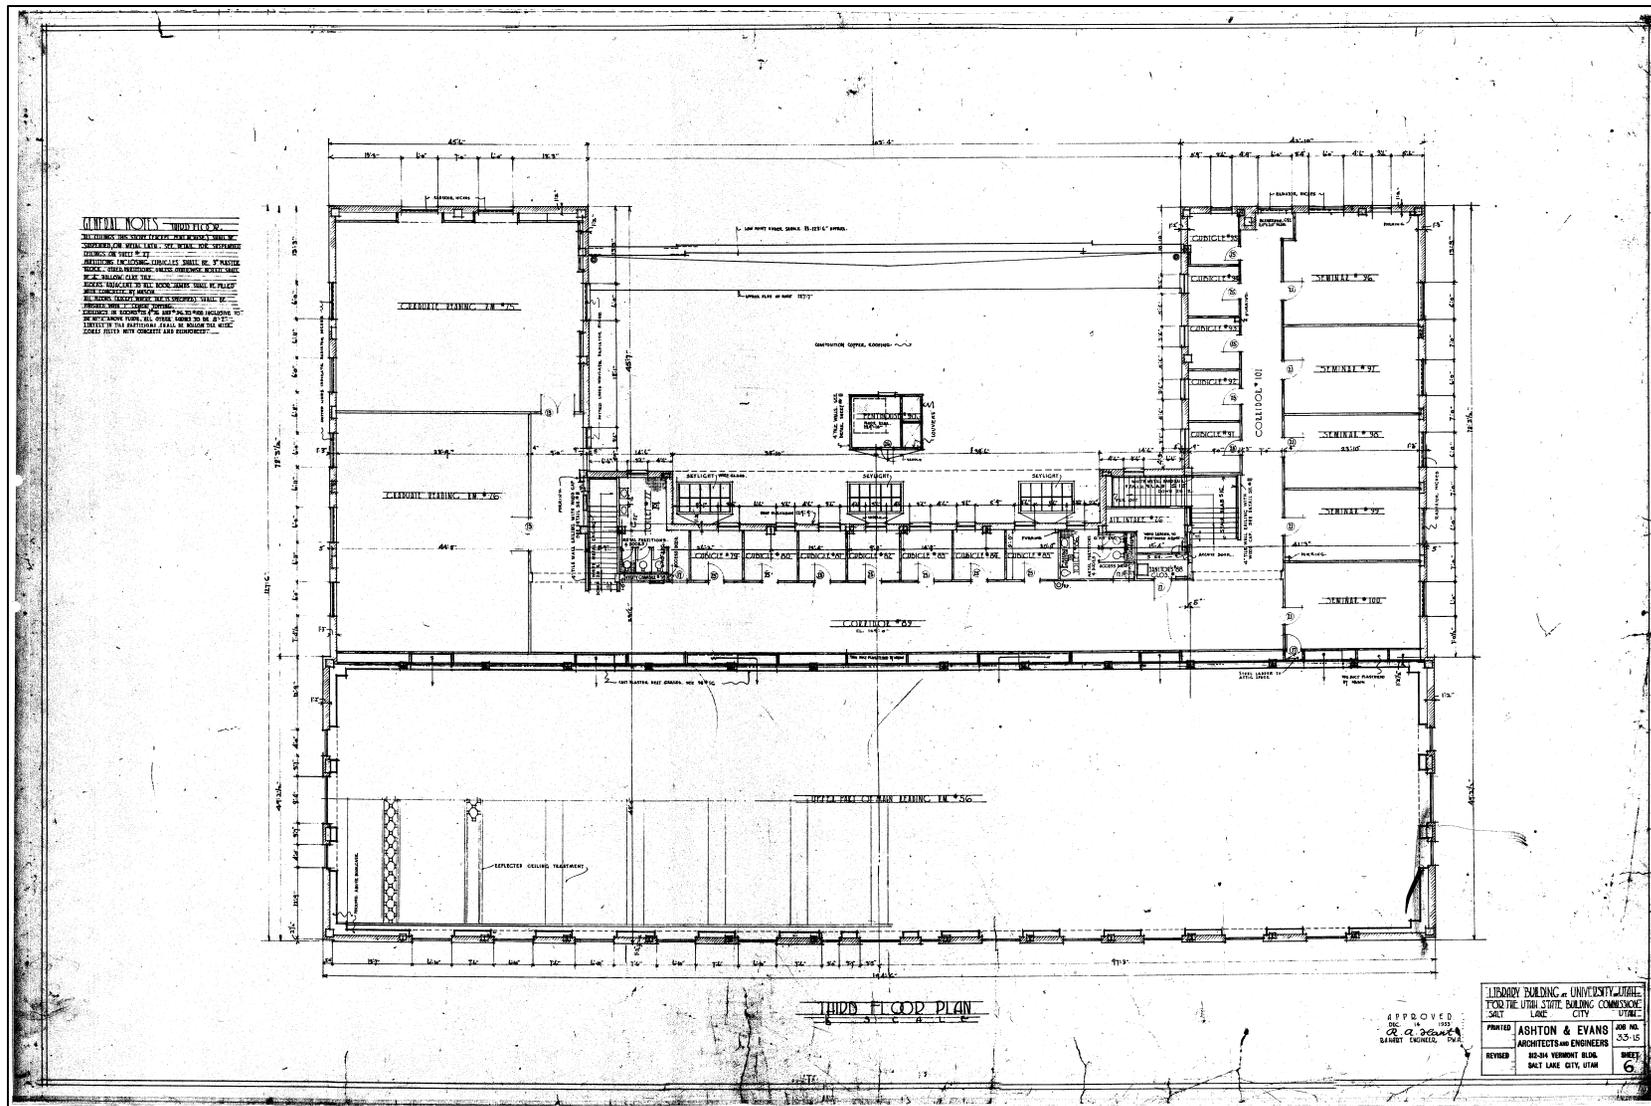
Figure 2e. Original third floor plan for the George Thomas Library prepared by Ashton and Evans, 1933.

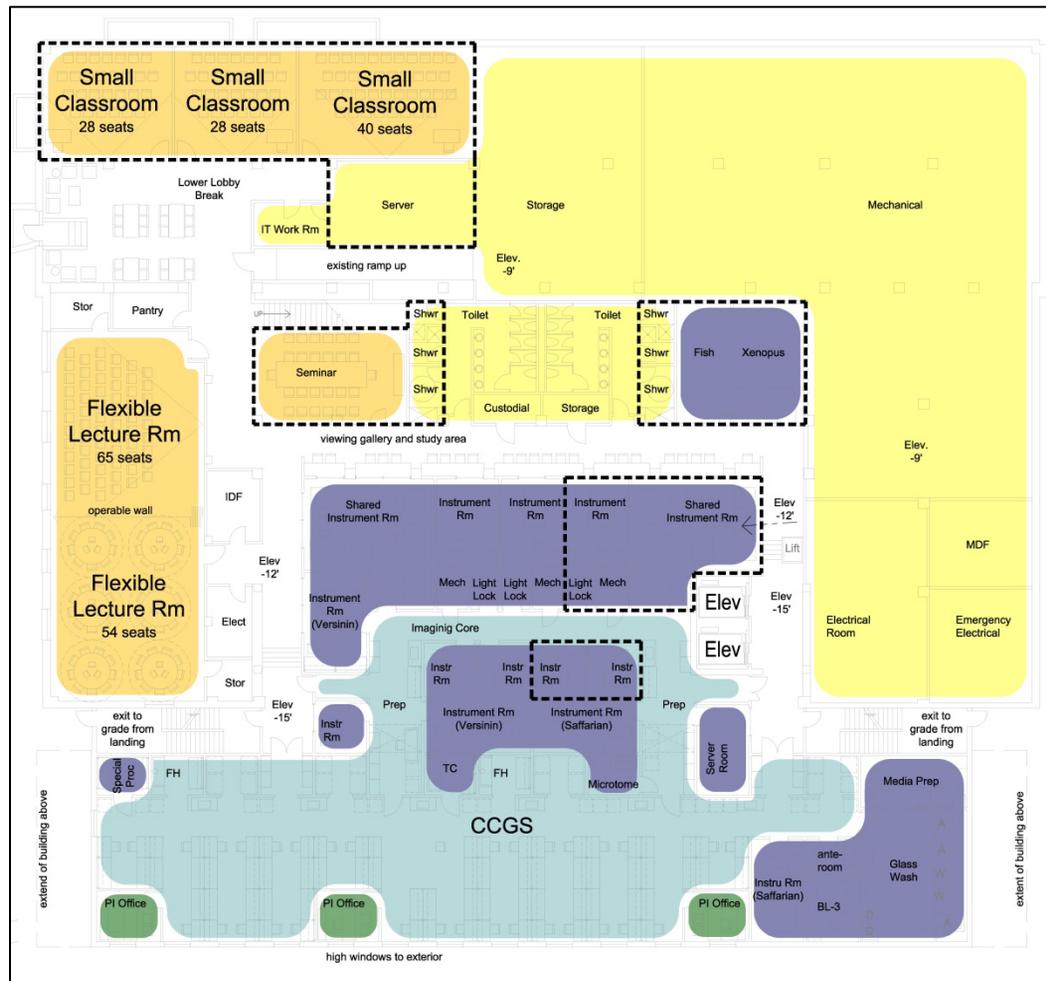
Figure 3a. Final test fit diagram prepared by EDA Architects for the basement level of the George Thomas Building/Crocker Science Center, 2013.

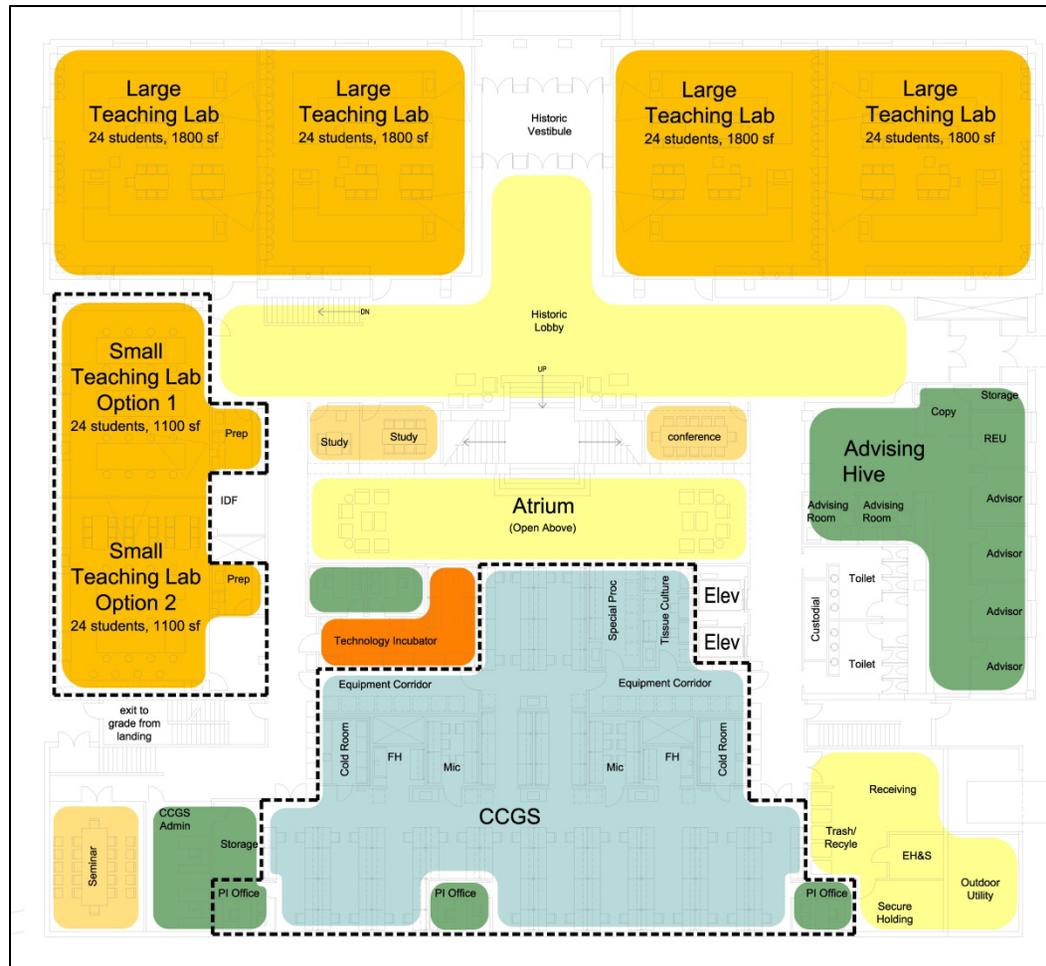
Figure 3b. Final test fit diagram prepared by EDA Architects for the first floor level of the George Thomas Building/Crocker Science Center, 2013.

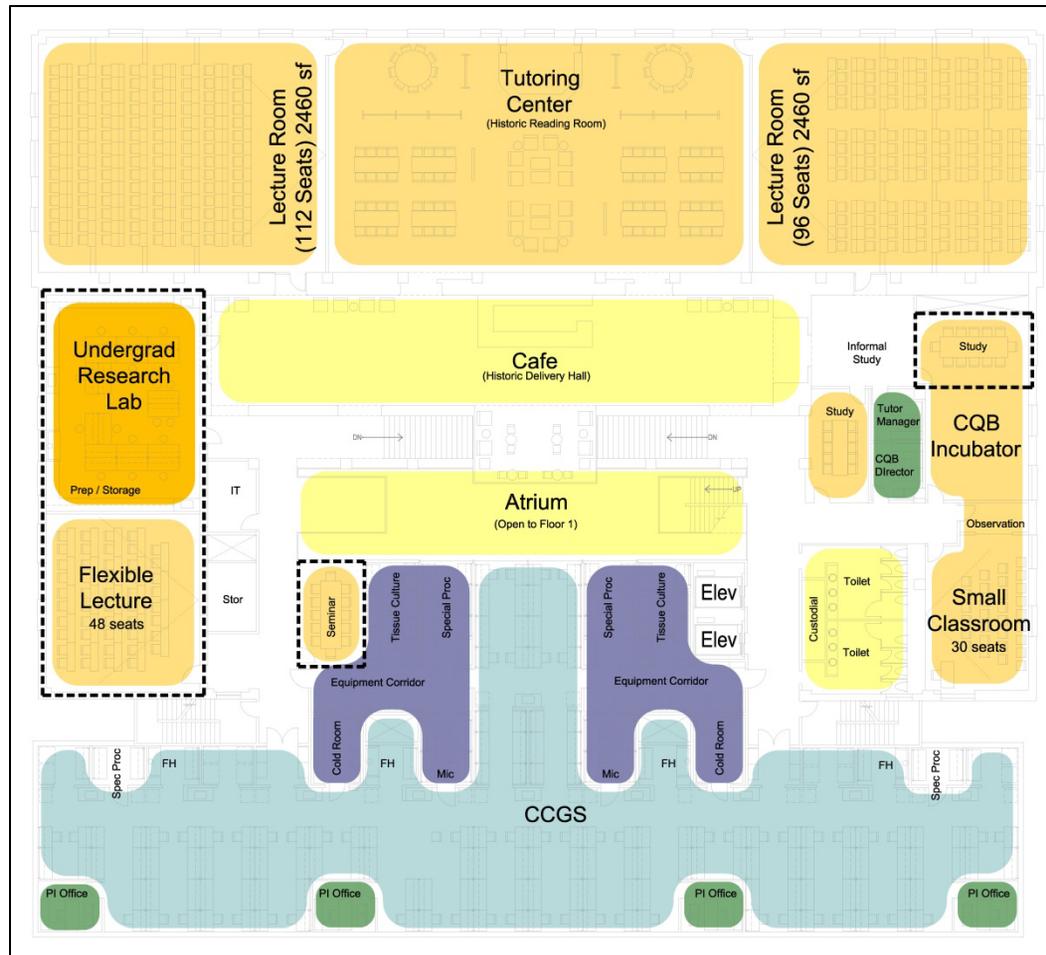
Figure 3c. Final test fit diagram prepared by EDA Architects for the second floor level of the George Thomas Building/Crocker Science Center, 2013.

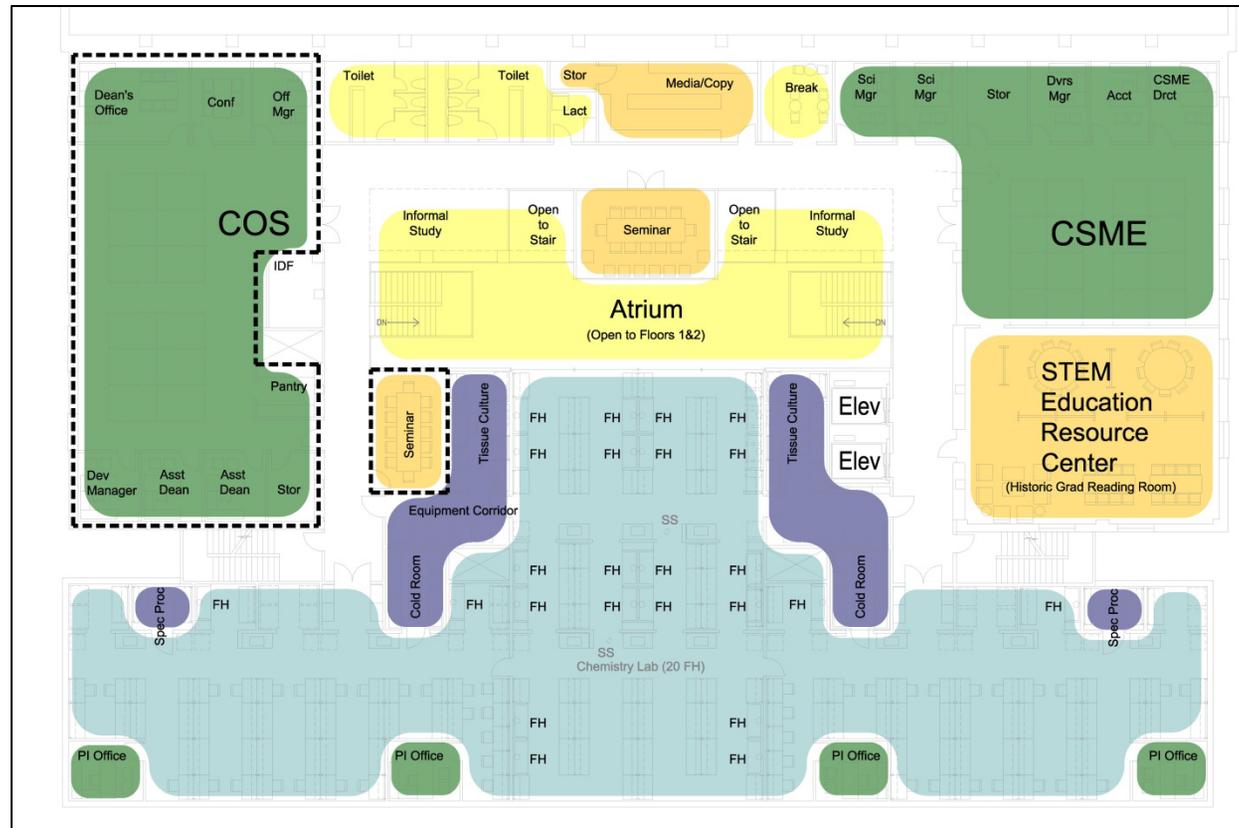
Figure 3d. Final test fit diagram prepared by EDA Architects for the third floor level of the George Thomas Building/Crocker Science Center, 2013.

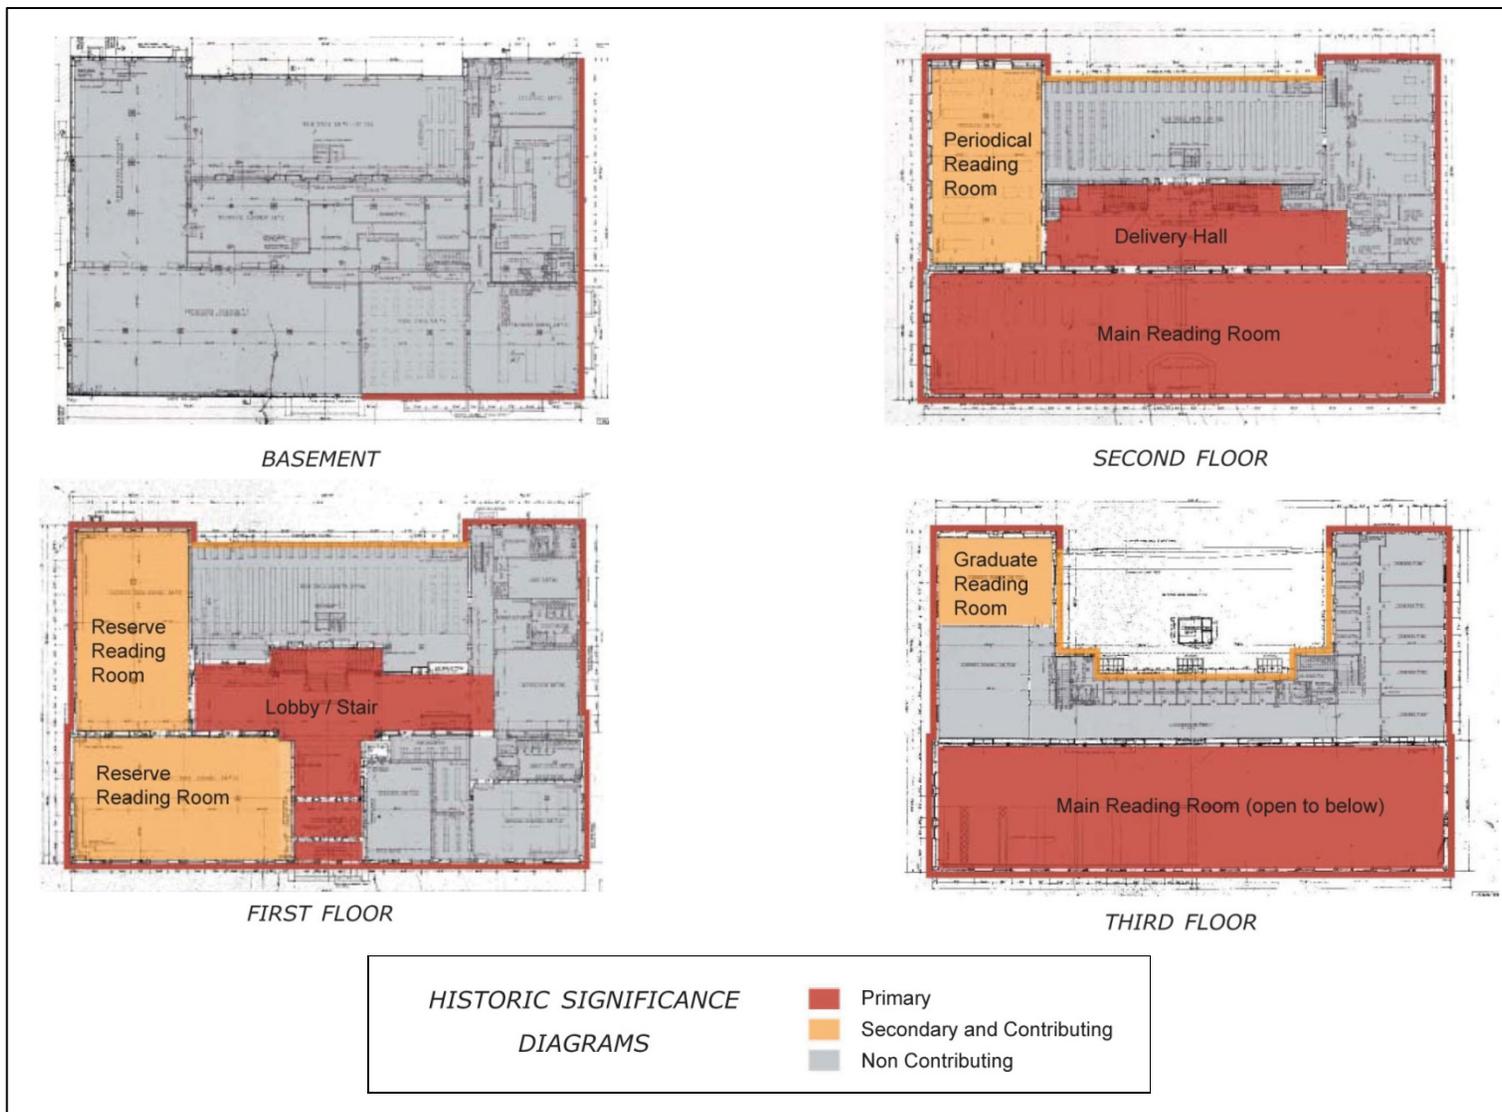
Figure 5. Historic significance diagrams for the George Thomas Building (courtesy EDA Architects).

At the George Thomas Building, zones of primary significance comprise the exterior envelope of the U-shaped part of the building, the lobby and main staircase, the delivery hall, and the main reading room. Areas of secondary/contributing importance comprise the south exterior wall of the stacks wing, the two reserve book reading rooms on the first floor, the periodical reading room on the second floor, and the graduate reading room on the third floor. All other areas are considered non-contributing or non-historic zones (Figure 5). Rehabilitation efforts can be directed toward retaining primary zones and, to the extent possible, secondary/contributing ones. Major changes can be programmed for non-contributing and non-historic zones or for secondary/contributing ones when other options are not viable.

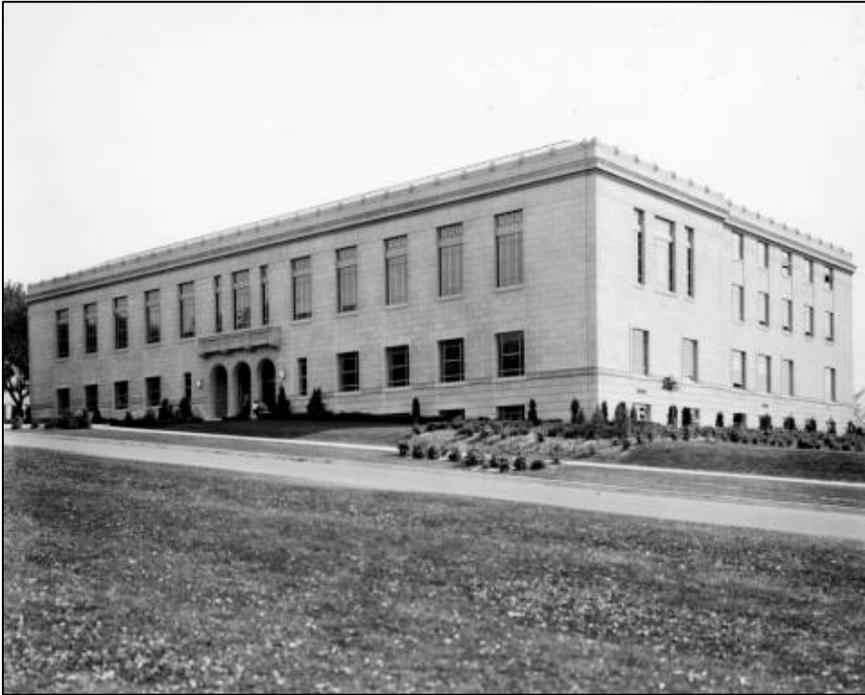
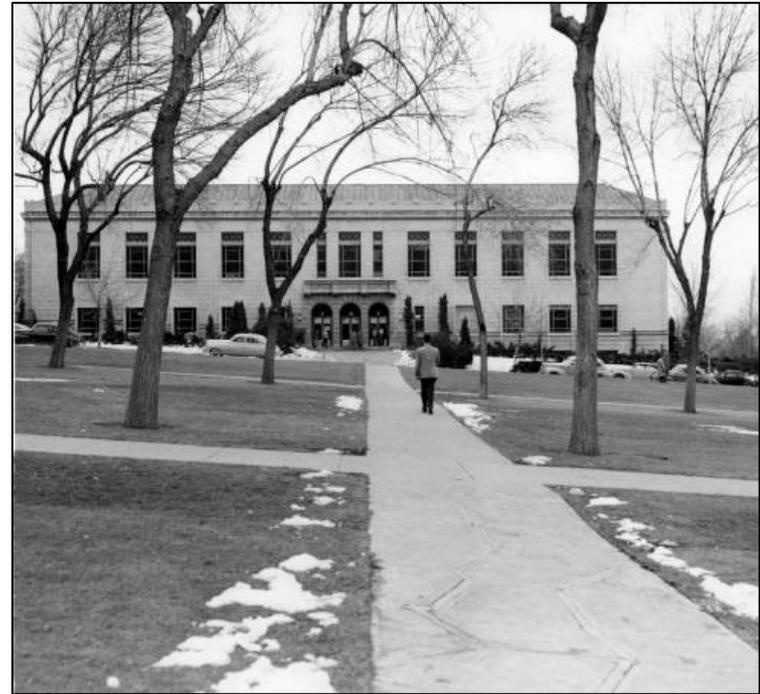
Figures 6a and 6b. Views of the George Thomas Library showing a) the north and east elevation shortly after construction in 1936 and b) the north elevation in 1950. (Courtesy Utah State Historical Society.)

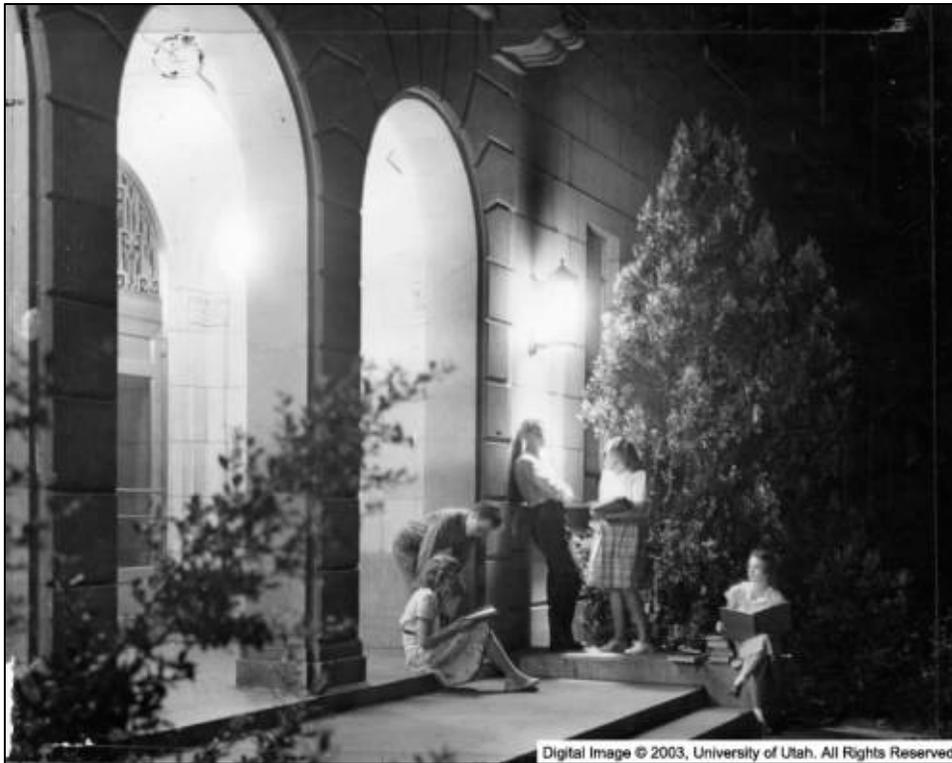
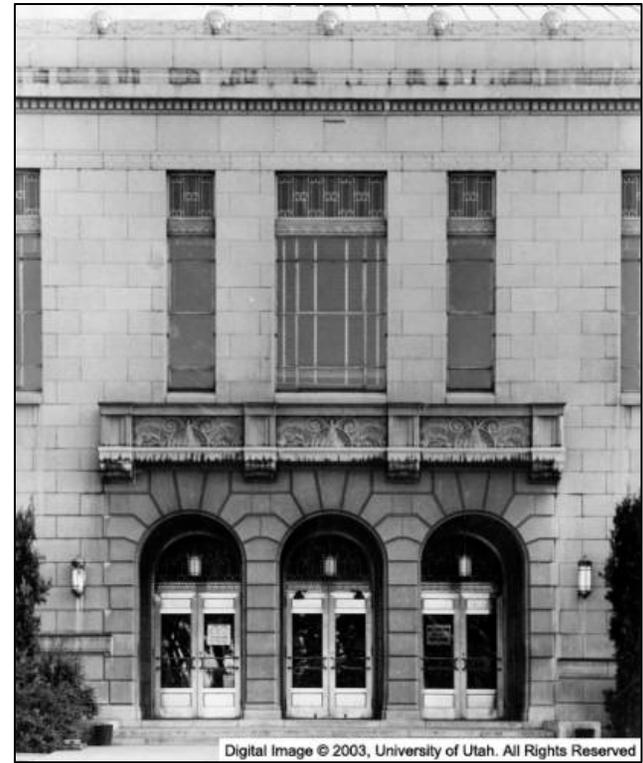
Figures 6c and 6d. Views of the main entrance on the north side of the George Thomas Library, c. 1950s. (Courtesy University of Utah Health Sciences Collection.)

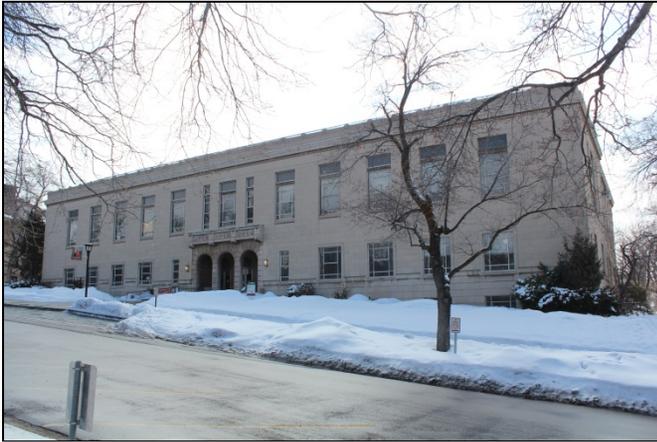
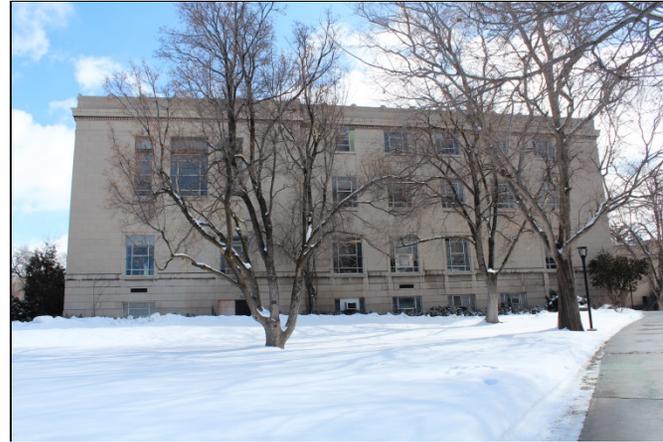
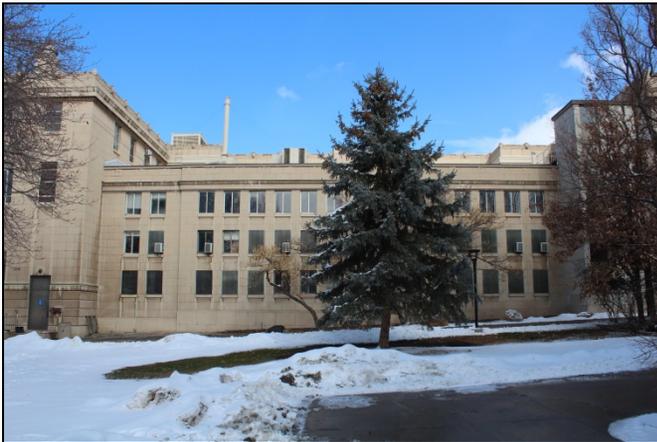
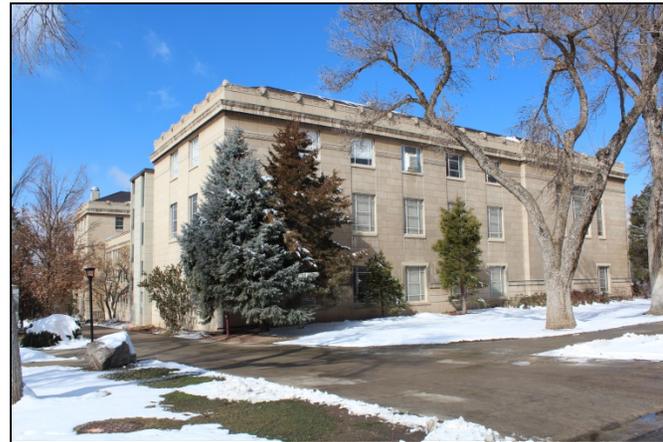
Figures 7a–7d. Top left to bottom right: Views of the a) main façade (facing southeast); b) west side (facing east); c) south side (facing north); and d) south and east sides (facing northwest).

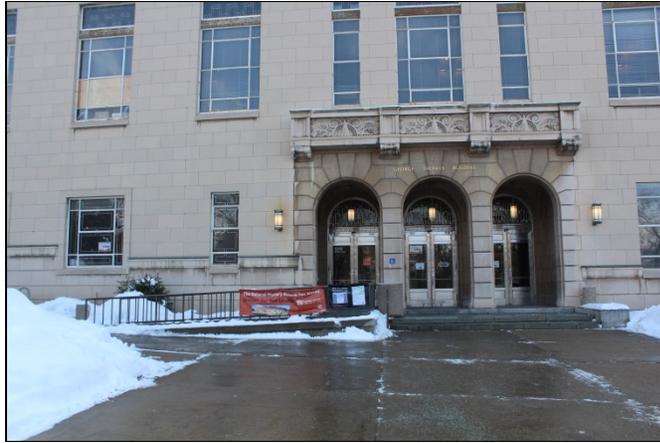
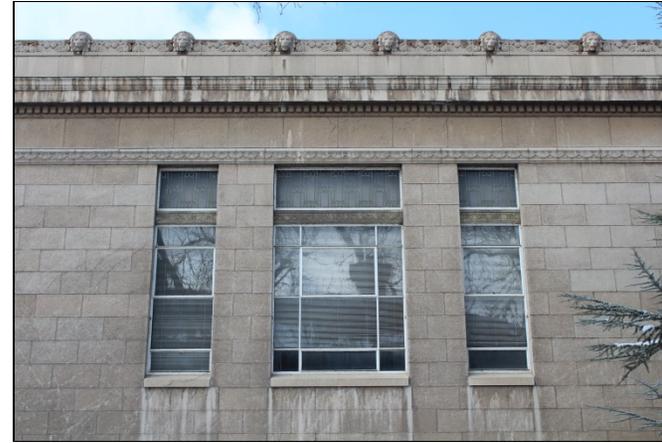
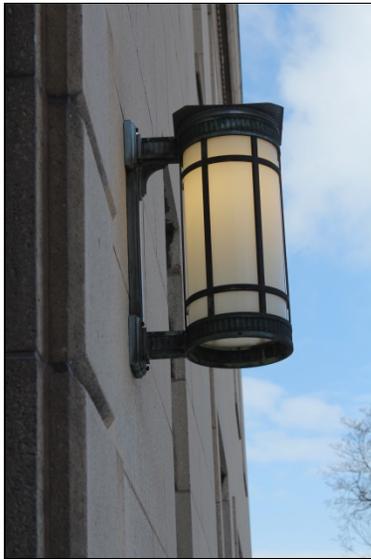
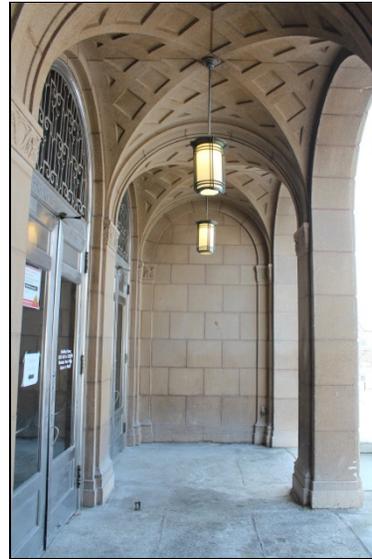
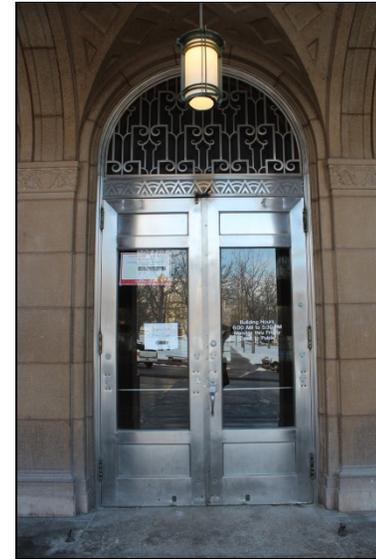
Figures 7e–7i. Top left to bottom right: Views of the e) main entrance with newer ramp (facing south); f) main reading room windows and cornice (facing east); g) original light fixture at entry (facing west); h) loggia (facing west); and i) main entrance doors (facing south).

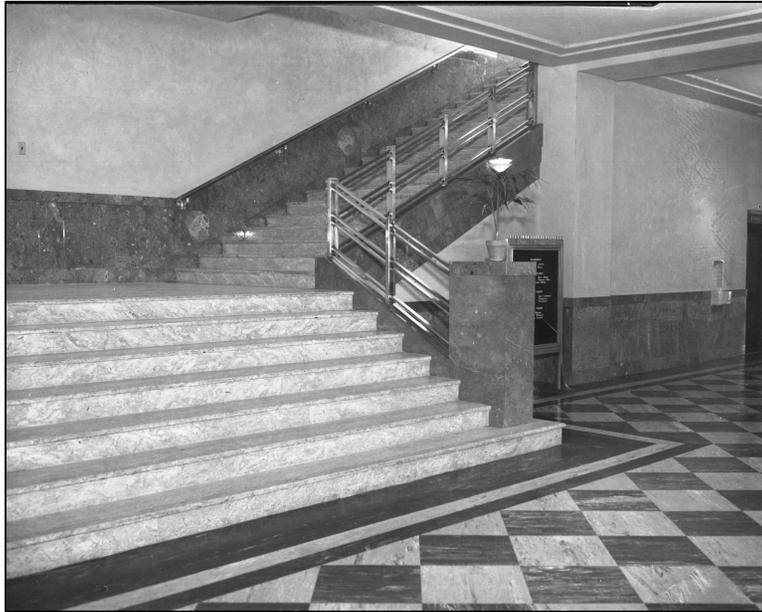
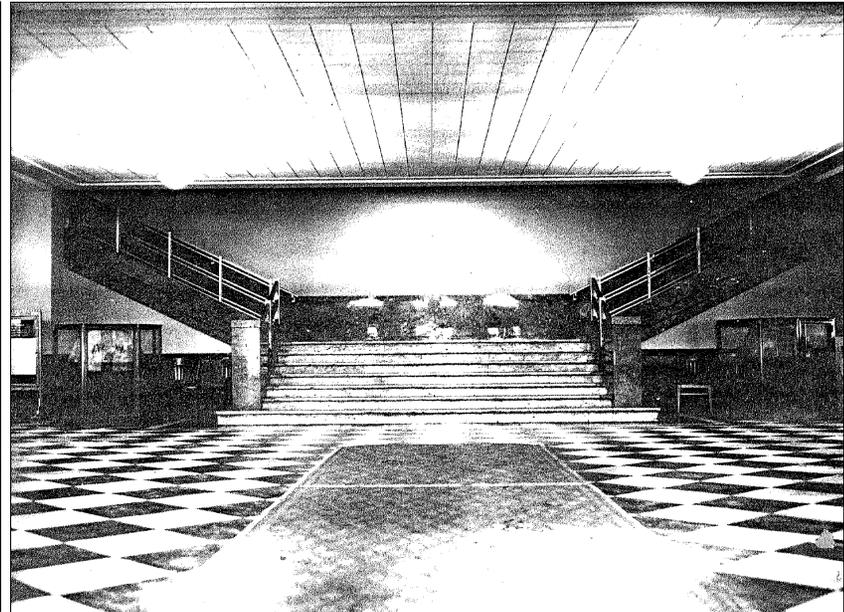
Figures 8a and 8b. View of the staircase and main lobby of the George Thomas Library c. 1935, a) facing southwest and b) c. 1950 facing south. (Courtesy a: Utah State Historical Society and b: from National Register of Historic Places nomination form.)

Early alterations to the lobby included the installation of acoustic ceiling tile, a carpet runner, and possibly the partition wall in the west arm (see Figure 8b). More recent significant alterations include the installation of a low ramp and other alterations to the doorway leading to the Treasure Room on the west side of the lobby (just inside the vestibule doors), the addition of wall-to-wall carpet tiles, the addition of temporary office space in the east arm, the removal or alteration of original light fixtures, the installation of a ceiling-mounted fire suppression system, the blocking of the east staircase at the second floor level, and the partial enclosure of the basement staircase.

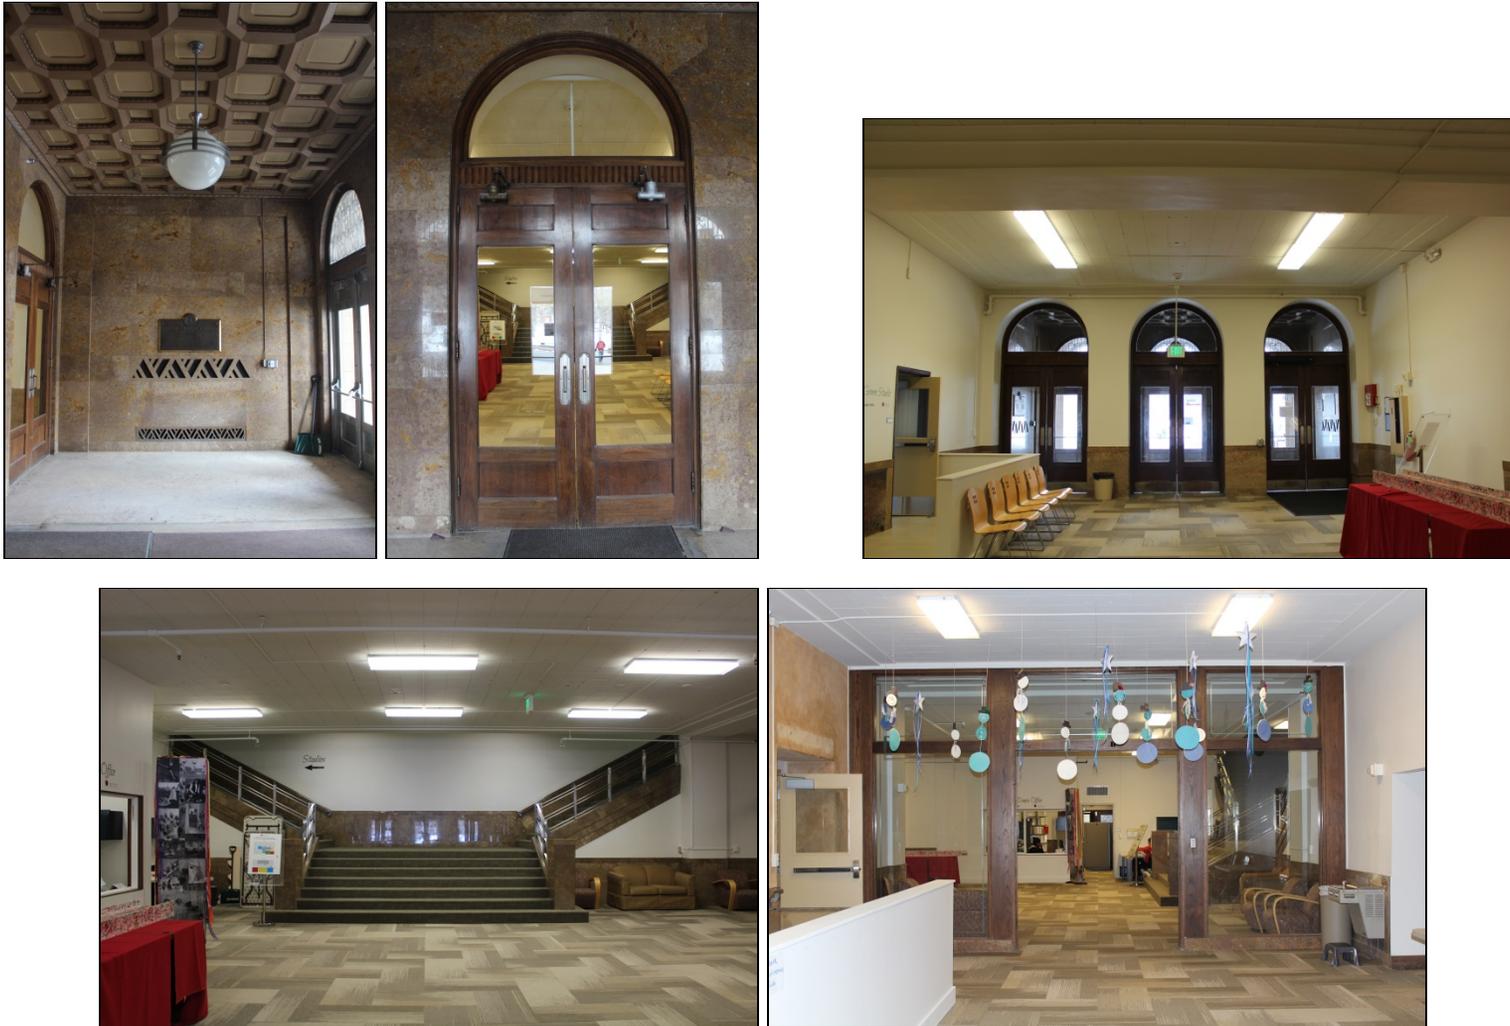
Figures 9a–9e. Top left to bottom right: Views of the a) vestibule (facing west); b) vestibule entrance doors (facing south); c) lobby and vestibule doors (facing north); d) main staircase (facing south); and e) partition doors in west arm of lobby (facing west).

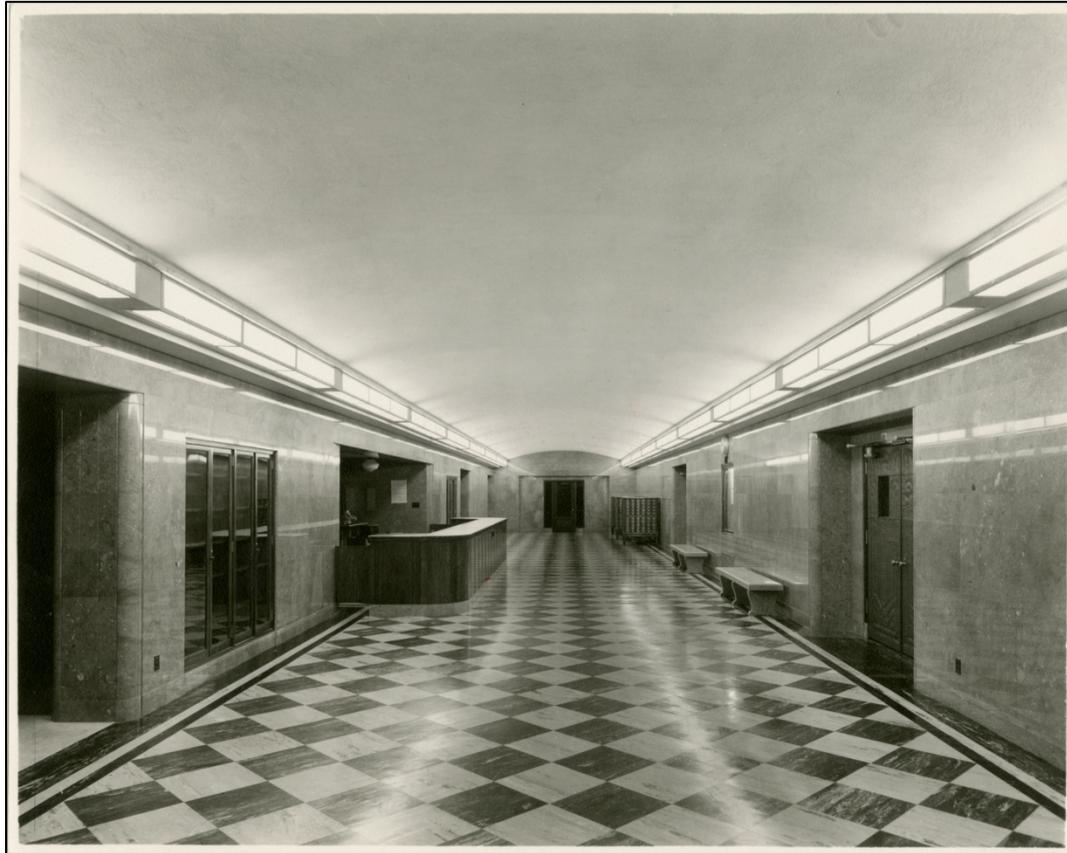
Figure 10a. View of the delivery hall on the second floor of the George Thomas Library c. 1935, facing west. The Main Reading Room is approached through the doors on the right. (Courtesy University of Utah Special Collections.)

The rectangular delivery hall is on the second floor of the George Thomas Building and lies at the head of the double staircase leading up from the lobby on the first floor (Figure 10a–10c and 11a–11d). Originally, books were requested at a desk set across a recess in the south wall; doors behind the desk led into the stacks wing, where books were retrieved and then delivered to patrons at the desk. Glass-fronted display cases were built into the walls on either side of the delivery desk. Two sets of doors on the north side of the hall led into the grand, vaulted main reading room. A doorway at the east end of the hall led into the periodical reading room and one at the west end provided access to offices. A corridor leading to a large cataloging and accessions room opened from the west end of the south wall. The space had no windows.
