**HISTORIC PRESERVATION PLAN
FOR THE
GEORGE THOMAS BUILDING
UNIVERSITY OF UTAH**

**Prepared by
Anne Oliver, M.S.**

September 19, 2013

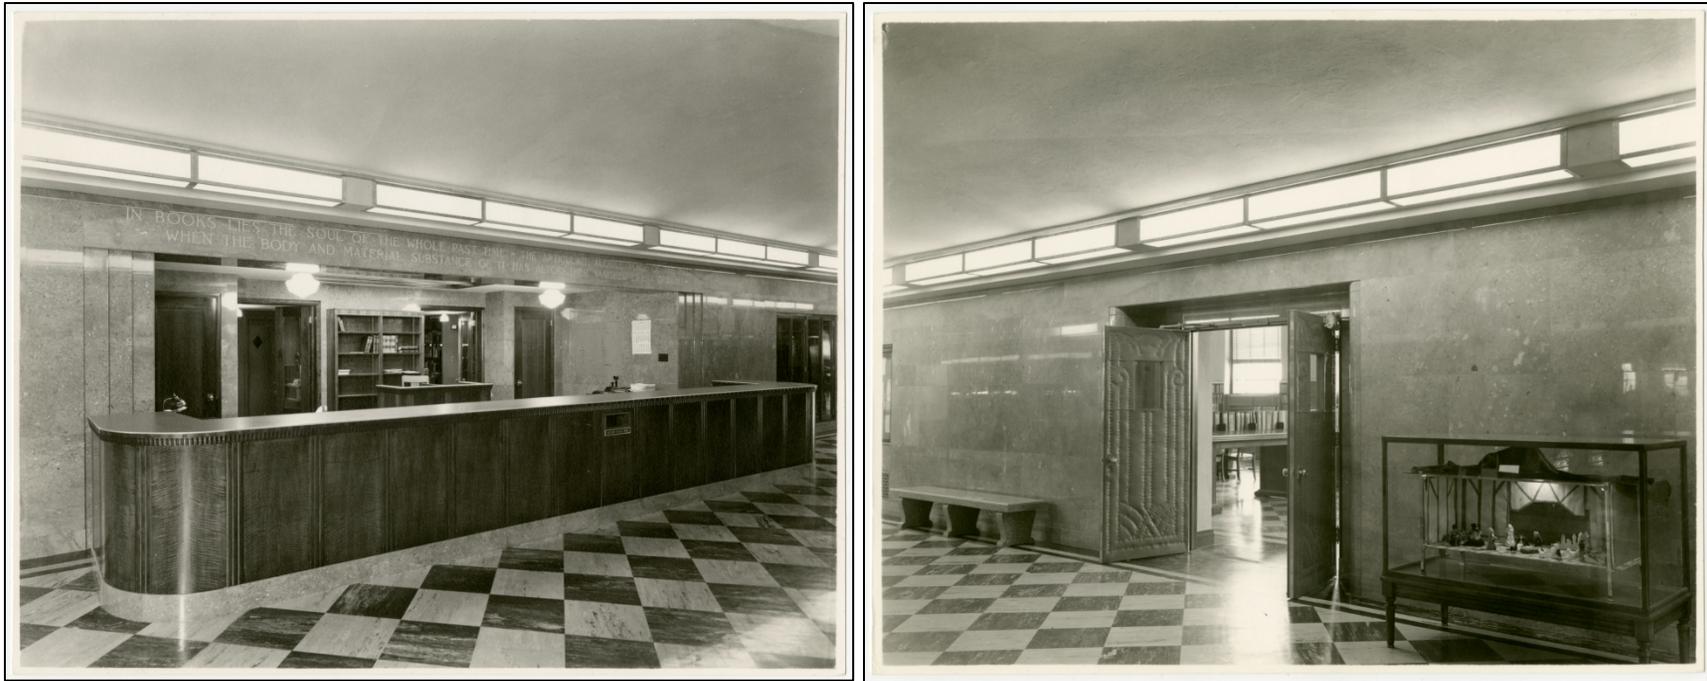
Figures 10b and 10c. Views of the delivery hall on the second floor of the George Thomas Library c. 1935, showing b) the delivery desk on the south side of the hall and c) the studded leather entry doors leading into the Main Reading Room on the north side of hall. (Courtesy University of Utah Special Collections.)

The rectangular delivery hall is on the second floor of the George Thomas Building and lies at the head of the double staircase leading up from the lobby on the first floor (Figure 10a–10c and 11a–11d). Originally, books were requested at a desk set across a recess in the south wall; doors behind the desk led into the stacks wing, where books were retrieved and then delivered to patrons at the desk. Glass-fronted display cases were built into the walls on either side of the delivery desk. Two sets of doors on the north side of the hall led into the grand, vaulted main reading room. A doorway at the east end of the hall led into the periodical reading room and one at the west end provided access to offices. A corridor leading to a large cataloging and accessions room opened from the west end of the south wall. The space had no windows.

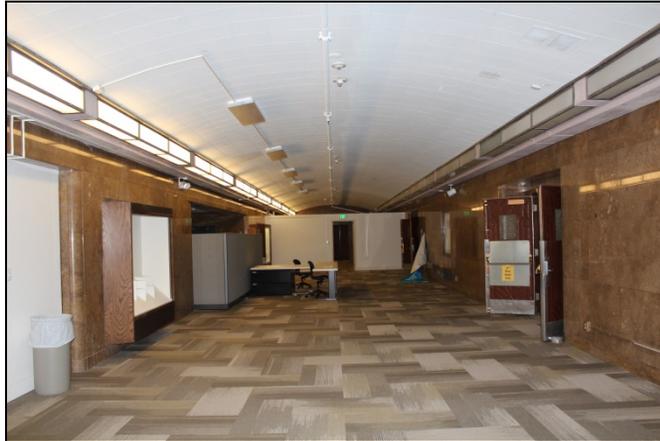
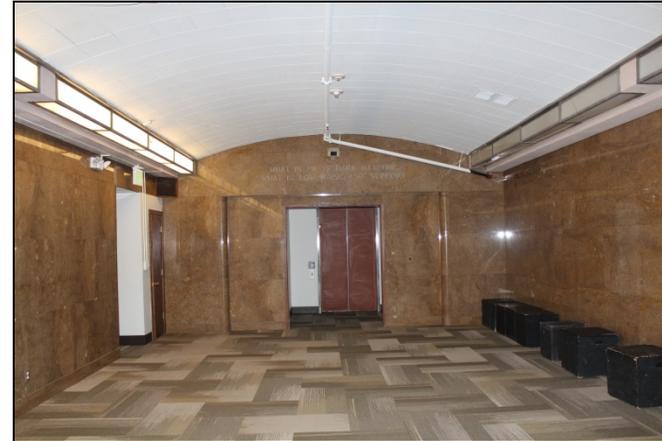
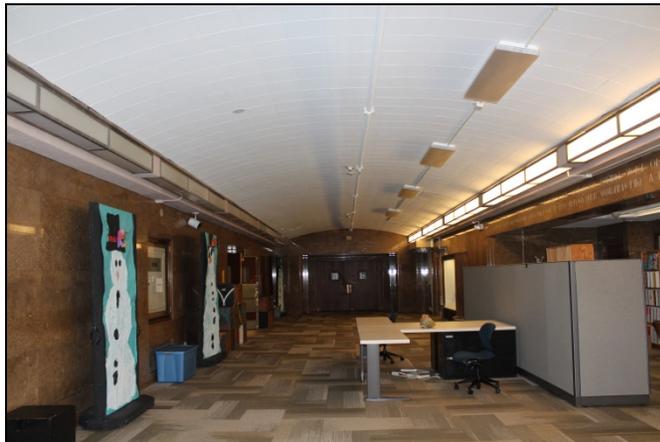
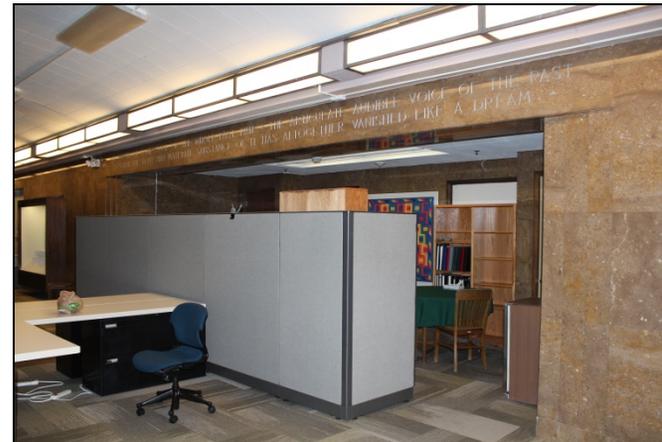
2013 Photographs – Delivery Hall

Figures 11a–11d. Top left to bottom right: Views of the a) delivery hall (facing west); b) west end of hall (facing west); c) delivery hall (facing east); and d) original delivery desk area at the center of the south wall (facing southeast).

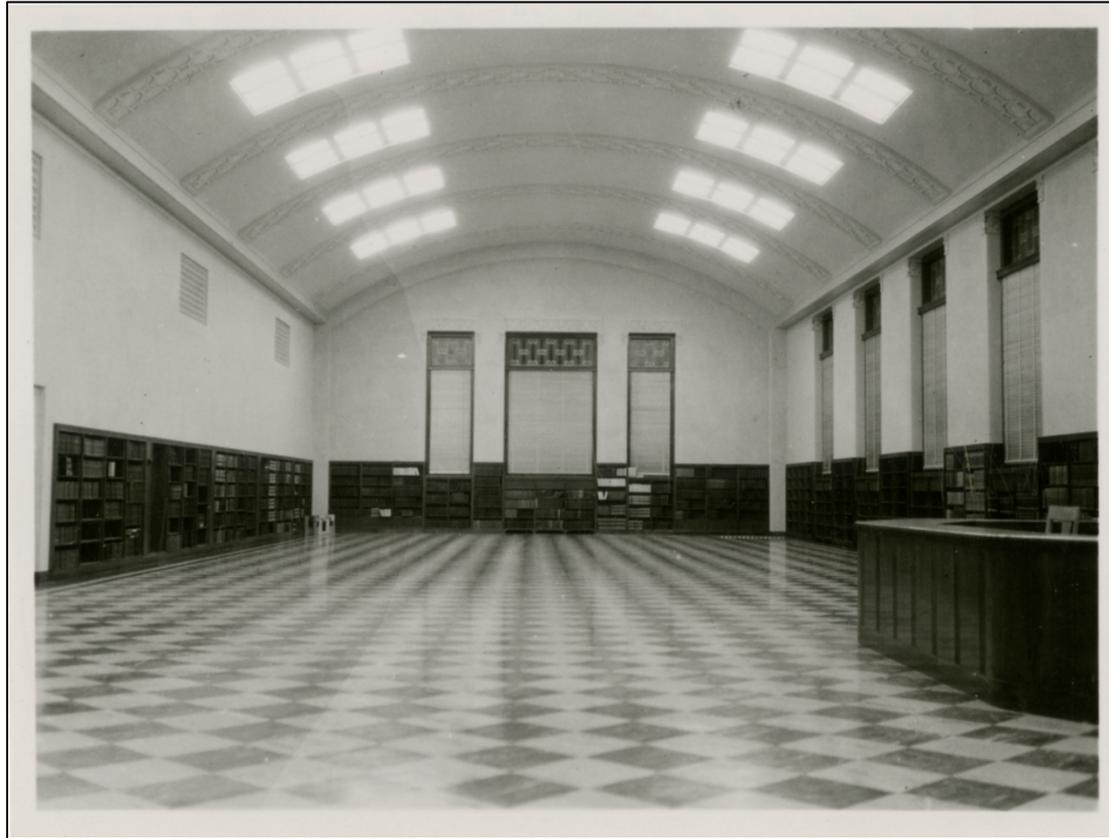
Figure 12a. View of the Main Reading Room in the George Thomas Library c. 1935, prior to the installation of furniture, facing west. (Courtesy University of Utah Special Collections.)

The rectangular main reading room is the most significant public area in the George Thomas Building and extends across the north side of the building on the second floor (Figures 12a–12f and 13a–13i). Originally, a librarian’s desk was located at the center of the north wall and the remainder of the space was filled with reading tables and chairs; by about the 1950s, the librarian’s desk had been moved to the south side of the room. The walls were lined with built-in bookcases and the space was lit by large windows set in the east, north, and west walls, as well as light panels recessed into the vaulted ceiling. Two doorways in the south wall led into the delivery hall and a third, at the east end of the south wall, led into the periodical room.

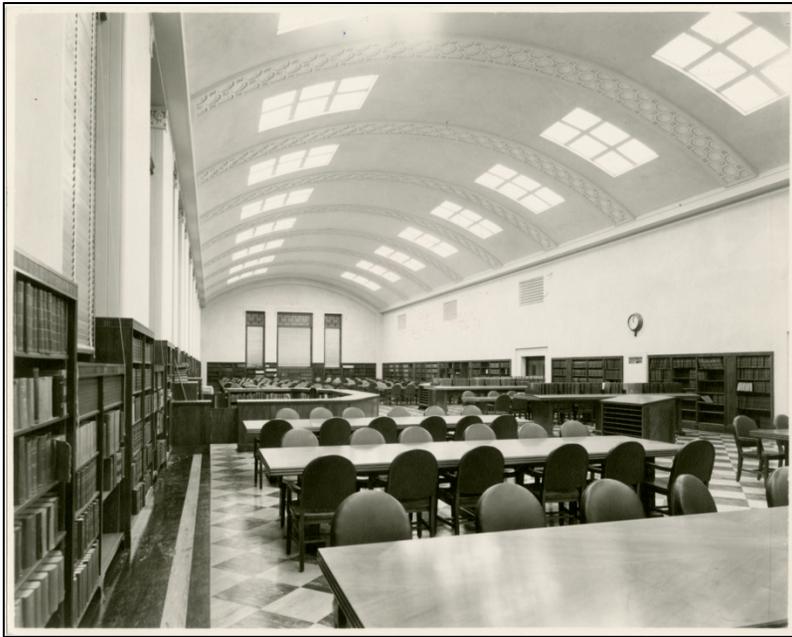
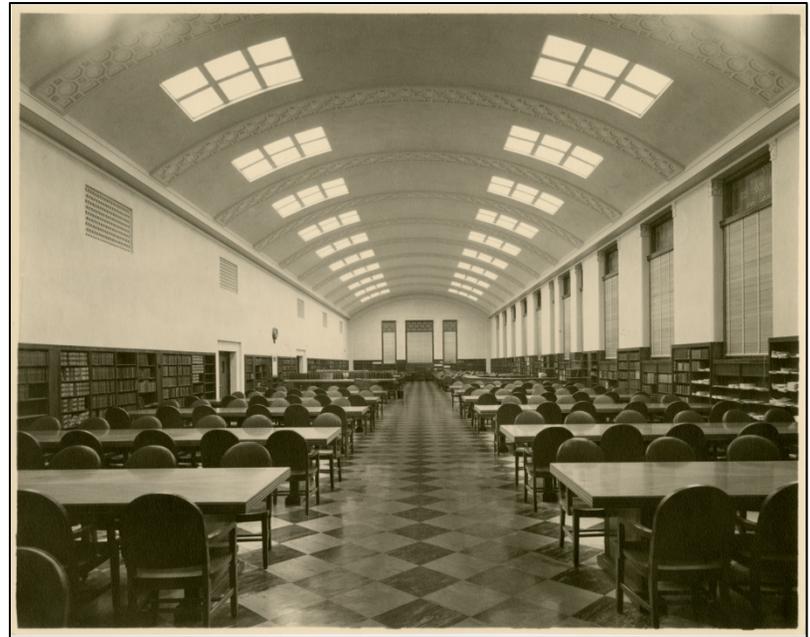
Figures 12b and 12c. From left to right: View of the Main Reading Room in the George Thomas Library c. 1935–1950, b) facing east and c) facing west. (Courtesy University of Utah Special Collections.)

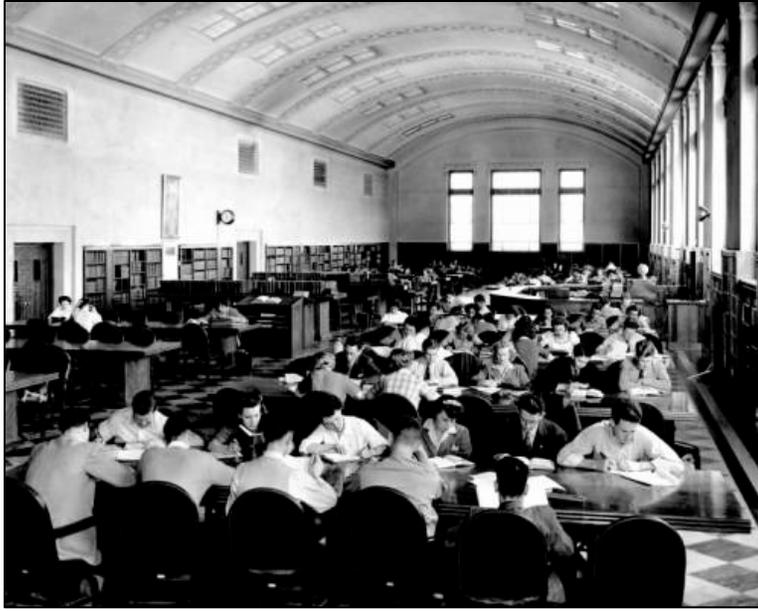
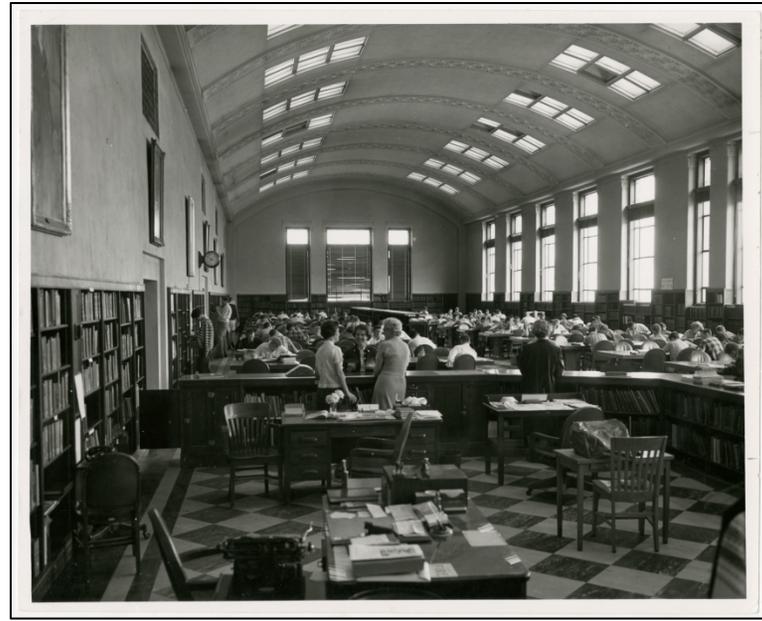
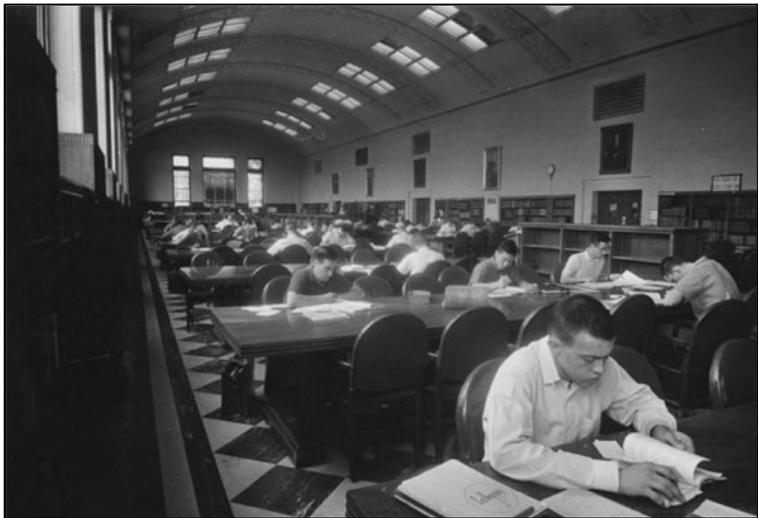
Figures 12d–12f. Top left to bottom left: Views of the Reading Room d) before the librarian’s desk was moved from the north to the south side of the room, c. 1935–1950, facing west, and e) after, c. 1950s, facing southwest and f) facing southeast. (Courtesy University of Utah Special Collections [d], University of Utah Health Sciences Collection [e], and Utah State Historical Society [f]).

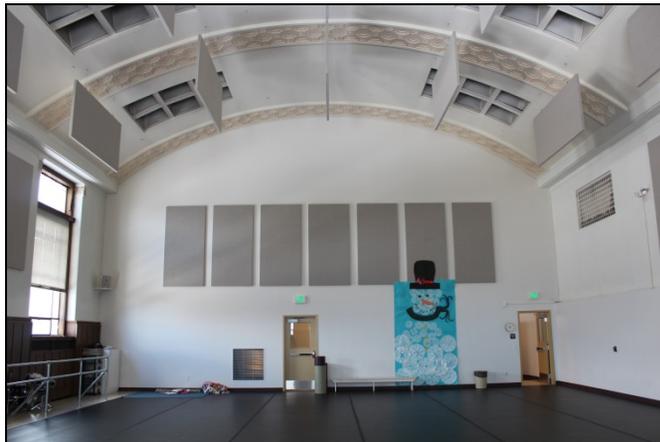
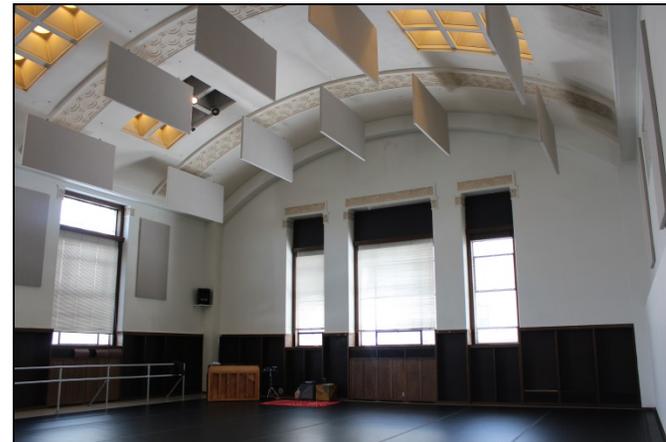
2013 Photographs – Main Reading Room

Figures 13a–13d. Top left to bottom right: Views of the main reading room a) at the west end (facing northwest); b) at the center (facing northwest); c) at the center (facing east); and d) at the east end (facing northeast).

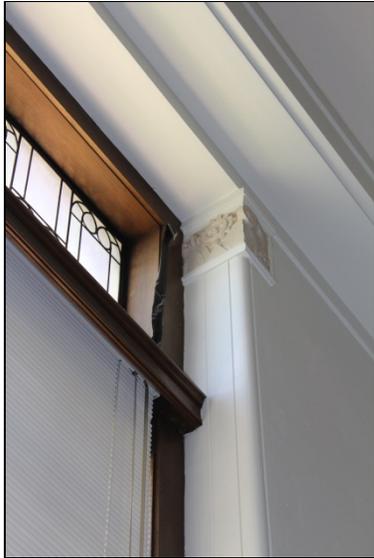
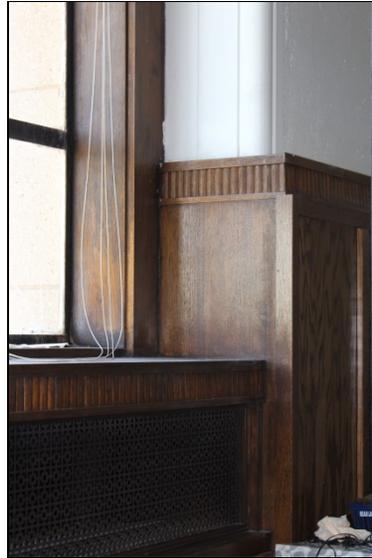
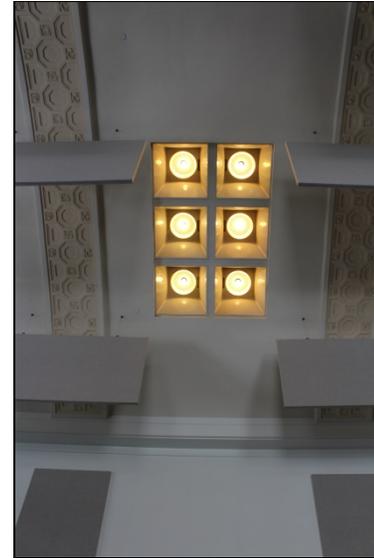
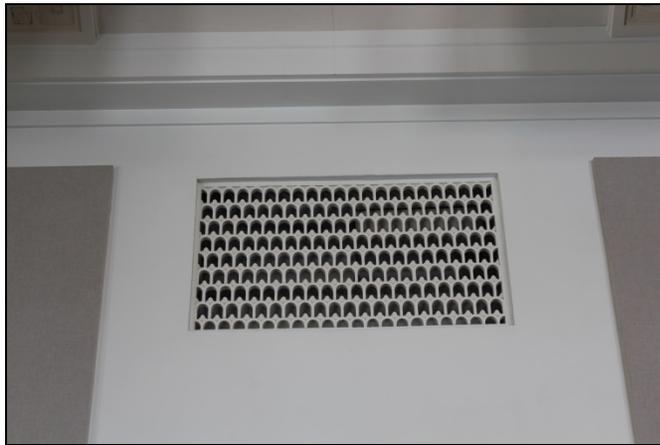
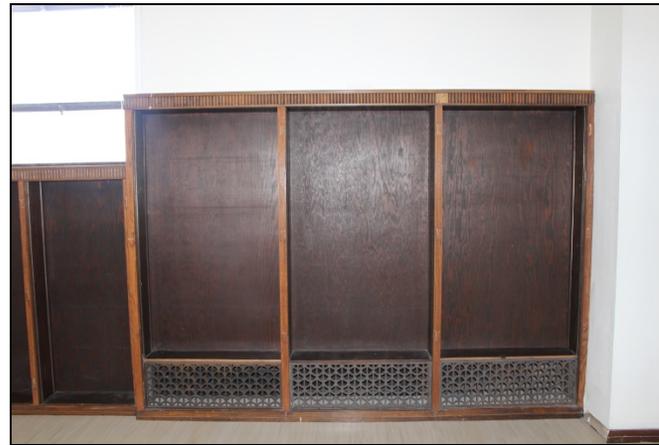
Figures 13e–13i. Top left to bottom right: Details of the main reading room, including a) window transom and reveal treatments; b) window casing and reveal treatments; c) original light recesses and decorative ceiling bands; d) an air return grate in the south wall; and i) original bookcases.

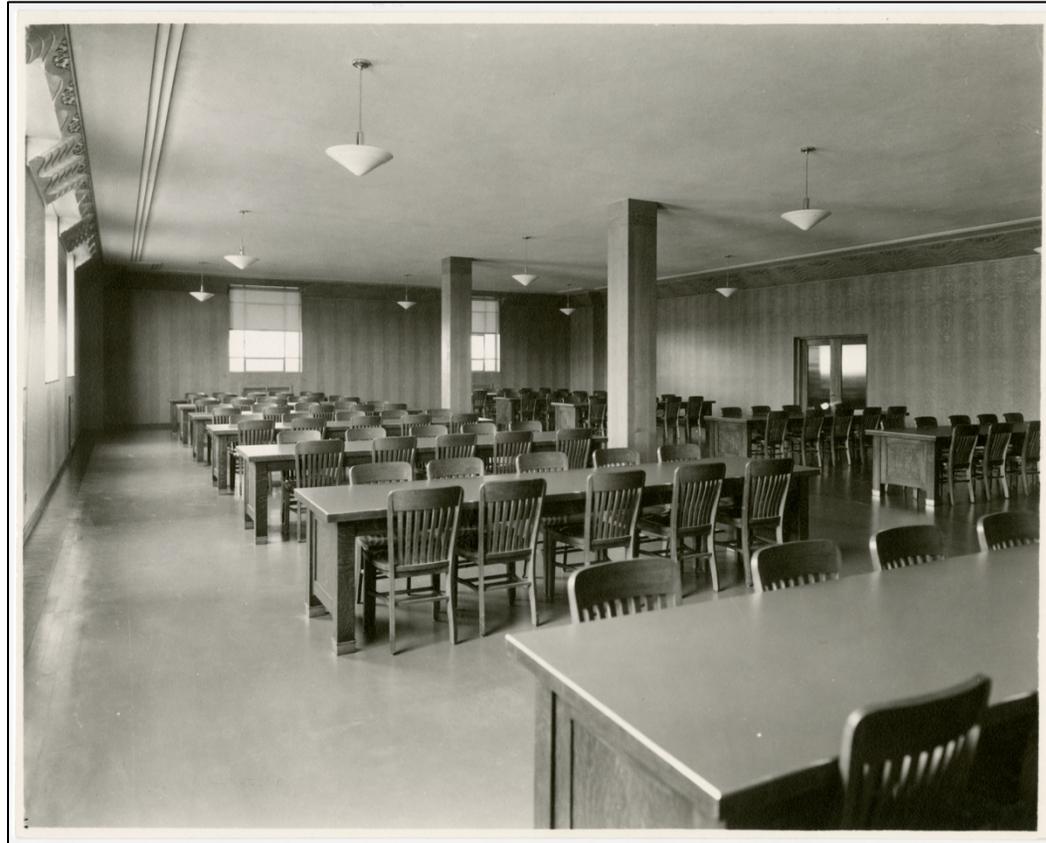
Figure 14. View of the reserve book reading room on the northeast corner of the first floor c. 1935, facing southeast. (Courtesy University of Utah Special Collections.)

The reserve book reading room in the northeast corner of the first floor is considered a secondary contributing space in the George Thomas Building (Figures 14 and 15a–15d). Originally, it was connected by double doors to the reserve book delivery desk in the east arm of the lobby and to a second reserve book reading room to the south. The room was lit by large windows and conical light fixtures depended from the ceiling. Furnishings were limited to tables and chairs.

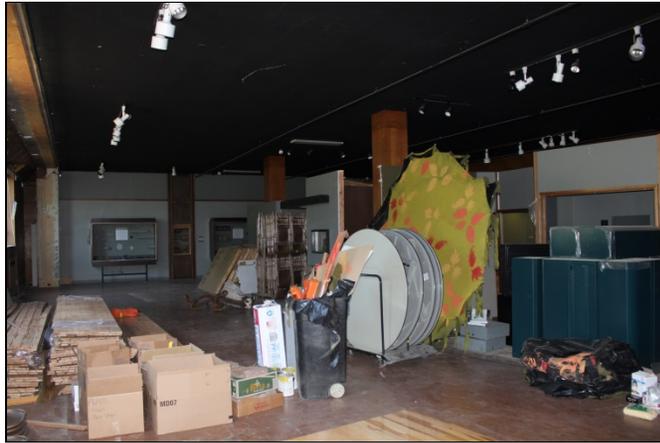
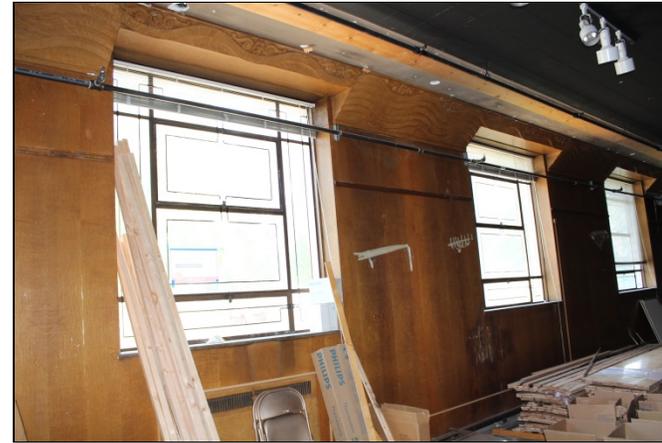
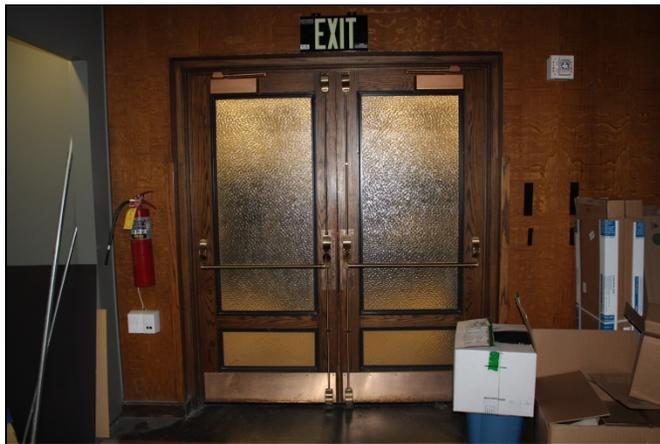
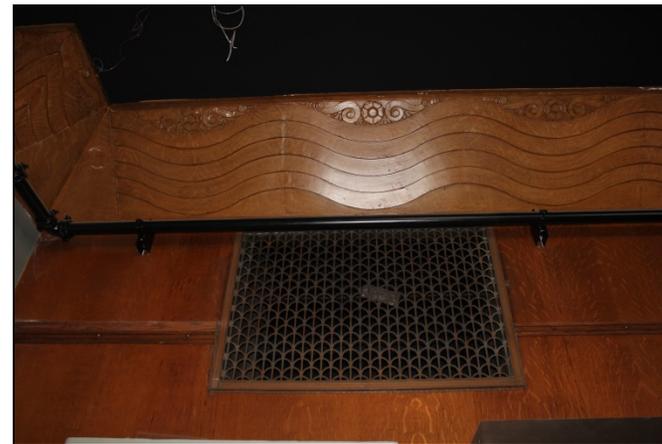
2013 Photographs – Reserve Book Reading Room (Northeast)

Figures 15a–15d. Top left to bottom right: Views of the reserve book reading room on the northeast corner of the first floor: a) general view (facing southeast); b) windows and cornice (facing northeast); c) paneling and doors to hallway (facing south); and d) air return grate and cornice (south wall).

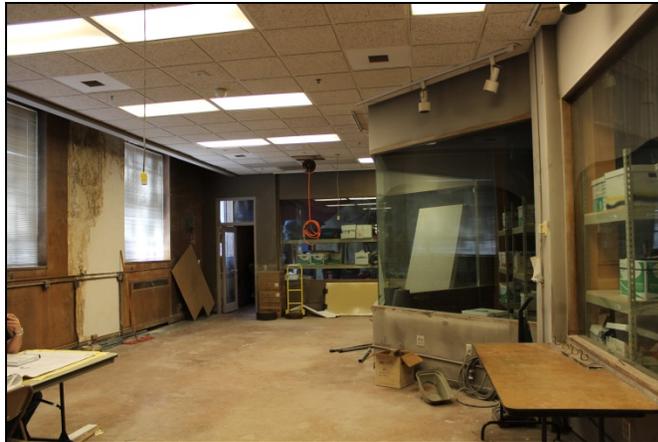
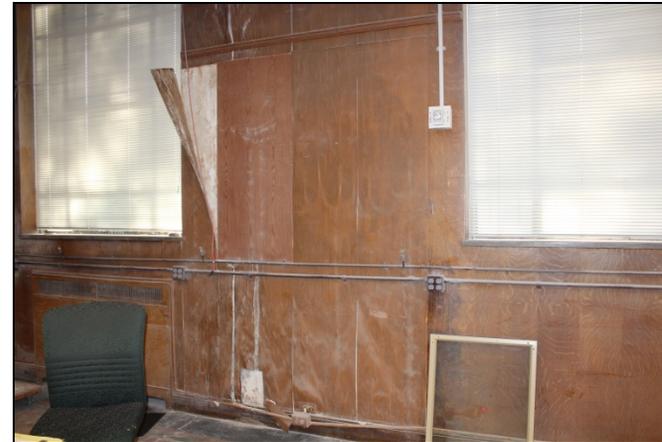
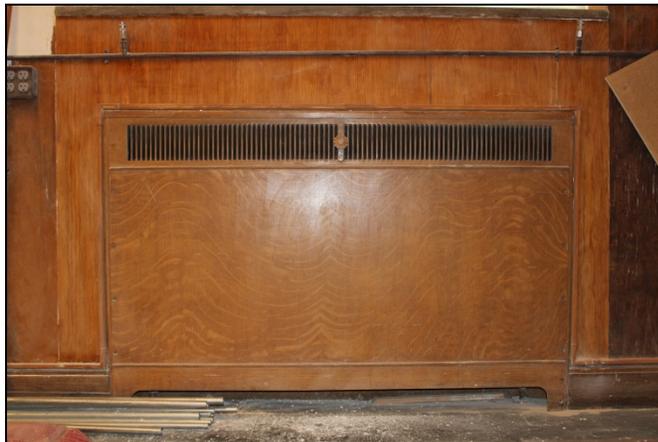
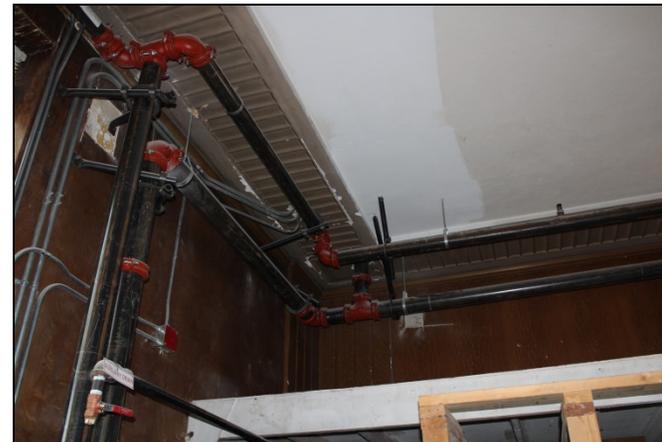
2013 Photographs – Reserve Book Reading Room (Southeast)

Figures 16a–16d. Top left to bottom right: Views of the reserve book reading room on the southeast corner of the first floor: a) general view (facing southeast); b) windows and damaged wall (facing northeast); c) wood-grained duct cover (facing east); and d) cornice and ceiling treatment (facing southeast).

The reserve book reading room in the southeast corner of the first floor is considered a secondary contributing space in the George Thomas Building (Figures 16a–16d). Originally, it was connected by double doors on the west wall to the reserve book delivery desk in the east arm of the lobby, and to the second reserve book reading room to the north. The room was lit by large windows in the east and south walls. No historic photographs were located but the room was likely furnished with tables and chairs in a manner similar to the northeast reserve book reading room.

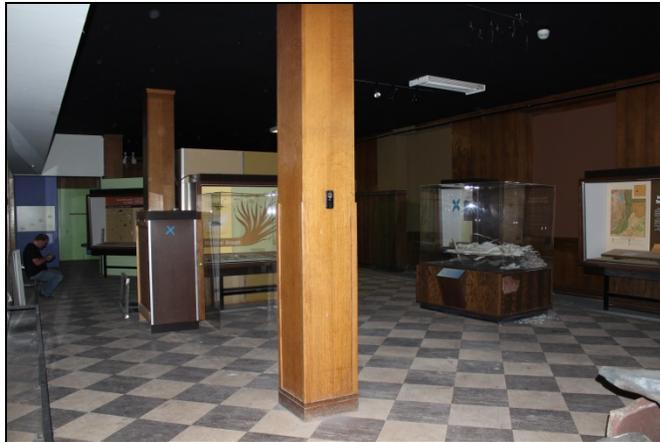
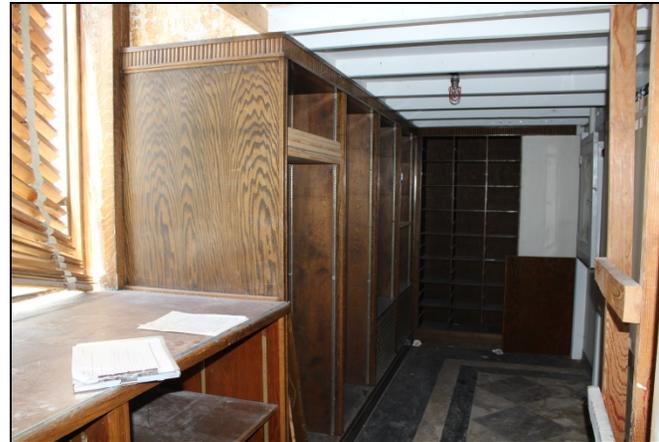
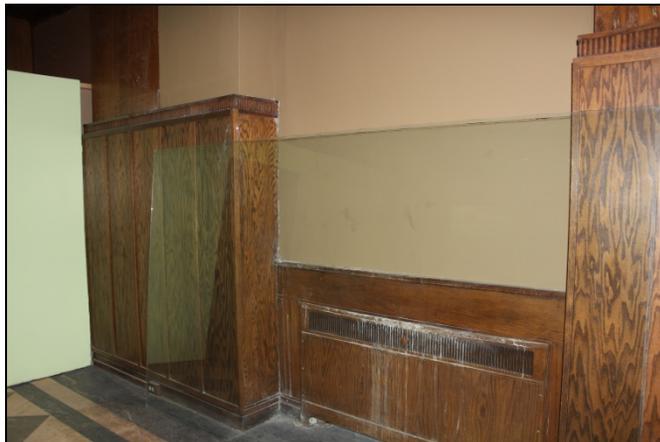
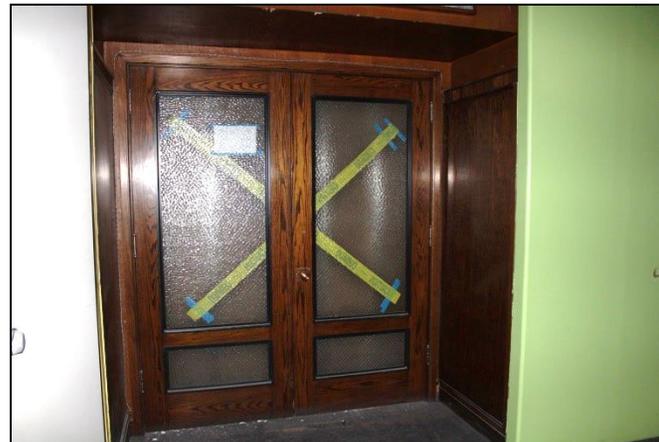
2013 Photographs – Periodical Room

Figures 17a–17d. Top left to bottom right: Views of the periodical room on the southeast corner of the second floor: a) general view (facing northeast); b) original window, wood blind, book cases and floor behind false wall on south end (facing west); c) wood-grained duct cover and possibly covered bookcases (facing northeast); and d) original doors leading into main reading room (facing north).

The periodical reading room in the southeast wing of the second floor is considered a secondary contributing space in the George Thomas Building (Figures 17a–17d). Originally, it was connected by double doors with sidelights on the west wall to the delivery hall and by double doors to the main reading room to the north. The periodical room was lit by large windows in the east and south walls. No historic photographs were located but the room was likely furnished with tables and chairs in a manner similar to the other reading rooms, and also had built-in wood bookcases and shelves lining most or all walls.

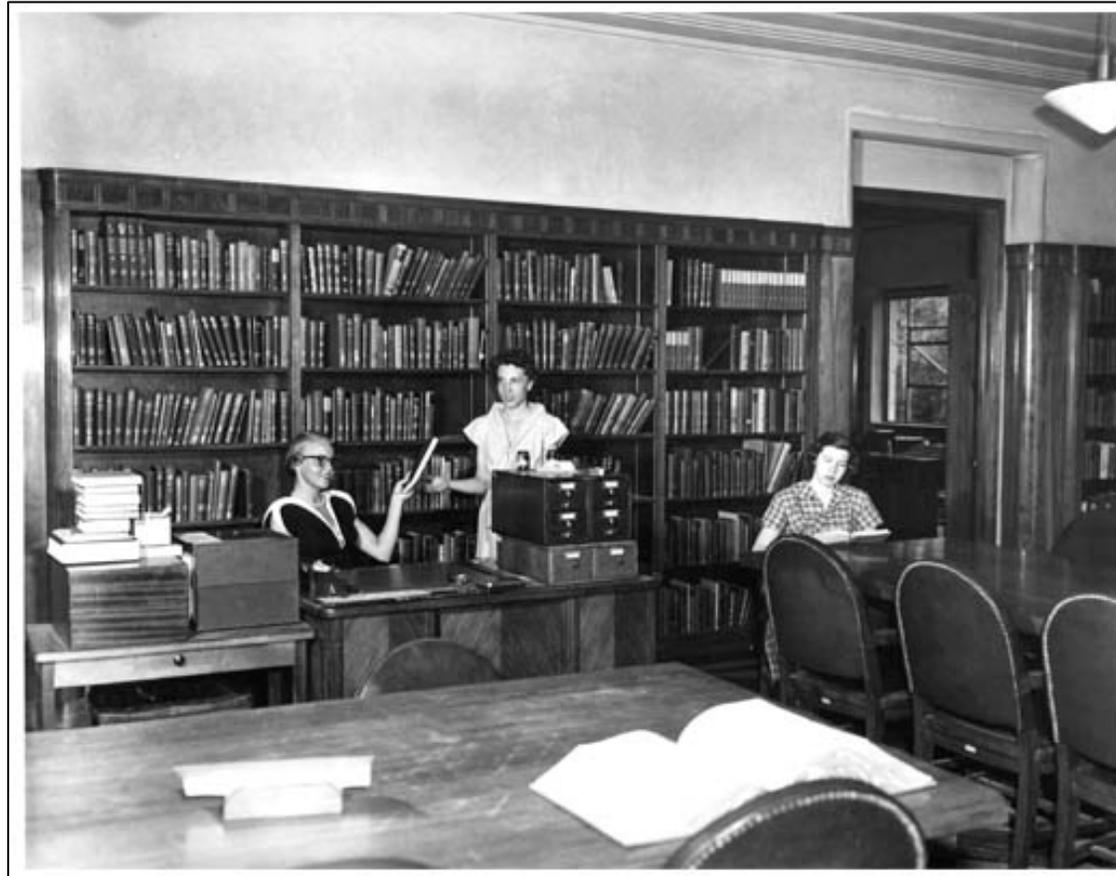
Figure 18. View of the Graduate Reading Room on the third floor c. 1950s, facing northeast. (Courtesy University of Utah Special Collections.)

Originally, two graduate reading rooms were located in the southeast wing on the third floor of the George Thomas Building (Figures 18 and 19a–19d). The south room, presently used as an office, is the more elaborate space and was likely the Edward Rosenbaum Memorial Library referenced in an early description (Federal Writers’ Project, 1941); it is considered a secondary contributing space. The walls were lined with built-in bookcases and the space was lit by windows set in the east, south, and west walls (the last overlooking the roof of the stacks wing). A doorway at the west end of the north wall gave access to the corridor while a second doorway near the center of the north wall, not shown in plans but apparently original, led into the graduate reading room to the north. Furnishings, some of which remain in the room, included reading tables, chairs, and a small librarian’s desk.

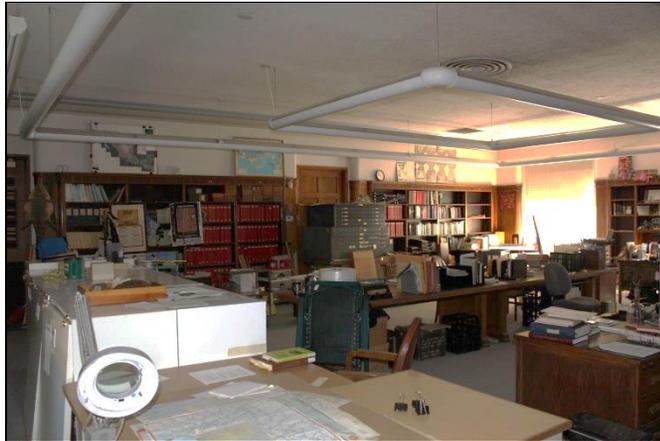
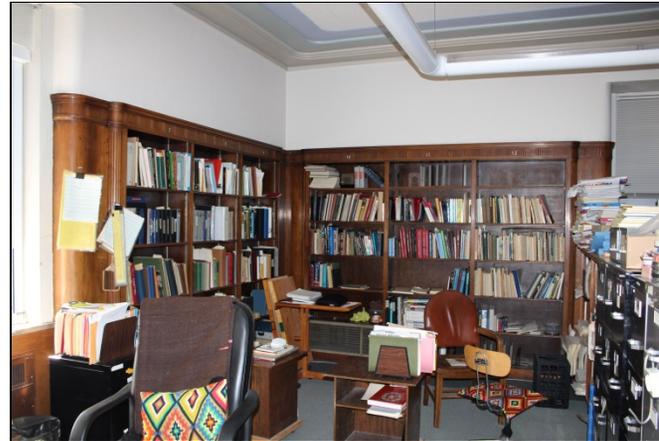
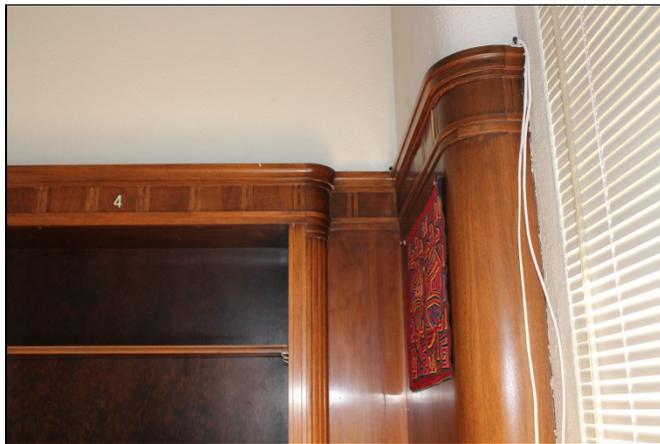
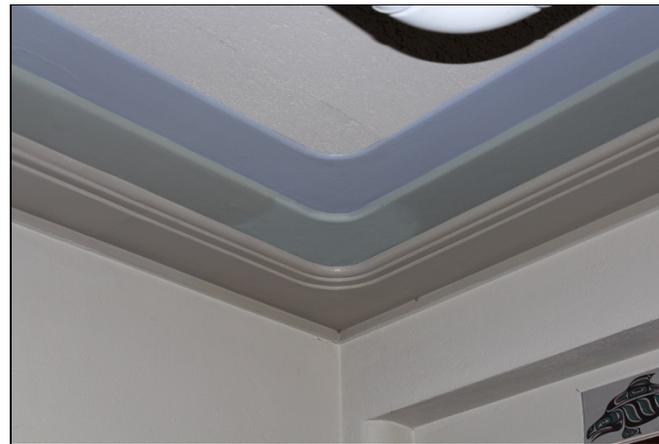
2013 Photographs – Graduate Reading Room

Figures 19a–19d. Top left to bottom right: Views of the graduate reading room on the southeast corner of the third floor: a) general view (facing northeast); b) original book cases (facing southeast); c) detail of bookcases (facing north); and d) detail of ceiling treatment (facing northwest).

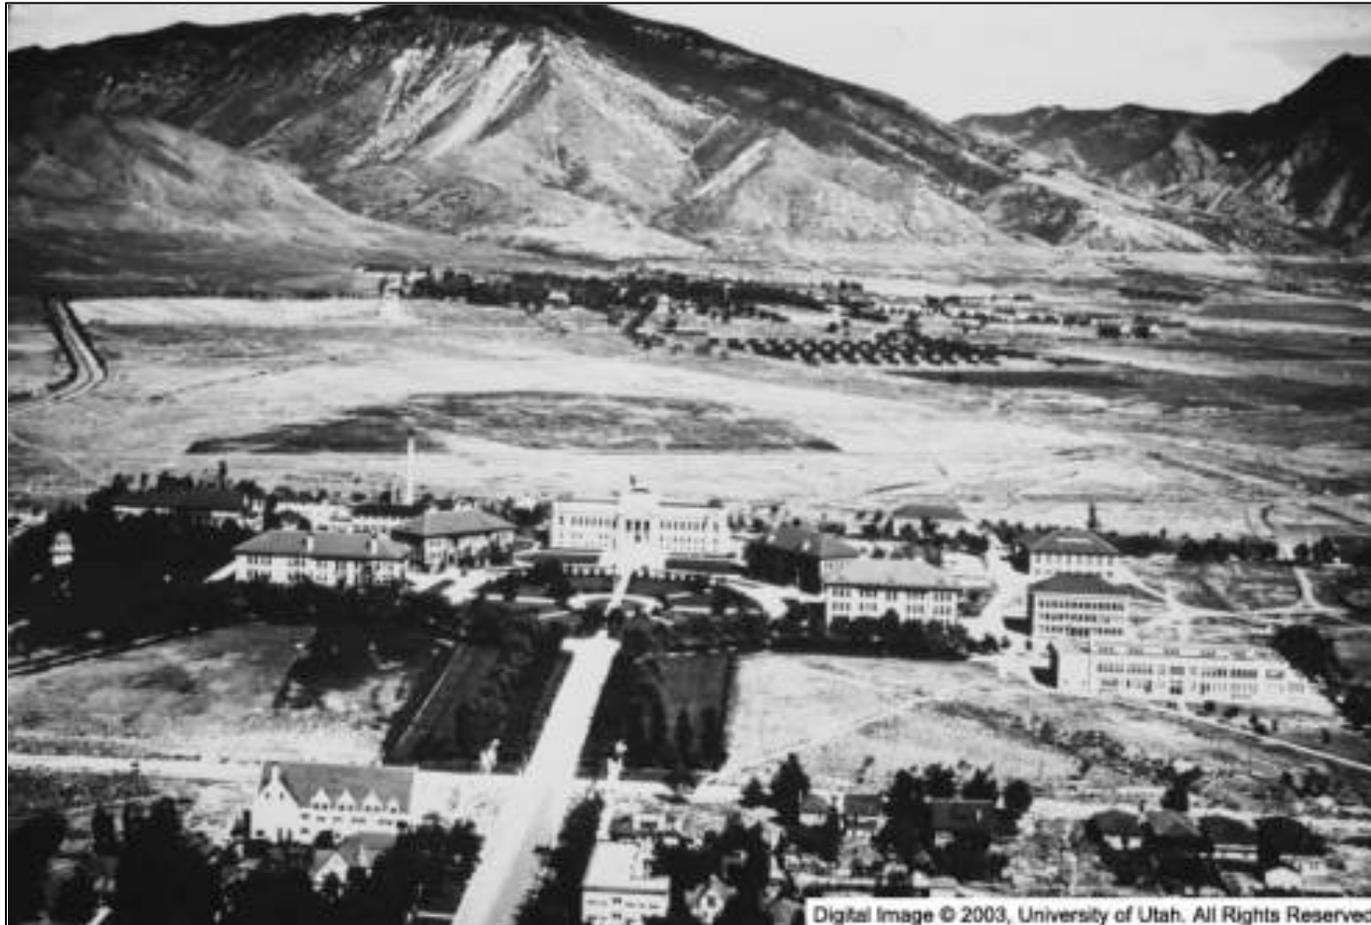
Figure 20a. Aerial view of University of Utah Circle with Cottam’s Gulch extending diagonally toward the bottom right of the photograph. The date is c. 1920–1932, after the construction of the Stewart Building and prior to construction of the George Thomas Library. (Courtesy University of Utah.)

Cottam’s Gulch is described in the “Historic Context and Significance” section of this report. In summary, it is a grass-covered gully extending southwestward from the George Thomas Building (Figures 20a–20b and 21a–21h). Built features include a stone walkway and staircase as well as a newer concrete, U-shaped planter. Trees in the gully and on the surrounding lawns were planted by Cottam and others beginning in the 1930s and most have reached maturity. Some trees are identified with metal or plastic nameplates on their trunks; circular concrete pads at the base of some trees are evidence of an earlier identification system.

None located. See historic aerial views for Cottam’s Gulch (Figures 20a and 20b).

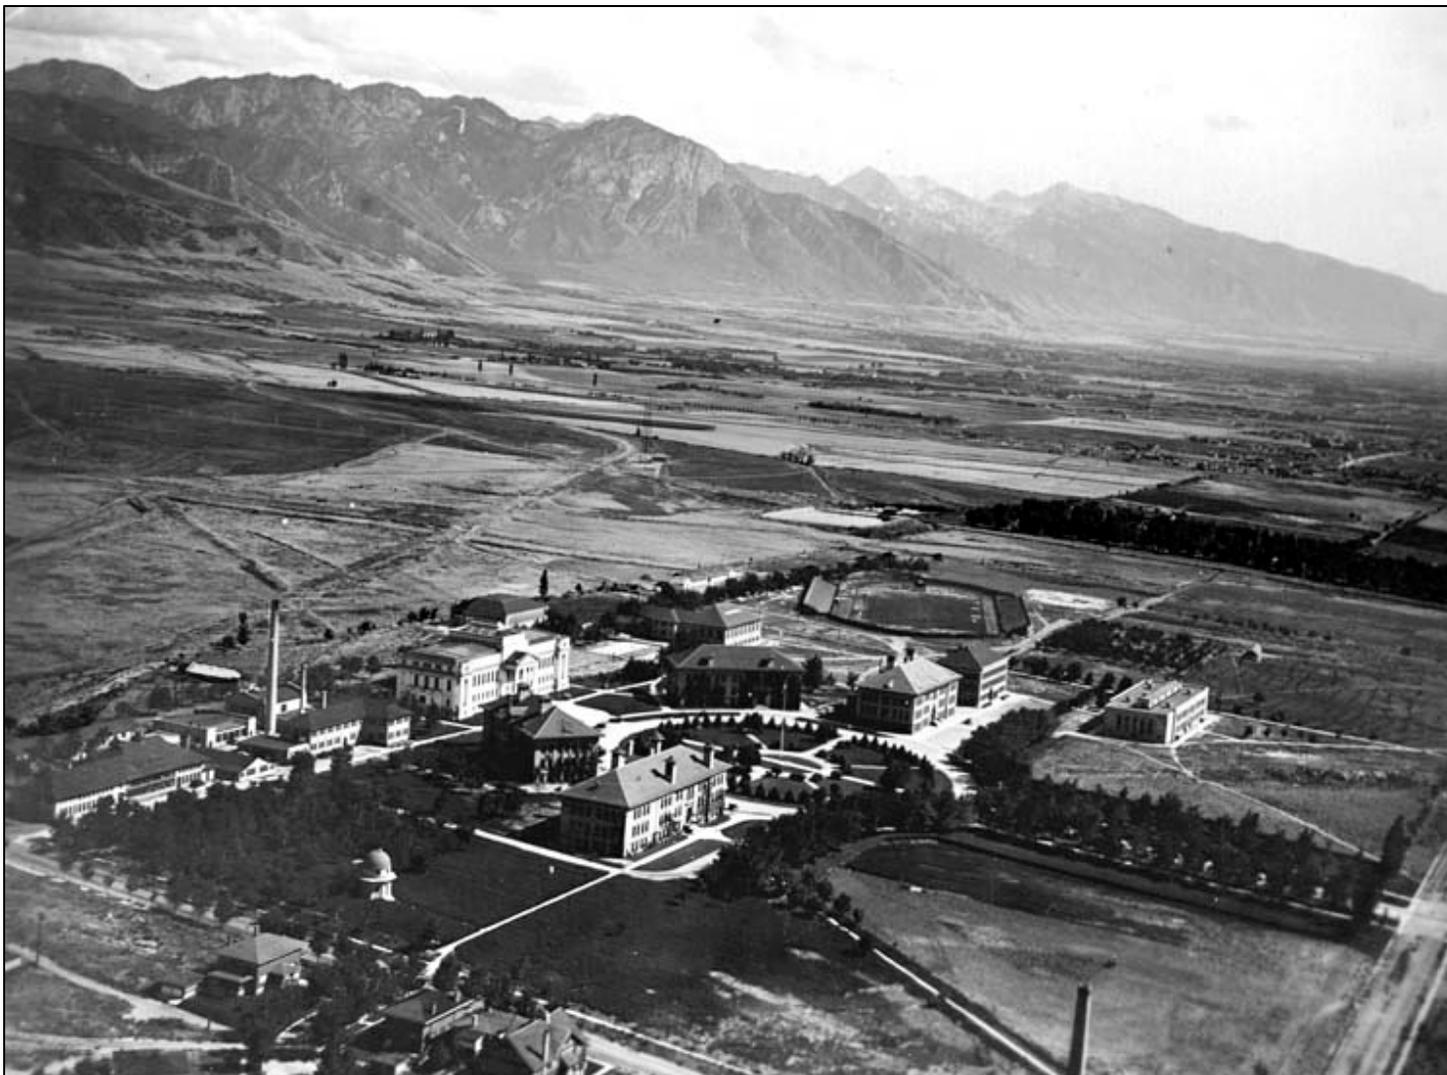
Figure 20b. Aerial view of University of Utah Circle facing southeast, with Cottam's Gulch extending toward the right side of the photograph. The date is c. 1920–1932, after the construction of the Stewart Building and prior to construction of the George Thomas Library. (Courtesy University of Utah.)

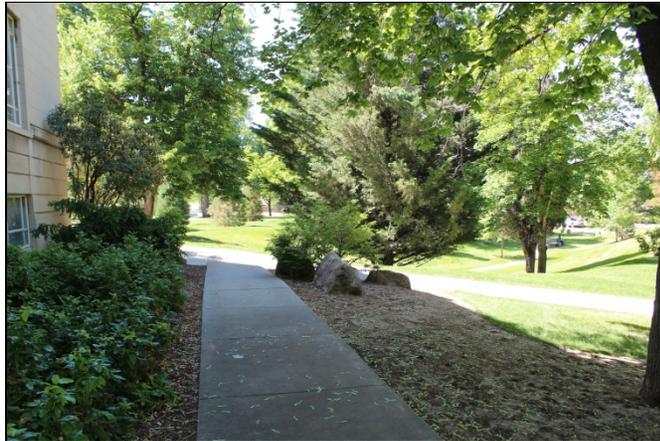
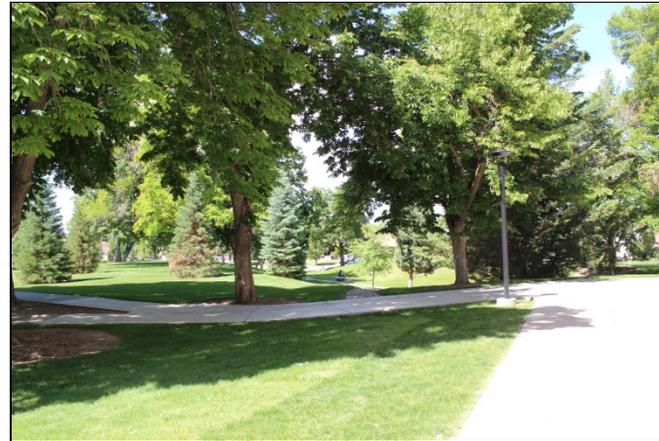
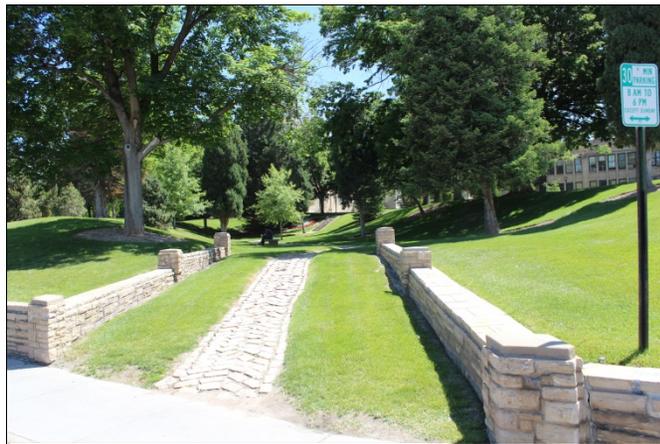
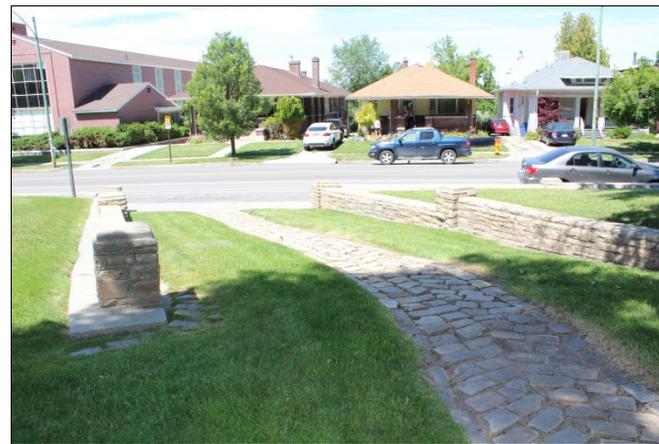
Figures 21a–21d. Top left to bottom right: Views of Cottam’s Gulch, including: a) general view from the west side of the George Thomas Building (facing south); b) general view from the south side of the George Thomas Building (facing west); c) view from University Street toward the George Thomas Building (facing northeast); and d) view toward University Street (facing west).

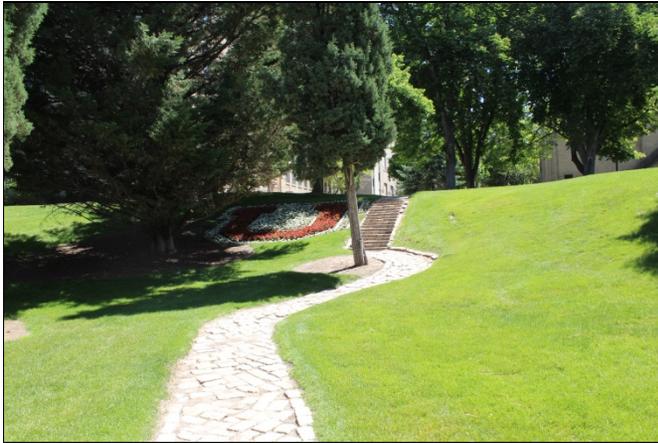
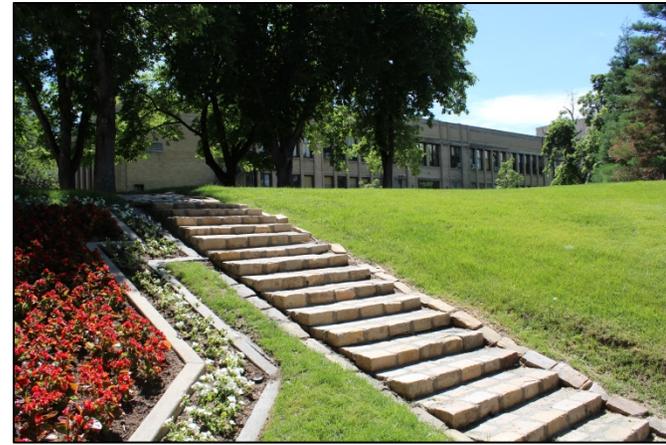
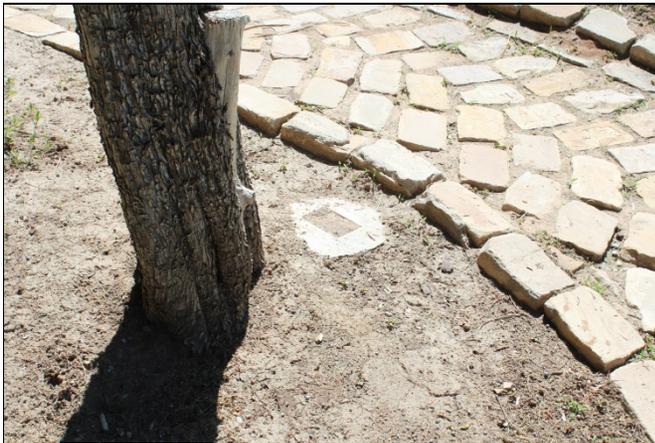
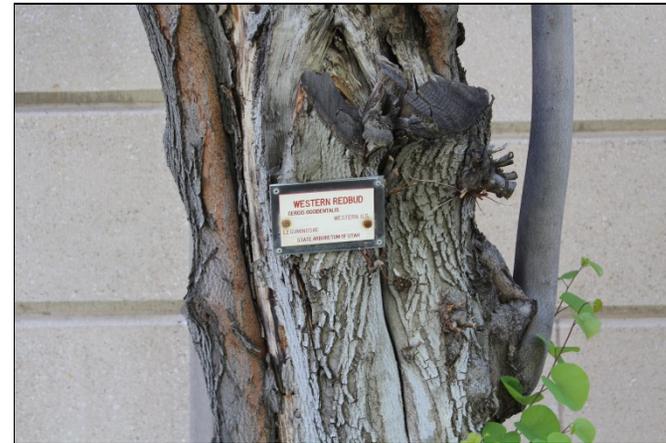
Figures 21e–21h. Top left to bottom right: Details of Cottam’s Gulch, including: e) the head of the gulch adjacent to the southwest corner of the George Thomas Building (facing northeast); f) the staircase and “U” planter at the head of the gulch (facing southeast); g) a disused in-ground concrete tree marker in the gulch; and h) an older tree label on a tree adjacent to the George Thomas Building.
