**HISTORIC PRESERVATION PLAN
FOR THE
GEORGE THOMAS BUILDING
UNIVERSITY OF UTAH**

**Prepared by
Anne Oliver, M.S.**

September 19, 2013

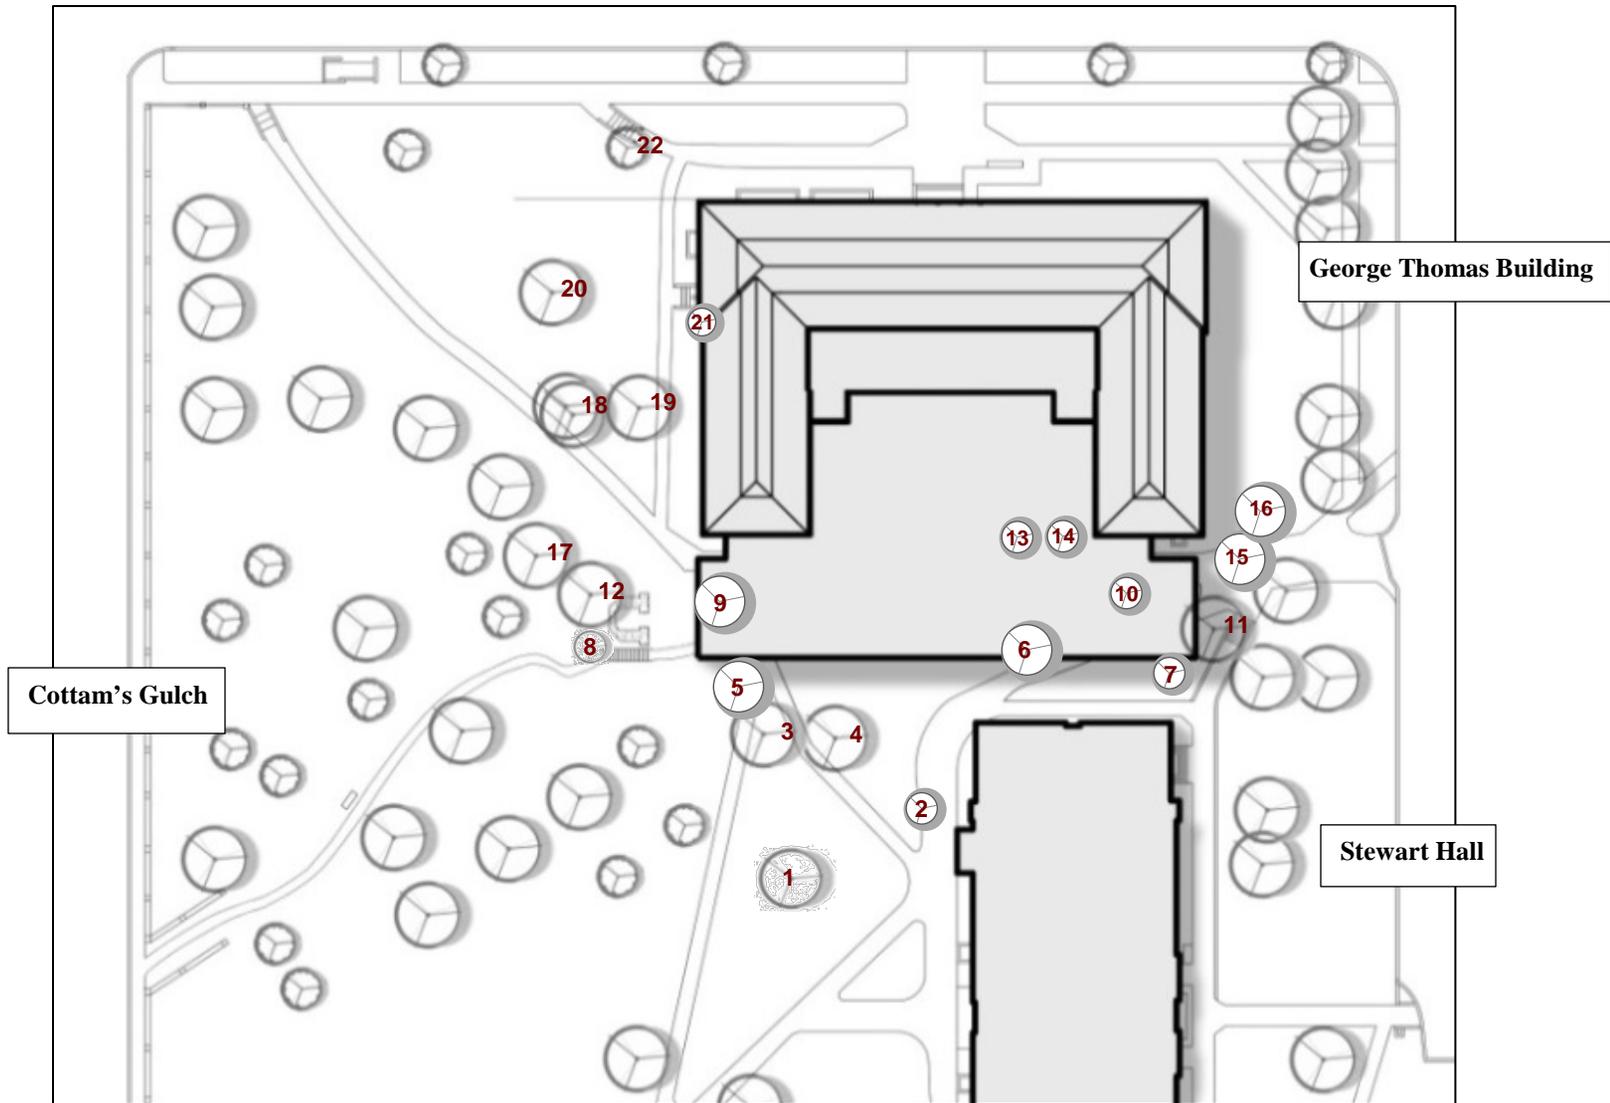
Figure 22. Plan of the landscaped area around the George Thomas Building with the proposed addition shown. The locations of existing trees that may be impacted by the addition or related construction activities are numbered. See Table 15 for available information on these trees.

Table 15. Existing trees adjacent to the George Thomas Building and/or Cottam's Gulch that may be affected by the proposed new addition and related construction activities for the Crocker Science Center. See Figure 22 for a plan of tree locations.

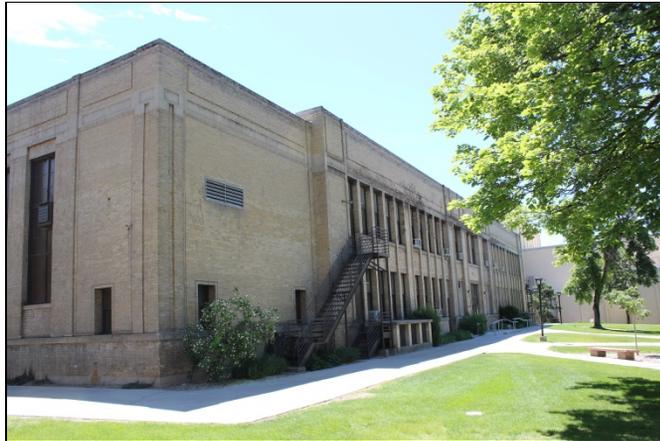
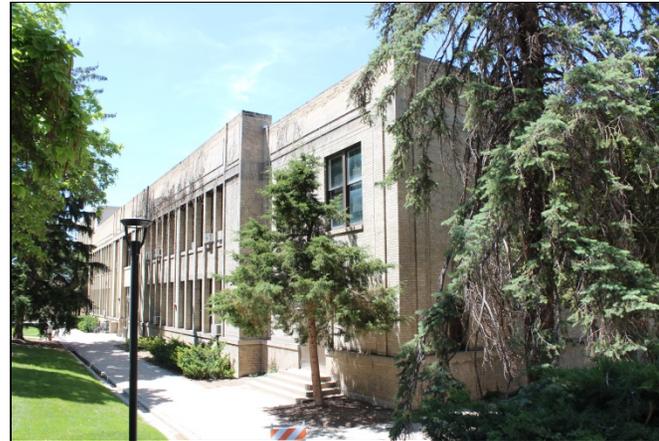
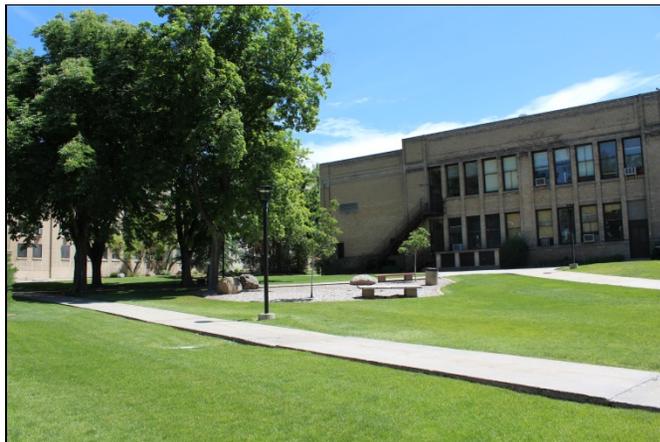
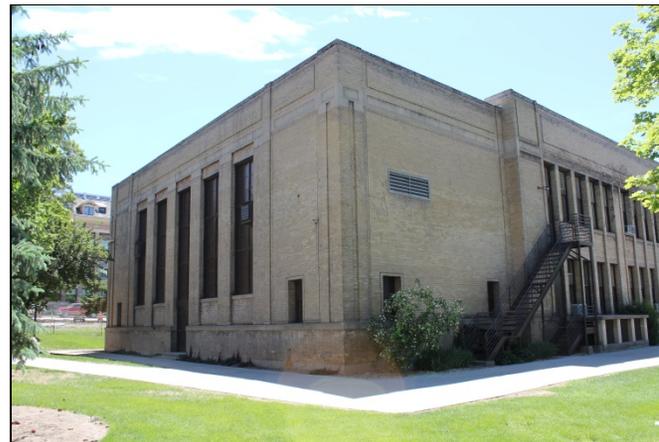
Figures 23a–23d. Top left to bottom right: Views of the Stewart Building, including: a) the west façade (facing southeast); b) the east façade (facing southwest); c) the north end of the building adjacent to the George Thomas Building (facing northeast); and d) detail of the north side and part of the west façade (facing southeast).

The Stewart Building is described in the “Historic Context and Significance” section of this report. In summary, it is a flat-roofed Neoclassical building with early Art Moderne details, built of pale yellow brick with concrete lintels and trim (Figures 23a–23d). The primary façades face east and west while the north side of the building, adjacent to the George Thomas Building, was originally a gymnasium and/or auditorium and is of secondary importance; all of its windows are presently painted over.
