ADDENDUM NO. 2

Reference: Electrical Distribution Upgrade – Camp Williams
Utah National Guard – Bluffdale, Utah
DFCM Project No. 07167480

**July 27, 2009
Utah National Guard
Camp Williams Electrical Power Distribution Upgrade
DFCM Project #07161480**

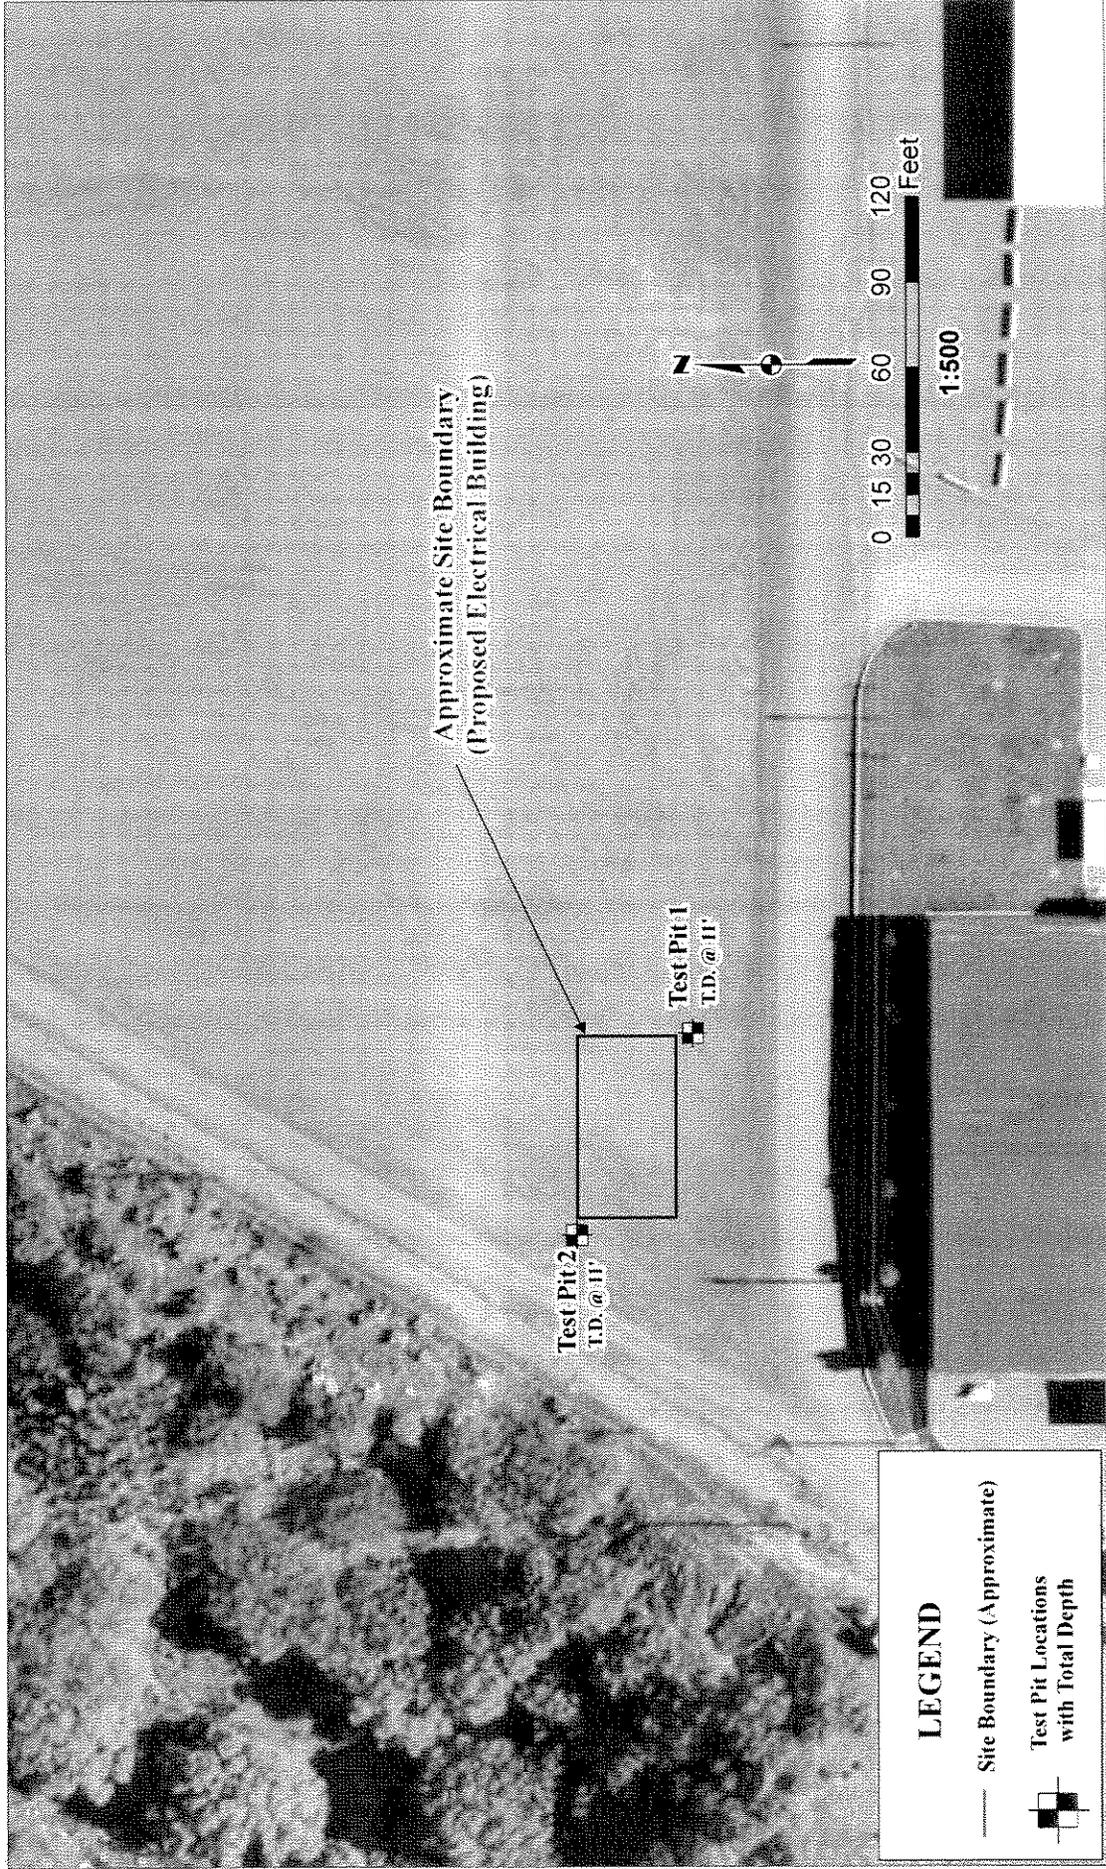
A-1

--- Site Boundary (Approximate)

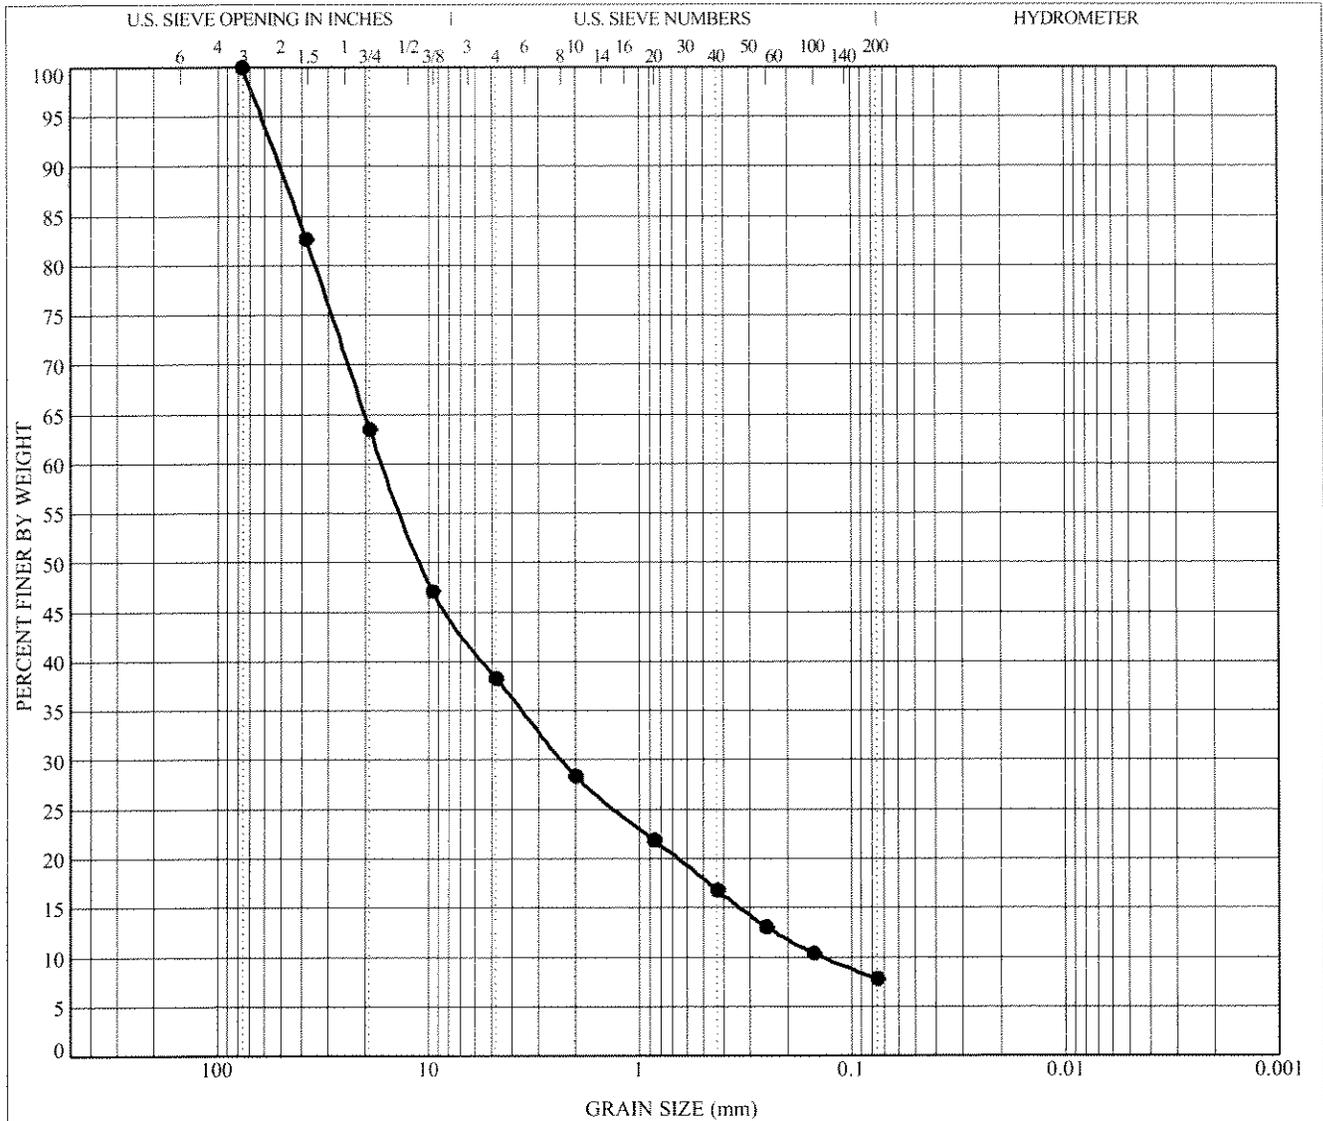
Plate
B - 2

COBBLES	GRAVEL		SAND			SILT OR CLAY
	coarse	fine	coarse	medium	fine

Sample Location	Depth	Classification	LL	PL	PI	Cc	Cu
● TP-1	5.0	Poorly Graded GRAVEL with sand (GP)				2.39	121.86

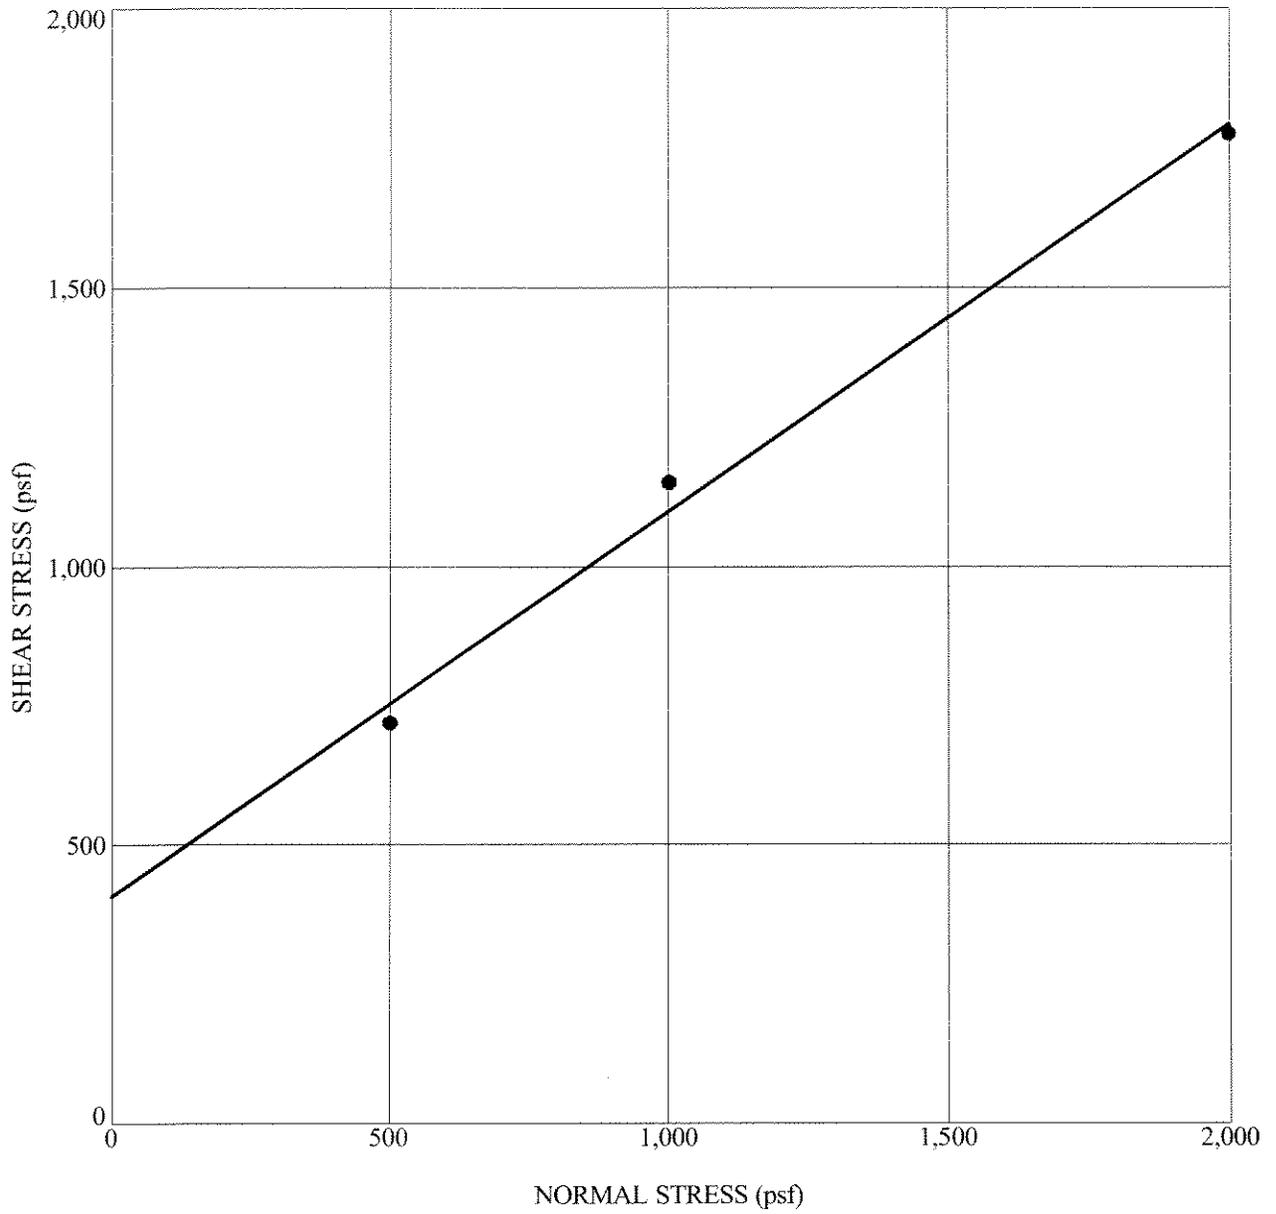
B DIRECT SHEAR CAMP WILLIAMS 01273-002.GPJ IGES.GDT 6/25/09

Sample Location	Depth (ft)	Classification	γ_d (pcf)	MC (%)	c (psf)	ϕ (deg)
● TP-2	3.5	Sandy SILT with trace gravel (ML)	83.8	22	408	35

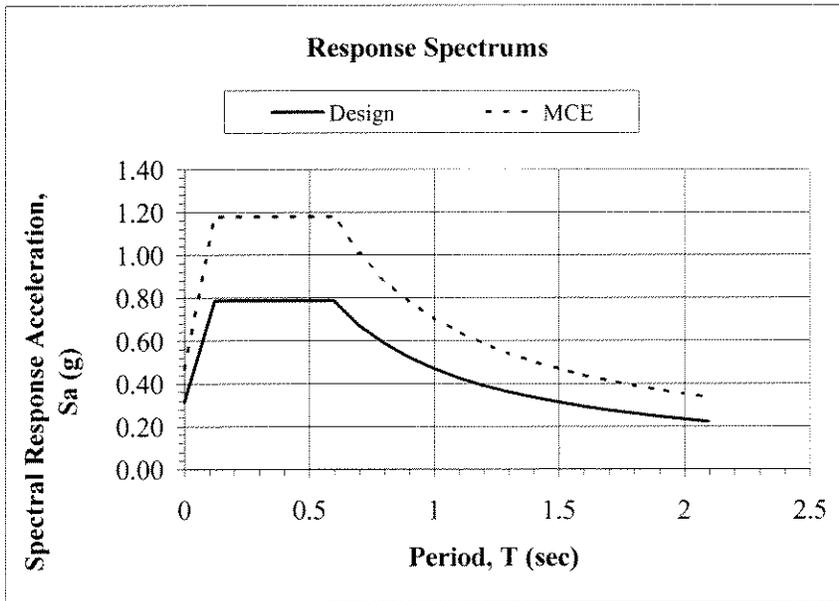
$S_{DS} = 0.786$ $S_{DS} = 2/3 * S_{MS}$ *The design spectral response acceleration
 $S_{D1} = 0.470$ $S_{D1} = 2/3 * S_{M1}$ at short and 1-second periods

$T_0 = 0.120$ $T_0 = 0.2 * S_{D1} / S_{DS}$
 $T_s = 0.598$ $T_s = S_{D1} / S_{DS}$ C
 $\Delta T = 0.1$ Time step for diagram

T (sec)	Sa (g)	Sa (MCE) (g)
0	0.31	0.47
0.12	0.79	1.18
0.60	0.79	1.18
0.70	0.67	1.01
0.80	0.59	0.88
0.90	0.52	0.79
1.00	0.47	0.71
1.10	0.43	0.64
1.20	0.39	0.59
1.30	0.36	0.54
1.40	0.34	0.50
1.50	0.31	0.47
1.60	0.29	0.44
1.70	0.28	0.42
1.80	0.26	0.39
1.90	0.25	0.37
2.00	0.24	0.35
2.10	0.22	0.34

Using the criteria outlined in the 2006 IBC, the maximum considered earthquake (MCE) ground motion is taken as that motion represented by an acceleration response spectrum having a 2% chance of exceedance within a 50-year period (Section 1613.5). This hazard was assessed for the site using the Java Application Ground Motion Parameter Calculator – Version 5.0.9 developed by the USGS located on their website at <http://earthquake.usgs.gov/research/hazmaps/design/>, which correlates with the International Building Code (2006 IBC) seismic hazard maps. This program, as with the IBC maps, is used to develop the probabilistic spectral accelerations corresponding to MCE seismic hazard level for rock-like conditions. To account for site soil effects, site coefficients (F_a and F_v) were used to attenuate the rock-based spectral acceleration values. Based on our observations of soils at the site, it is our opinion that the soils at this site are representative of a “stiff soil” profile; best described by IBC Site Class D with F_a and F_v values of 1.05 and 1.54, respectively. From these procedures the MCE PGA was established to be 0.47g. The MCE and Design response spectrum are presented on Plate C-1 in Appendix C. The following table presents response accelerations for 0.2 and 1.0 second periods.

^a 2006 IBC recommends scaling the MCE values by 2/3 to obtain the design spectral response acceleration values.

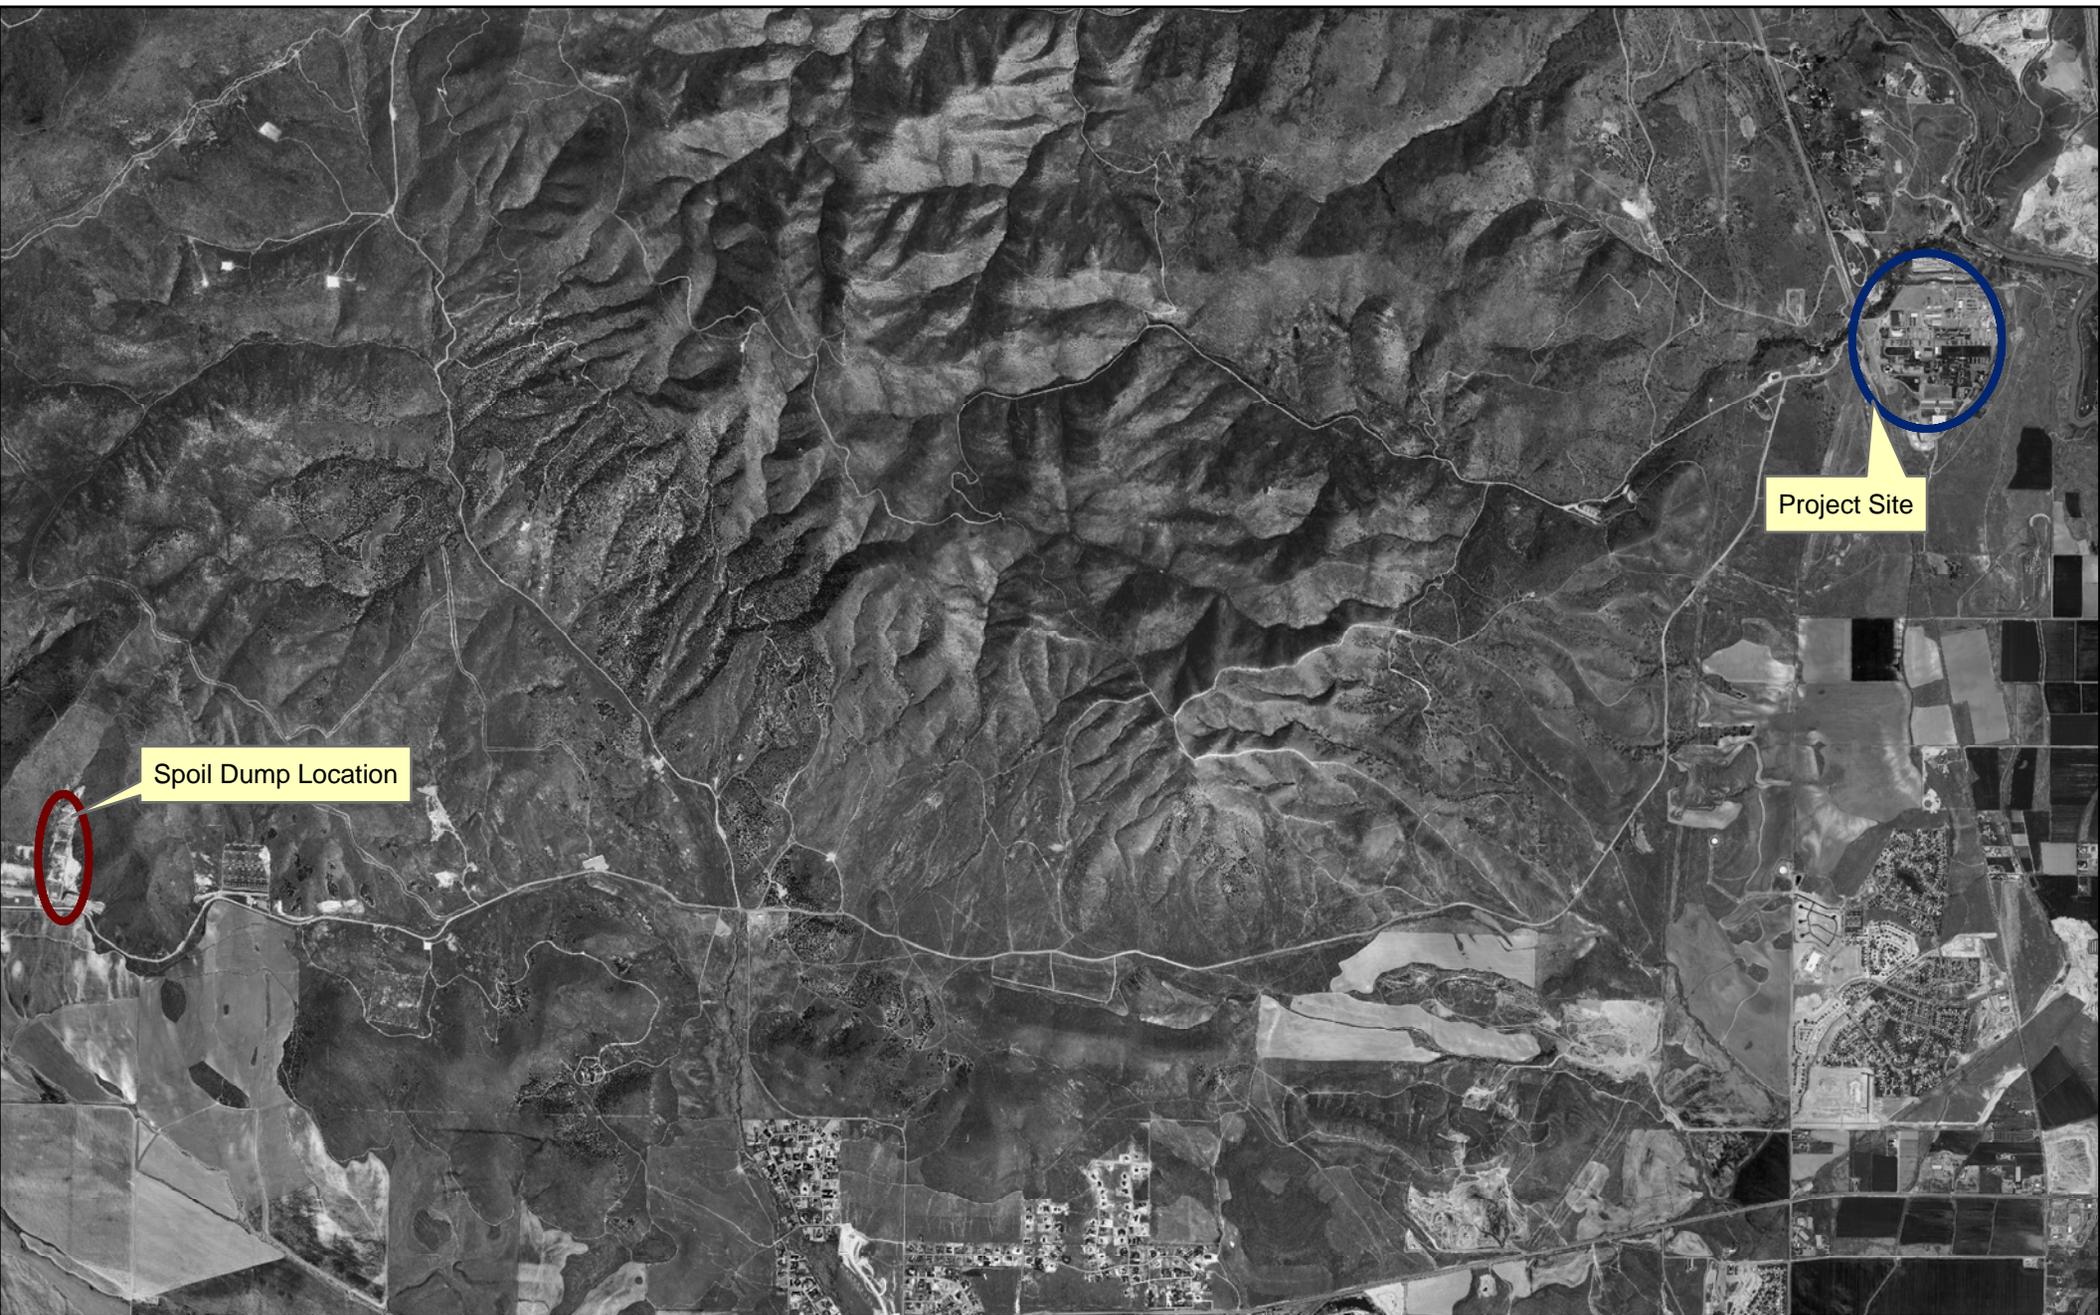
Spoil Dump Location

Project Site

It is approximately 10 miles from Redwood Rd via a graded gravel road.

All asphalt and or concrete must be disposed of off the installation.

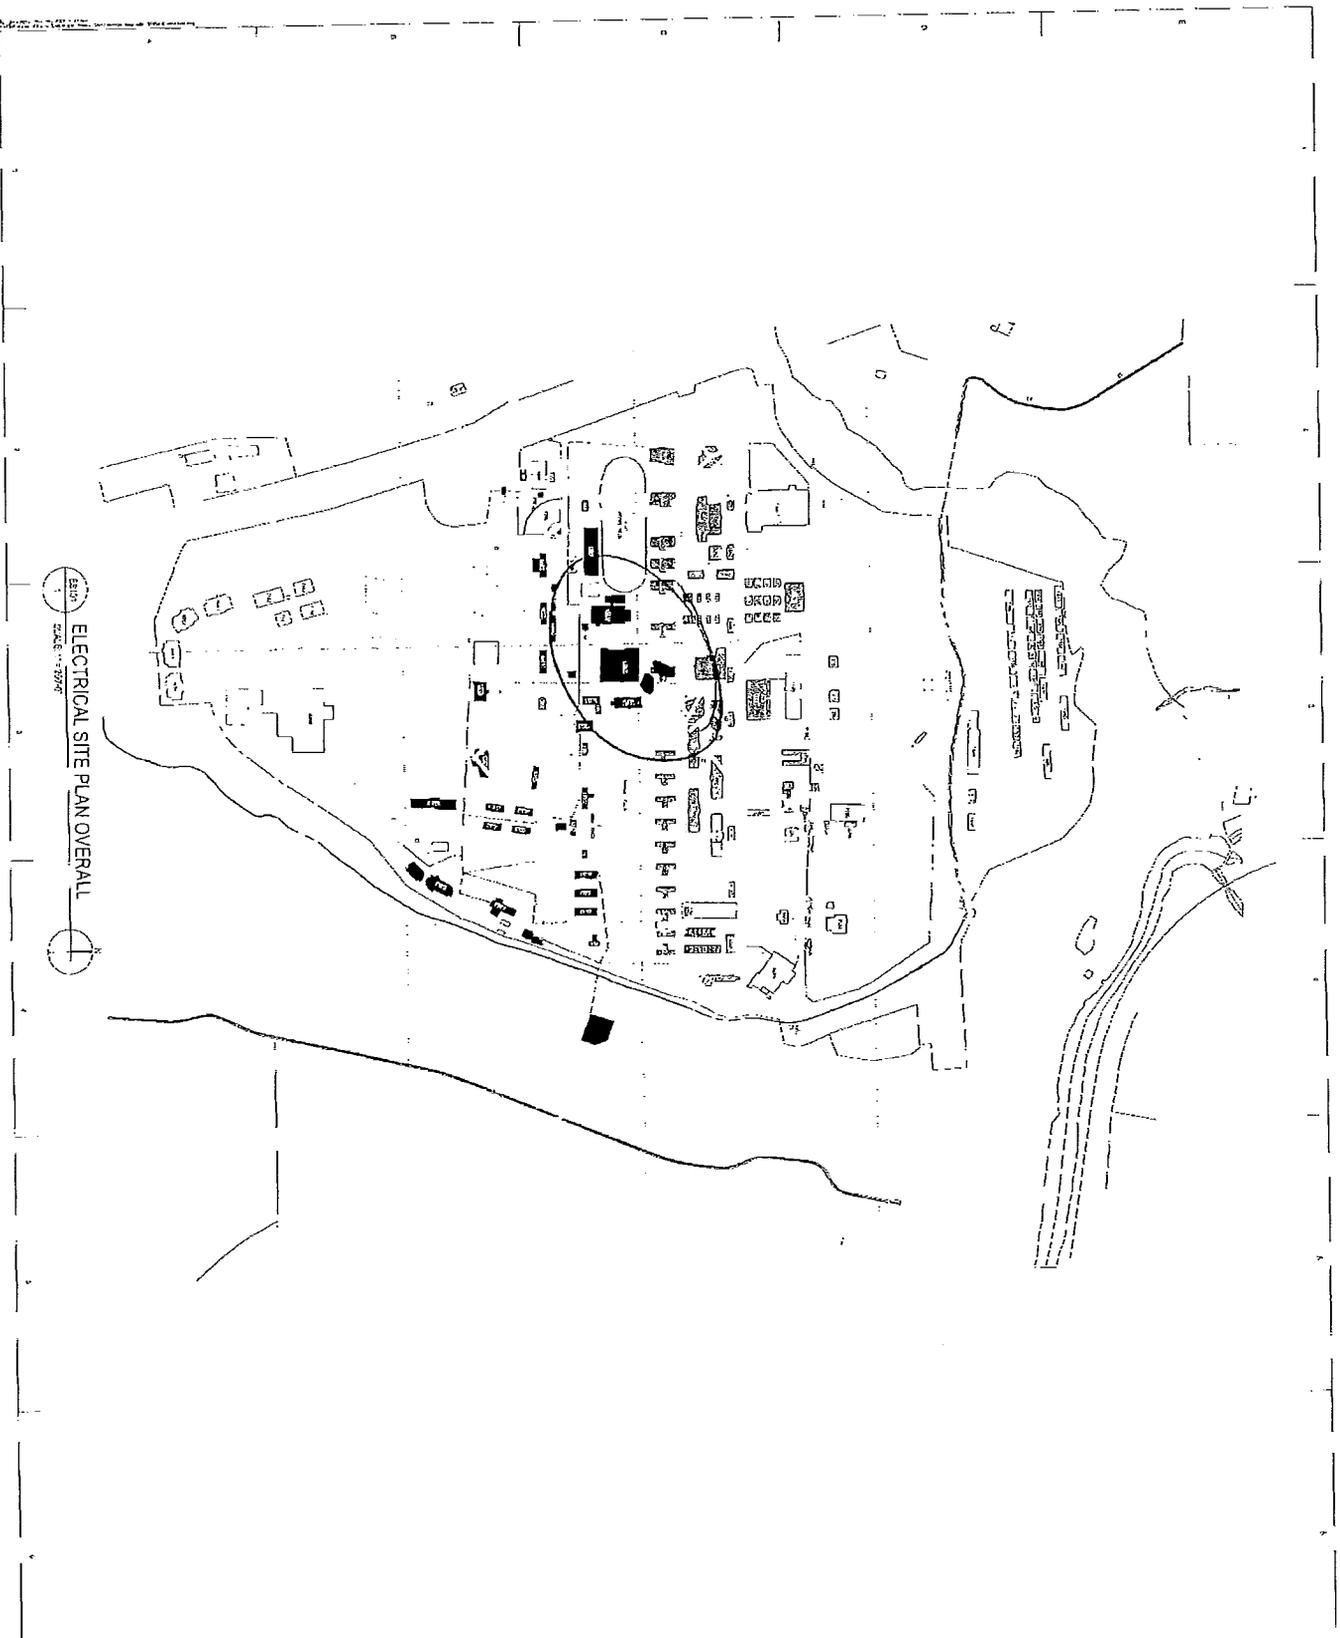
ES101
 SCALE: 1" = 100'

ELECTRICAL SITE PLAN OVERALL
